Date: 20th May, 2011

## GEOLOGICAL PRELIMINARY FIELD REPORT OF THE LORCA EARTHQUAKE (5.1 $M_w$ , 11<sup>TH</sup> MAY 2011)

*Translation from the original report in Spanish*

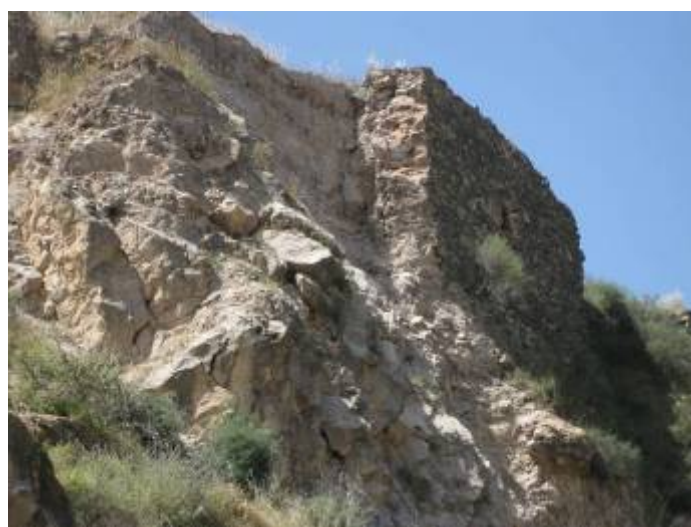
Figure 4.2.1f: Close up of the fall of part of an old retaining wall. It can be observed that the intrados filling remains meta-stable. This type of instability also appears on the south face of Lorca's castle cliff (see figure 2.1).

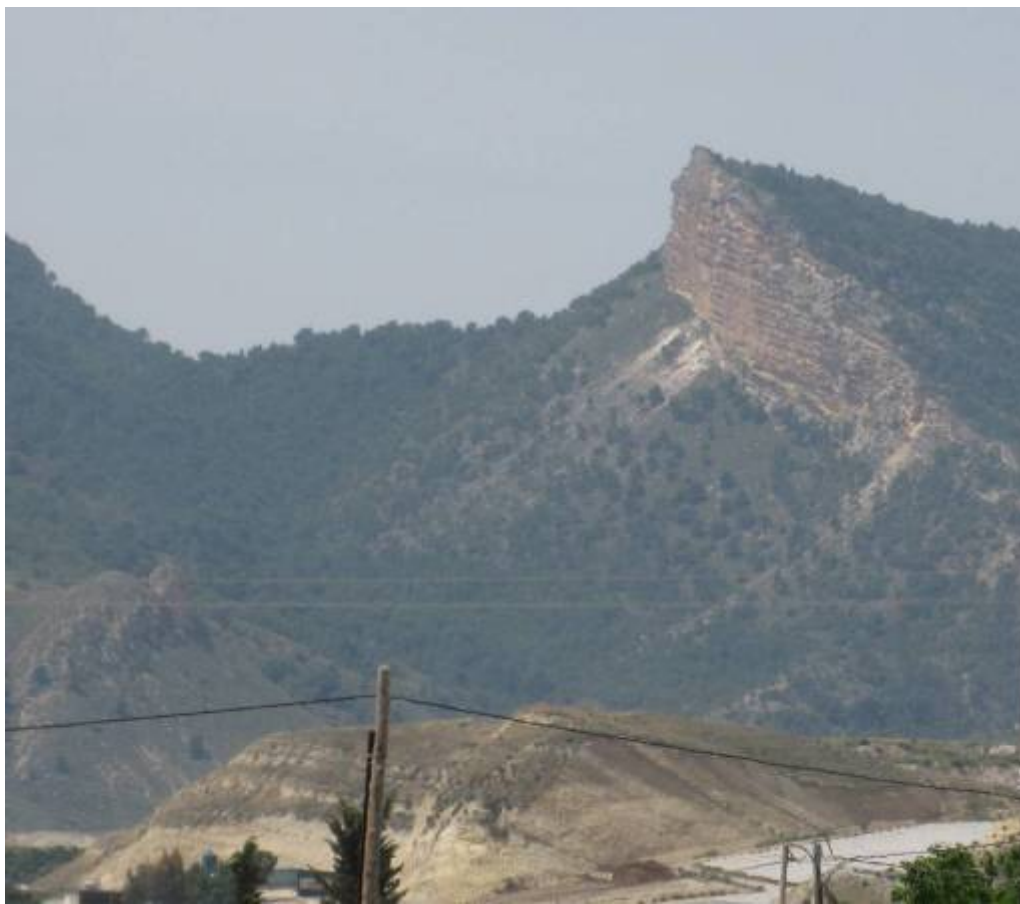
*Figura 4.4.2: Rock-falls and rock-debris at the Cejo de los Enamorados.*

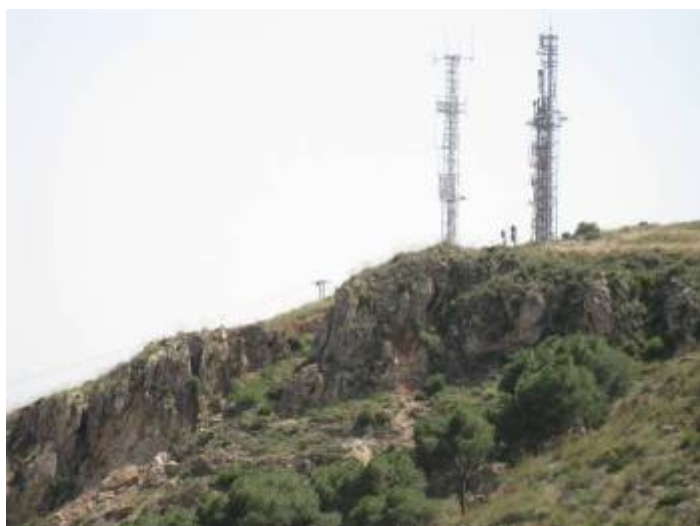
*Figure 4.5: Communications towers founded on a hill situated in front of the westernmost end of Lorca's castle cliff. Two recent instabilities are shown, which are attributed to the 11 May earthquakes.*

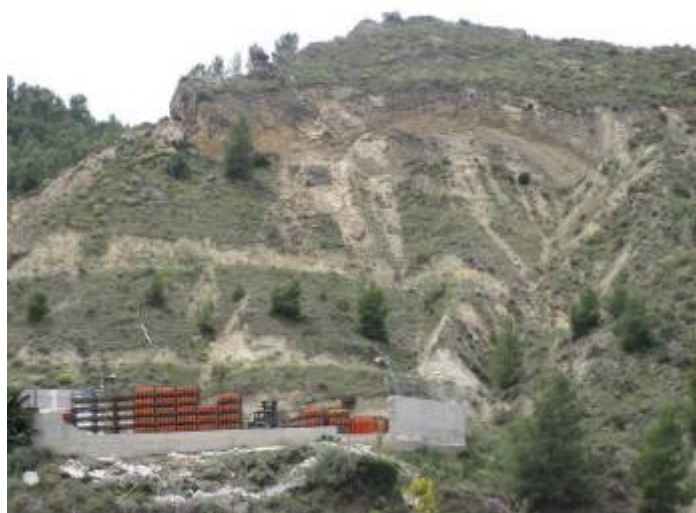
*Figure 4.6: View of the slope enclosing a butane-gas storage site on the Pantano de Puentes road. No slope instabilities that could be attributed to the earthquakes were identified here, although the collapse of the concrete-brick wall is attributed to them.*

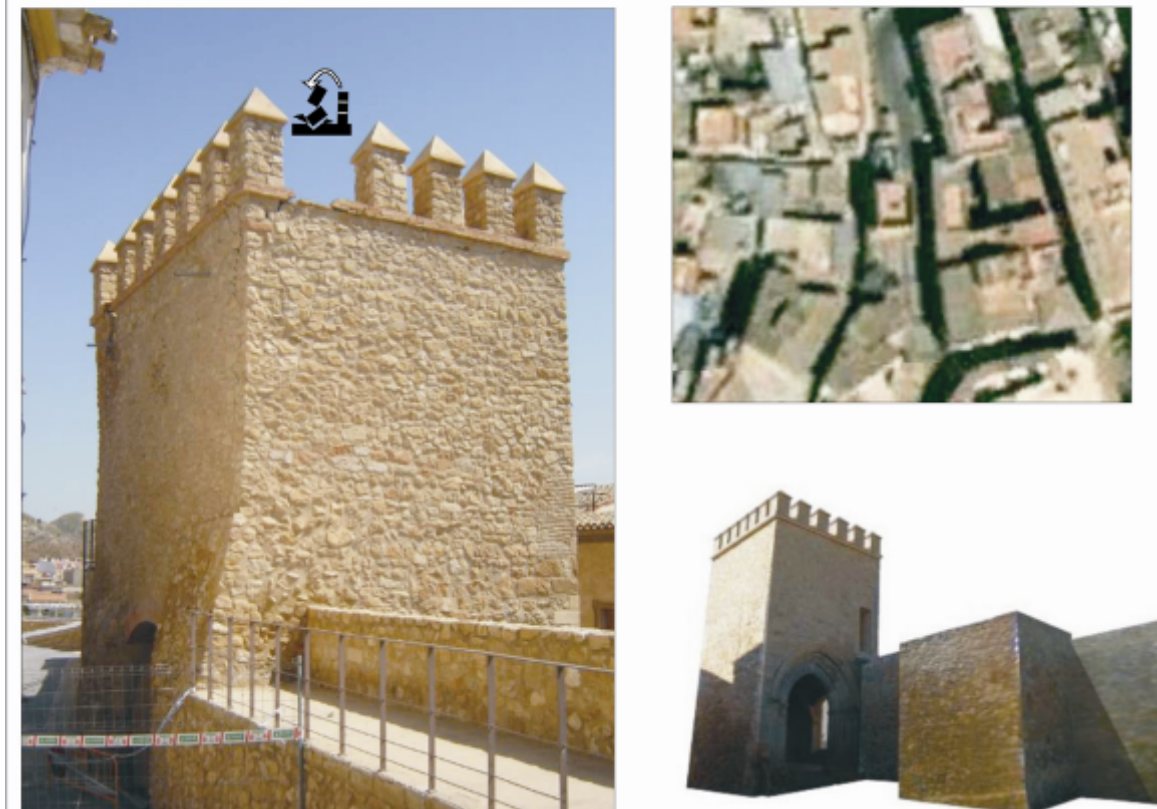
## Almena del Porche de San Antonio

Figure 5.4: Damage in the battlements of the entrance of San Antonio (Tower of the old defensive wall of the Islamic Period).
