Quick field report

Lorca earthquake 11th May 2011

Patrick Murphy Corella

Broadway Malyan

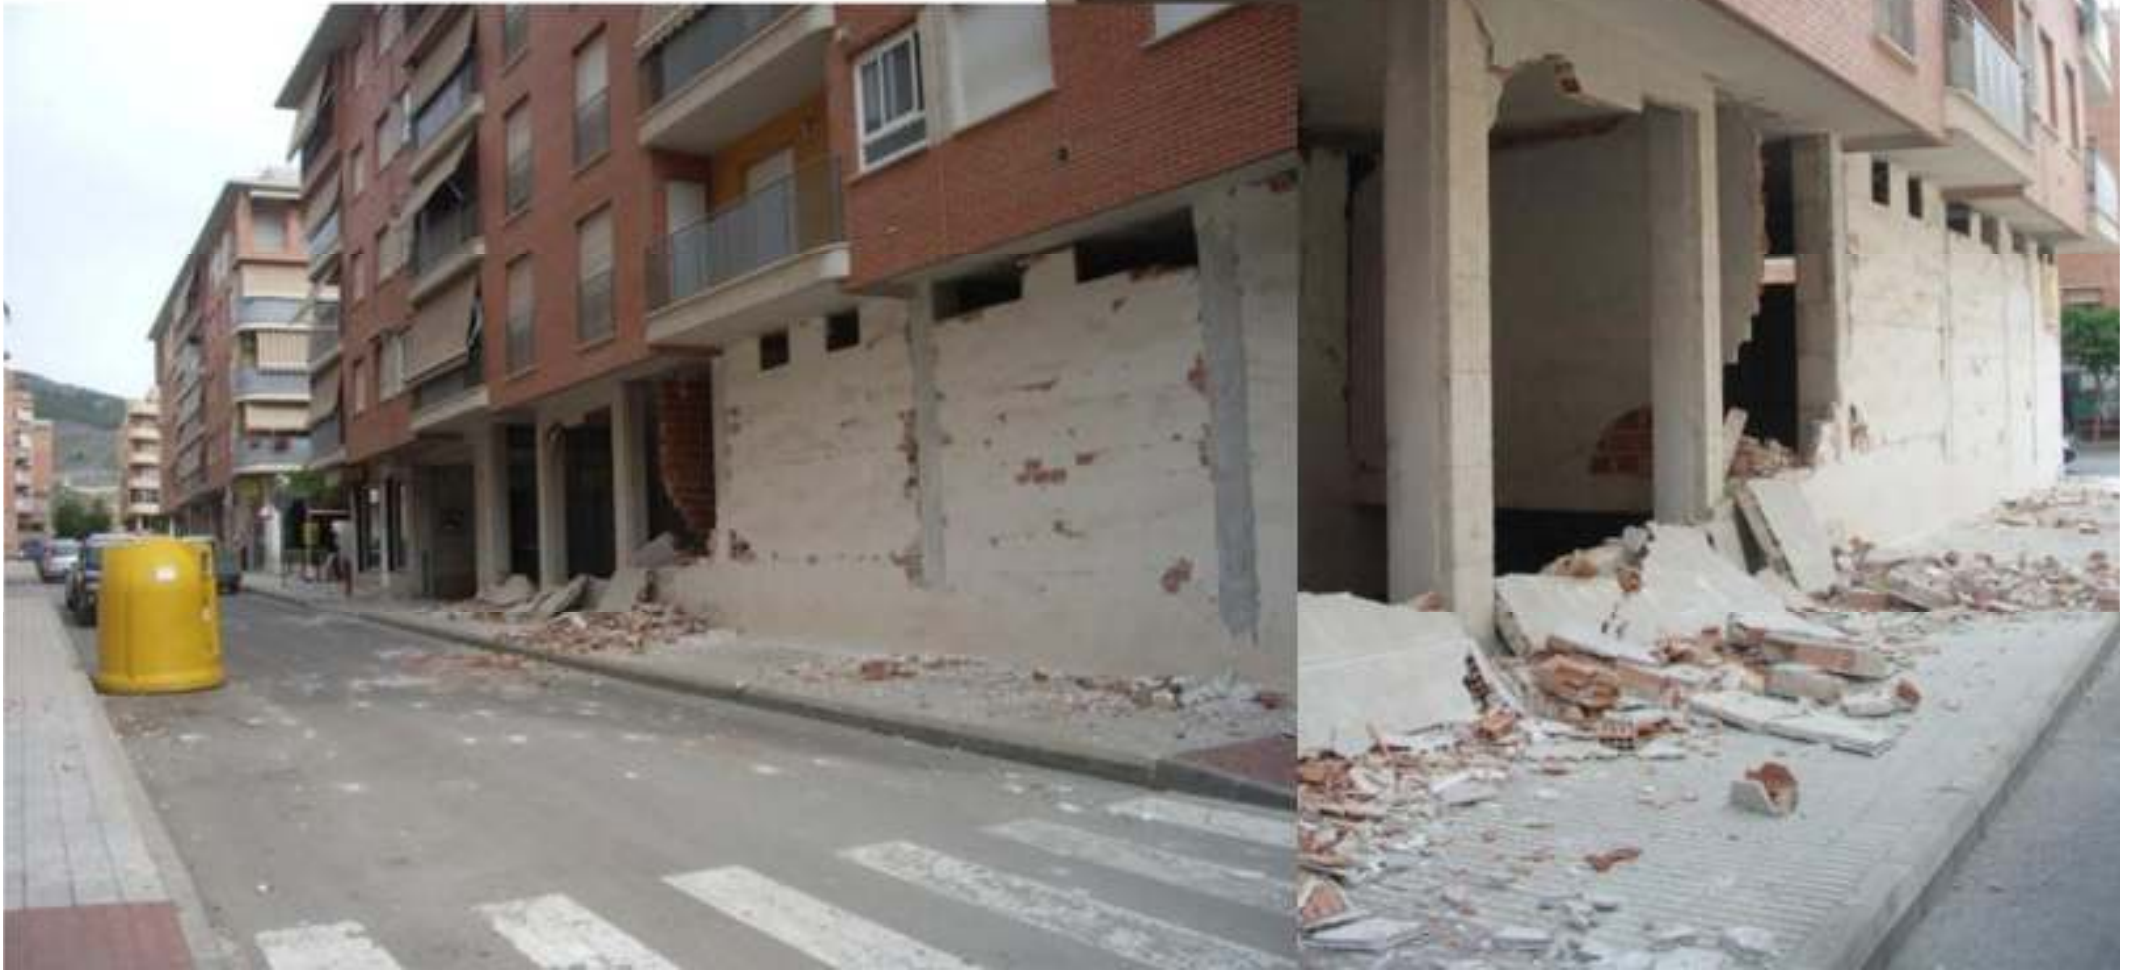
SEVERE DEFORMATION ON GROUND FLOOR SOFT STOREYS

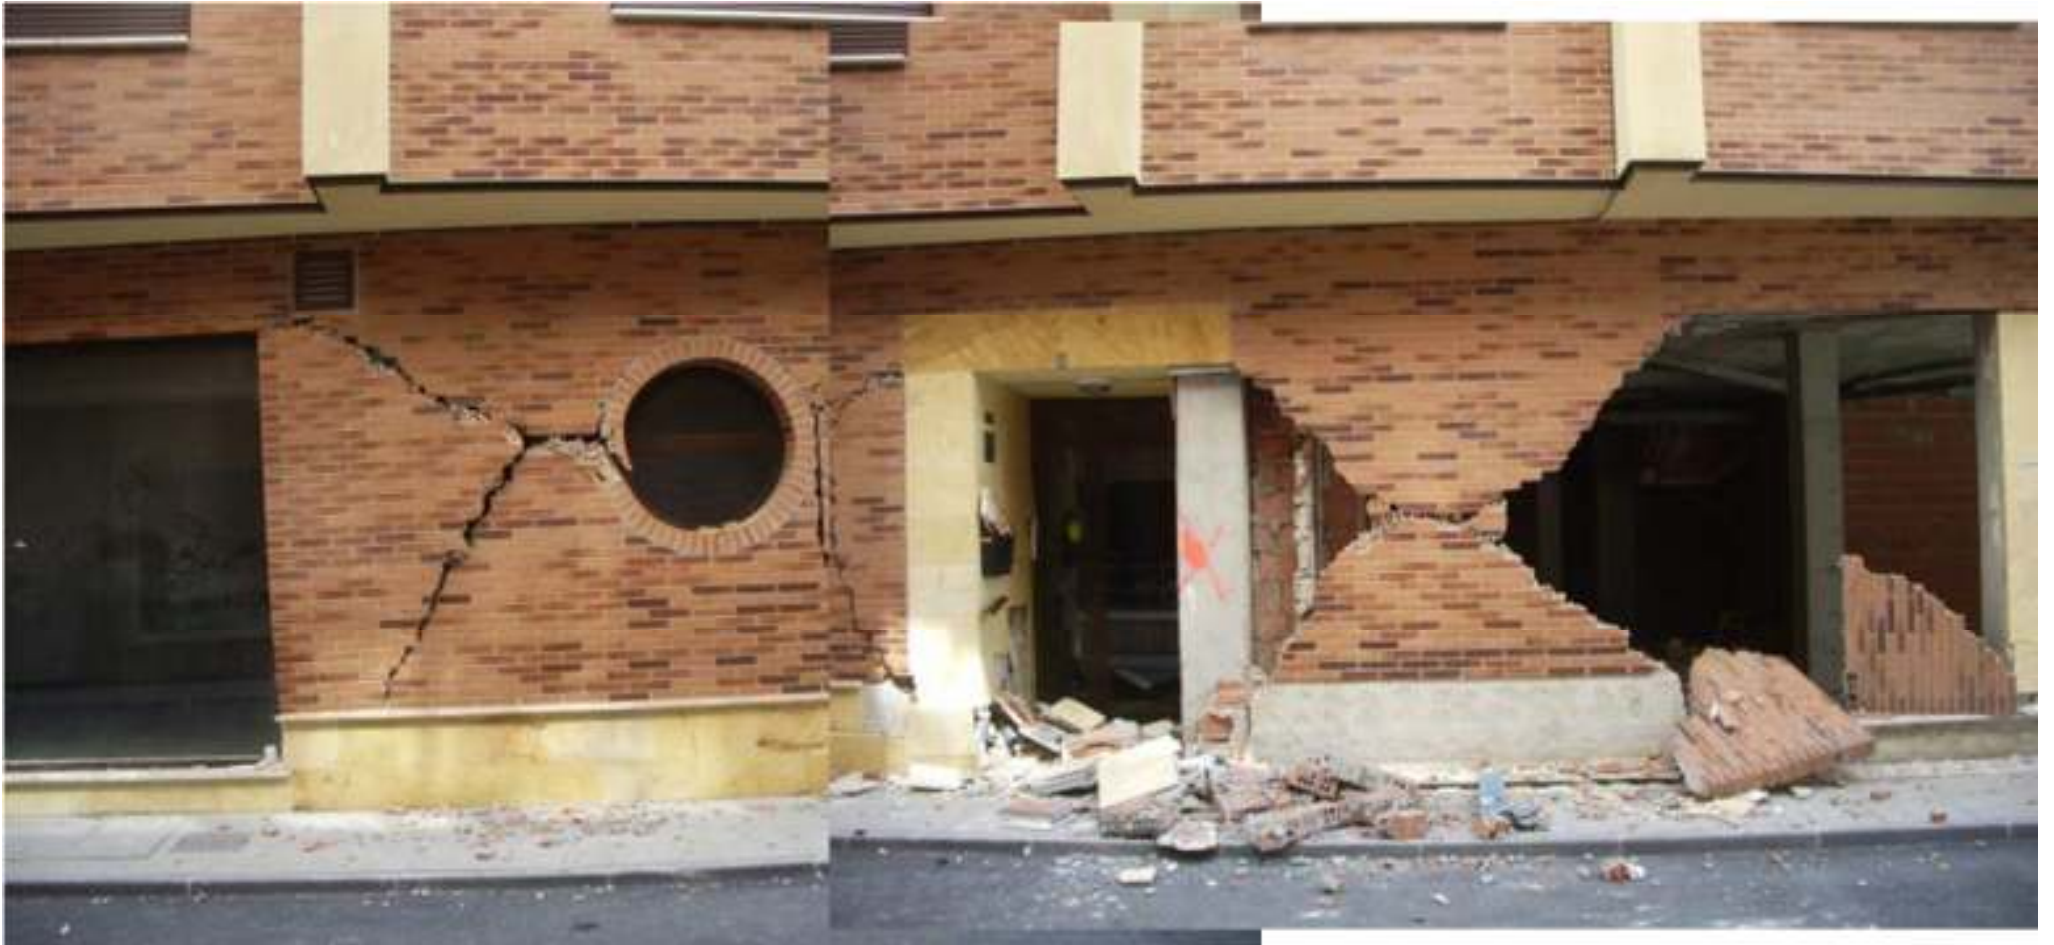
SEVERE DEFORMATION ON GROUND FLOOR SOFT STOREYS

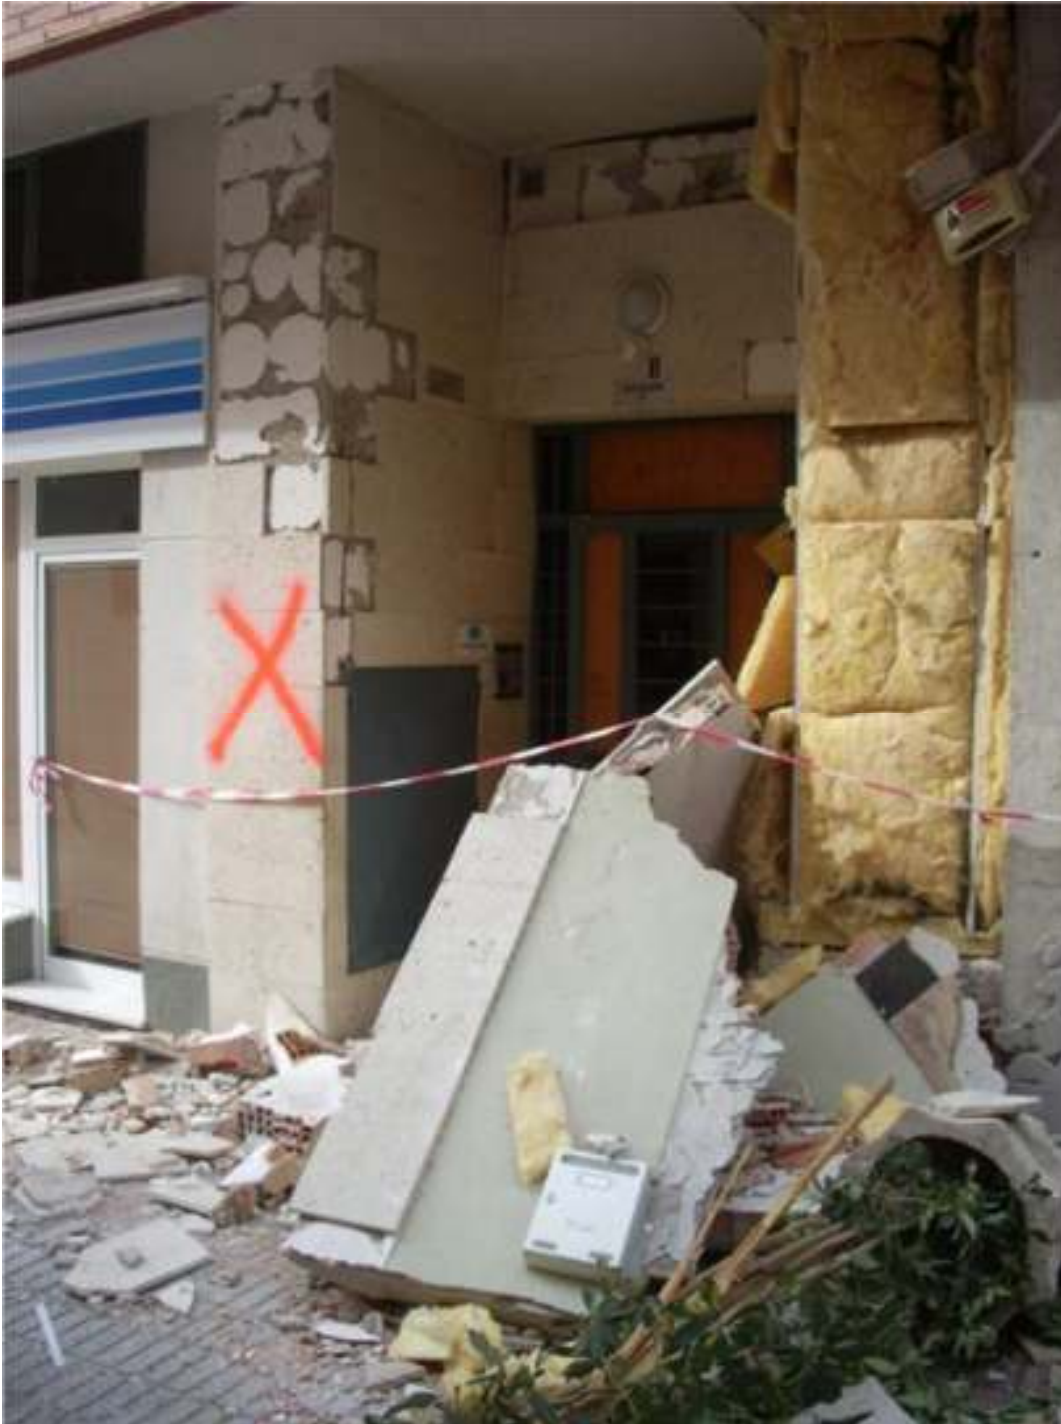
EXPELLED MASONRY PANELS

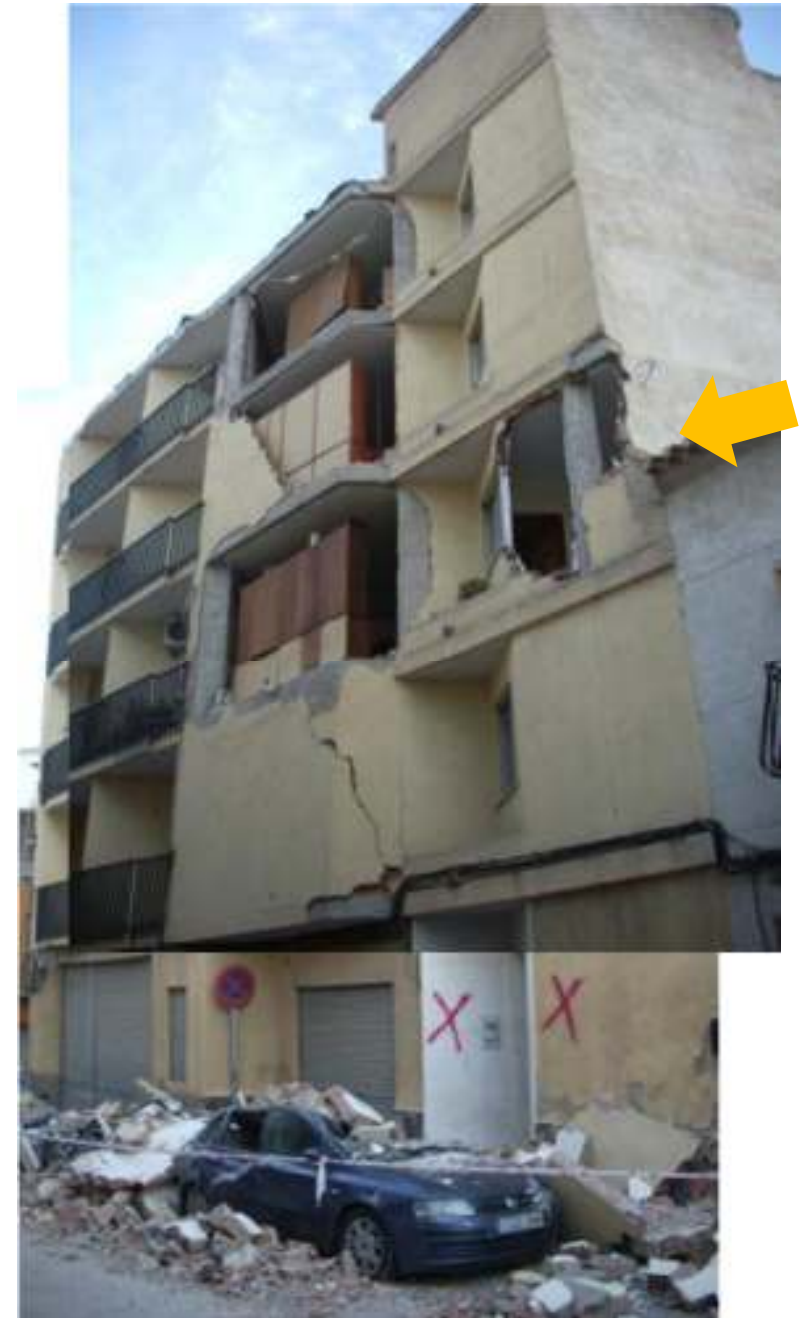
POUNDING DAMAGE

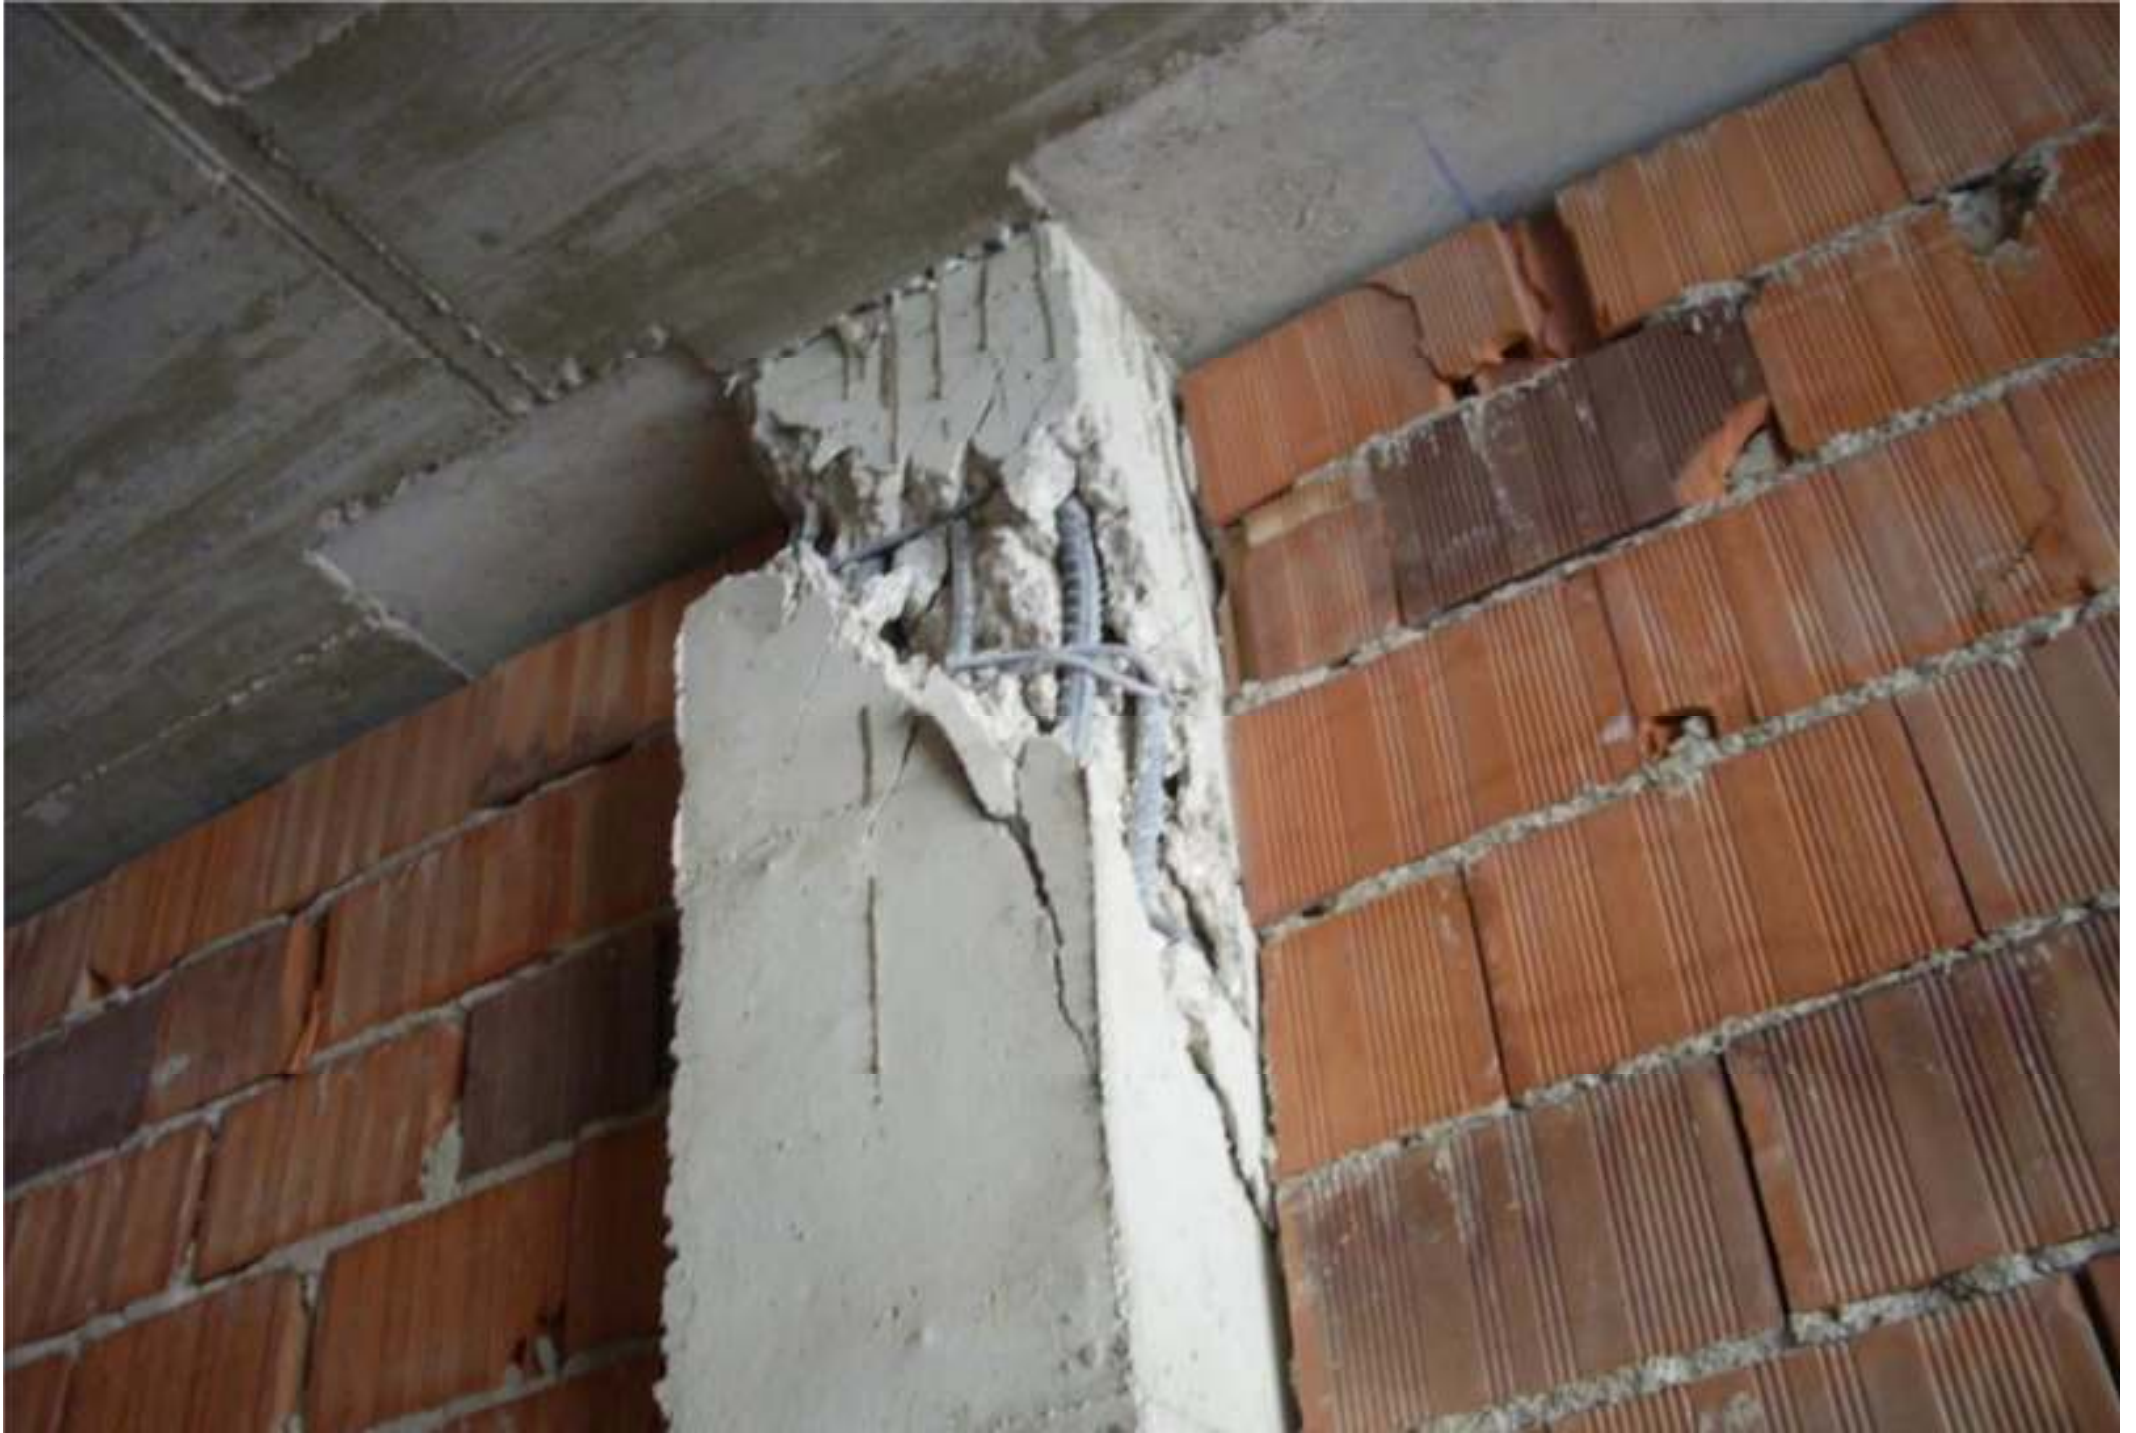
SHEAR FALIURE ON COLUMN HEADS

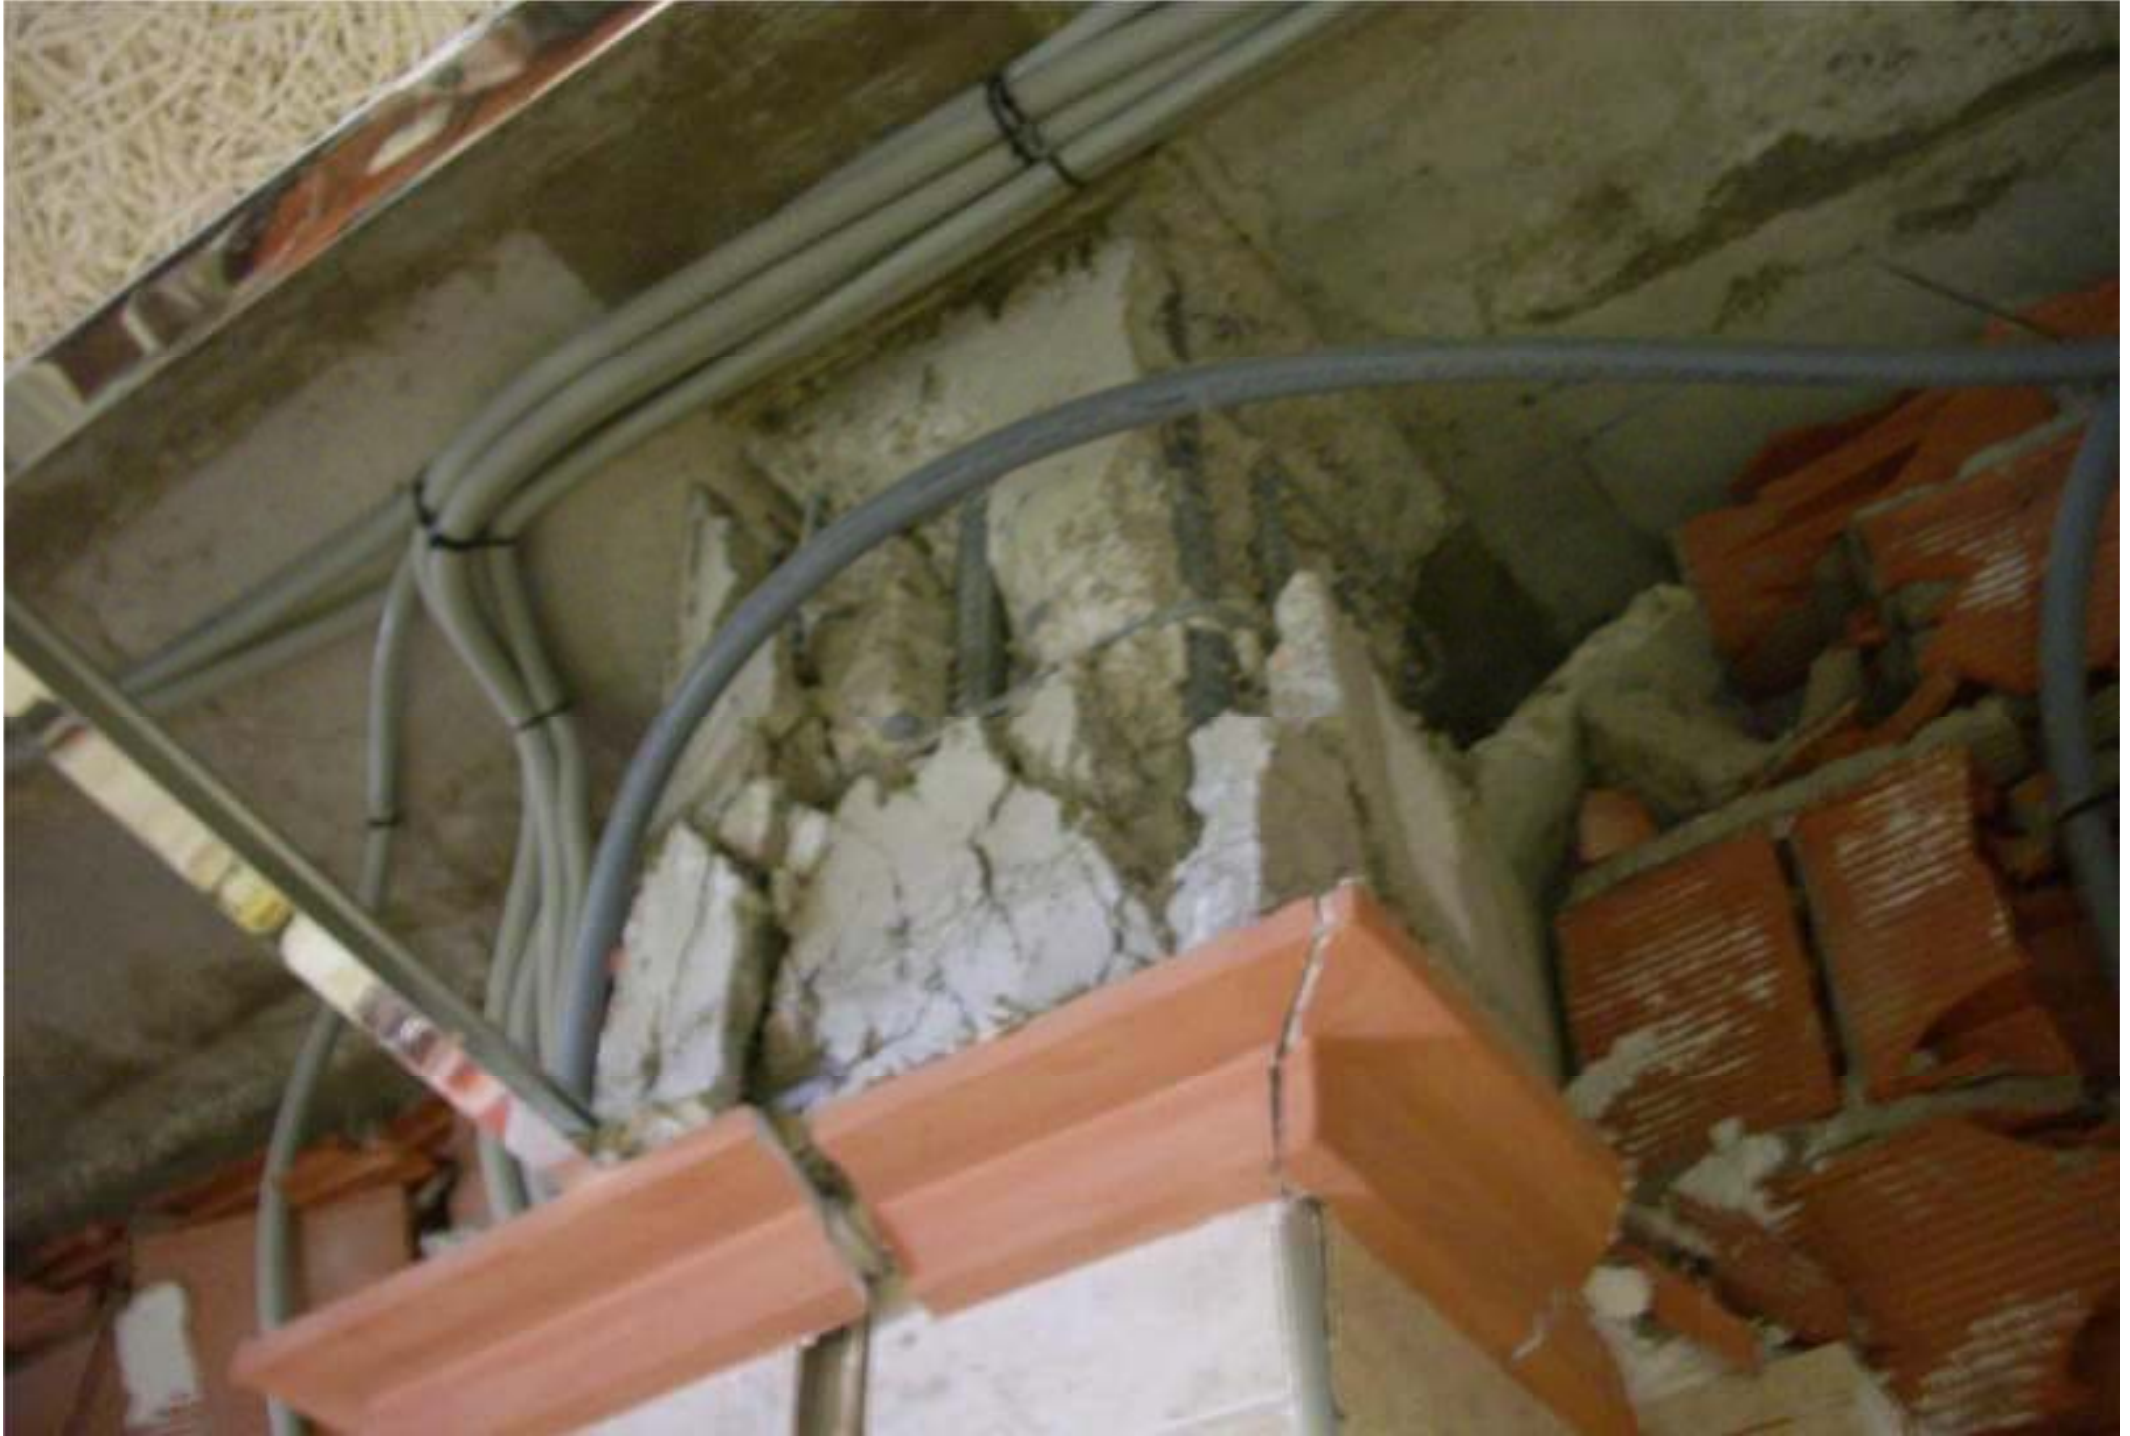
SHEAR FAILURE ON COLUMN HEADS- INADEQUATE LOOPING

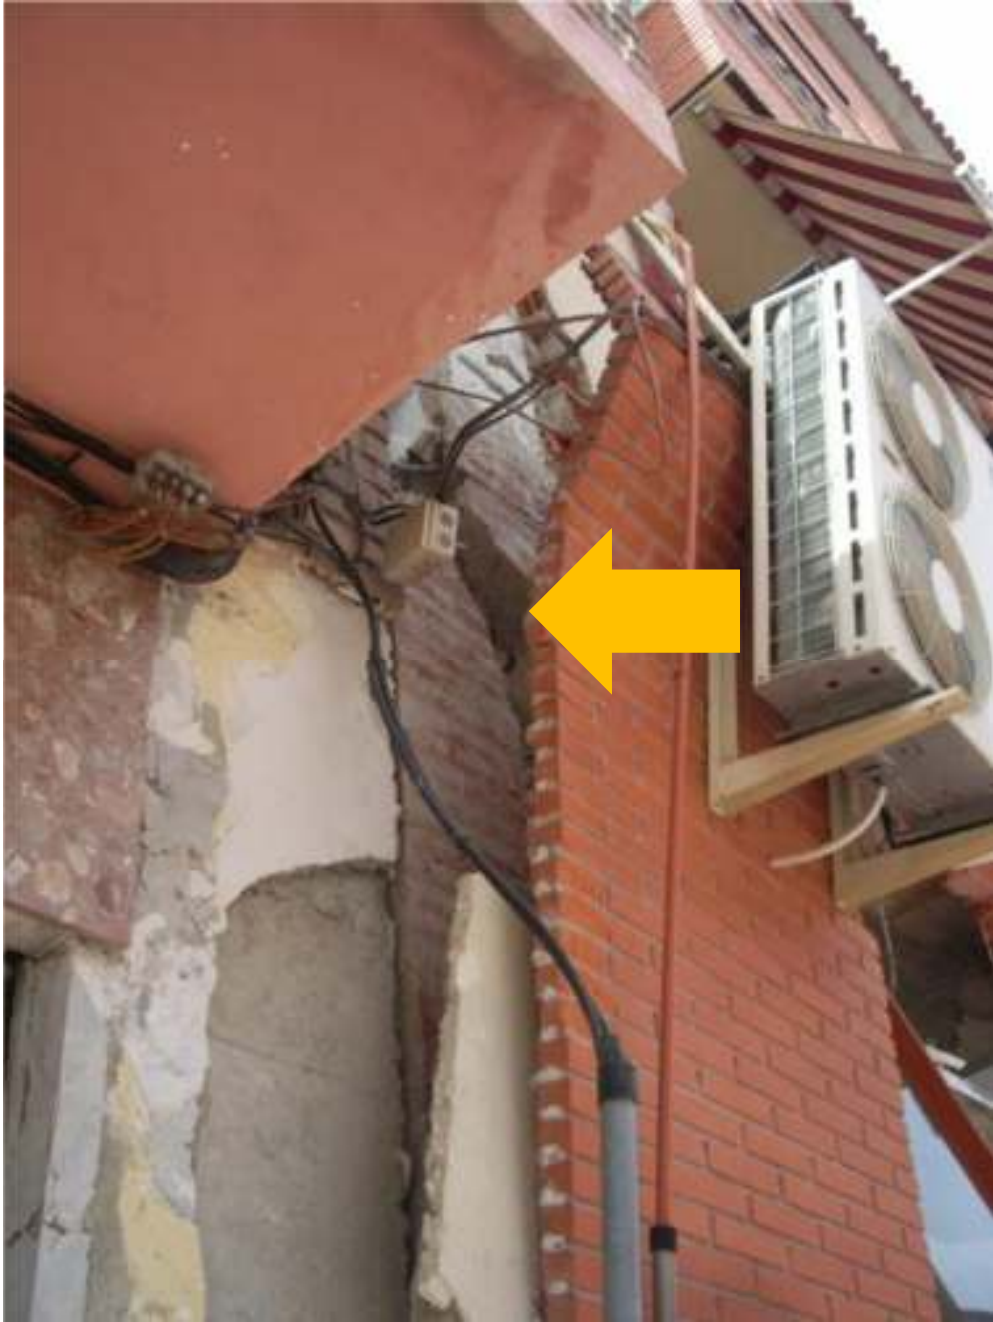
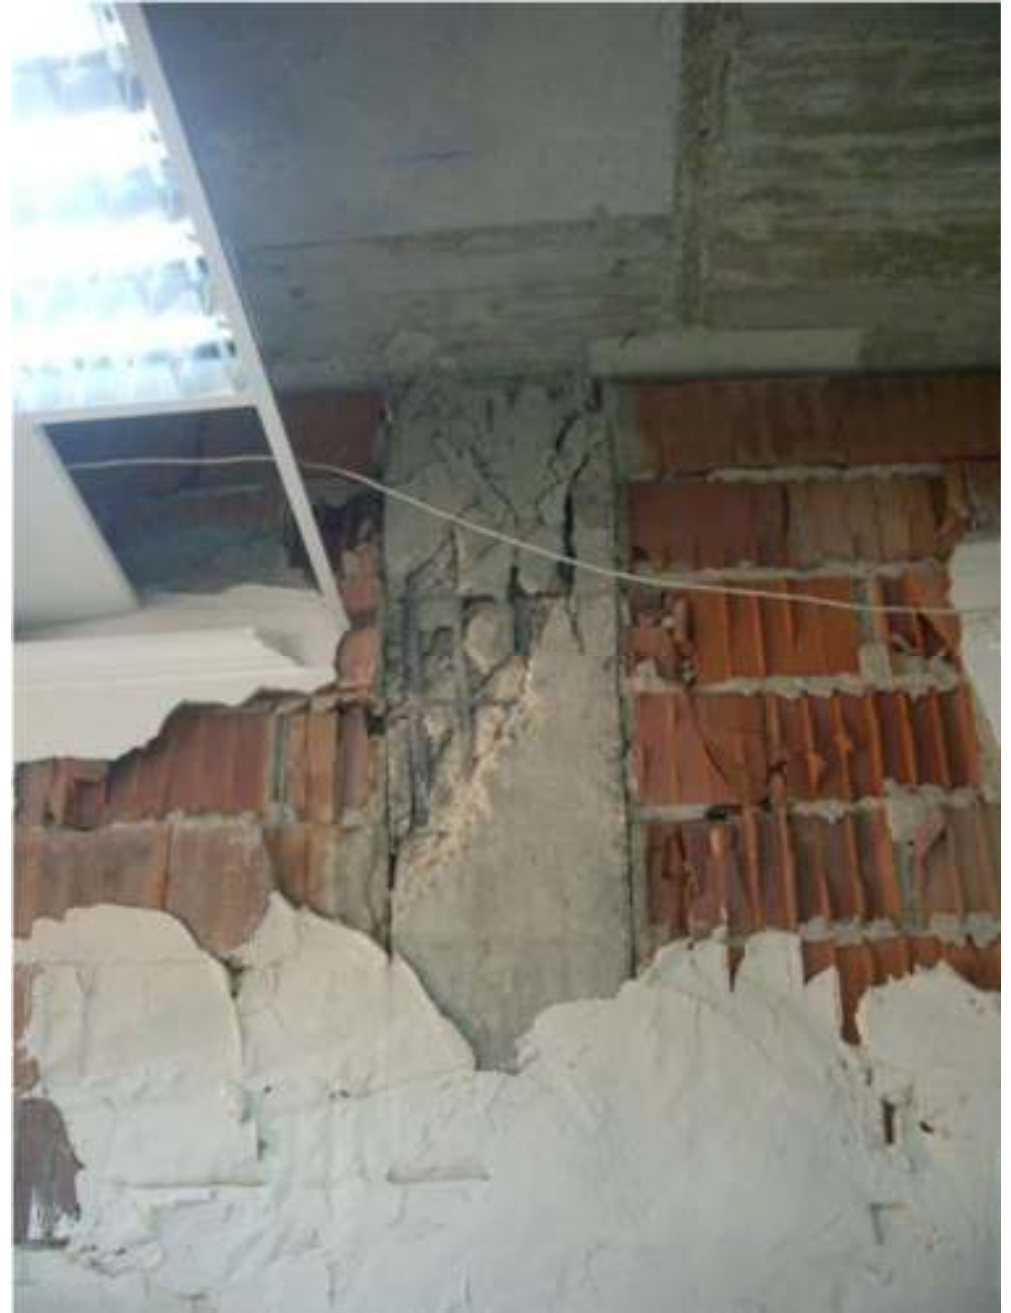
SHEAR FAILURE ON COLUMN HEADS- INADEQUATE LOOPING

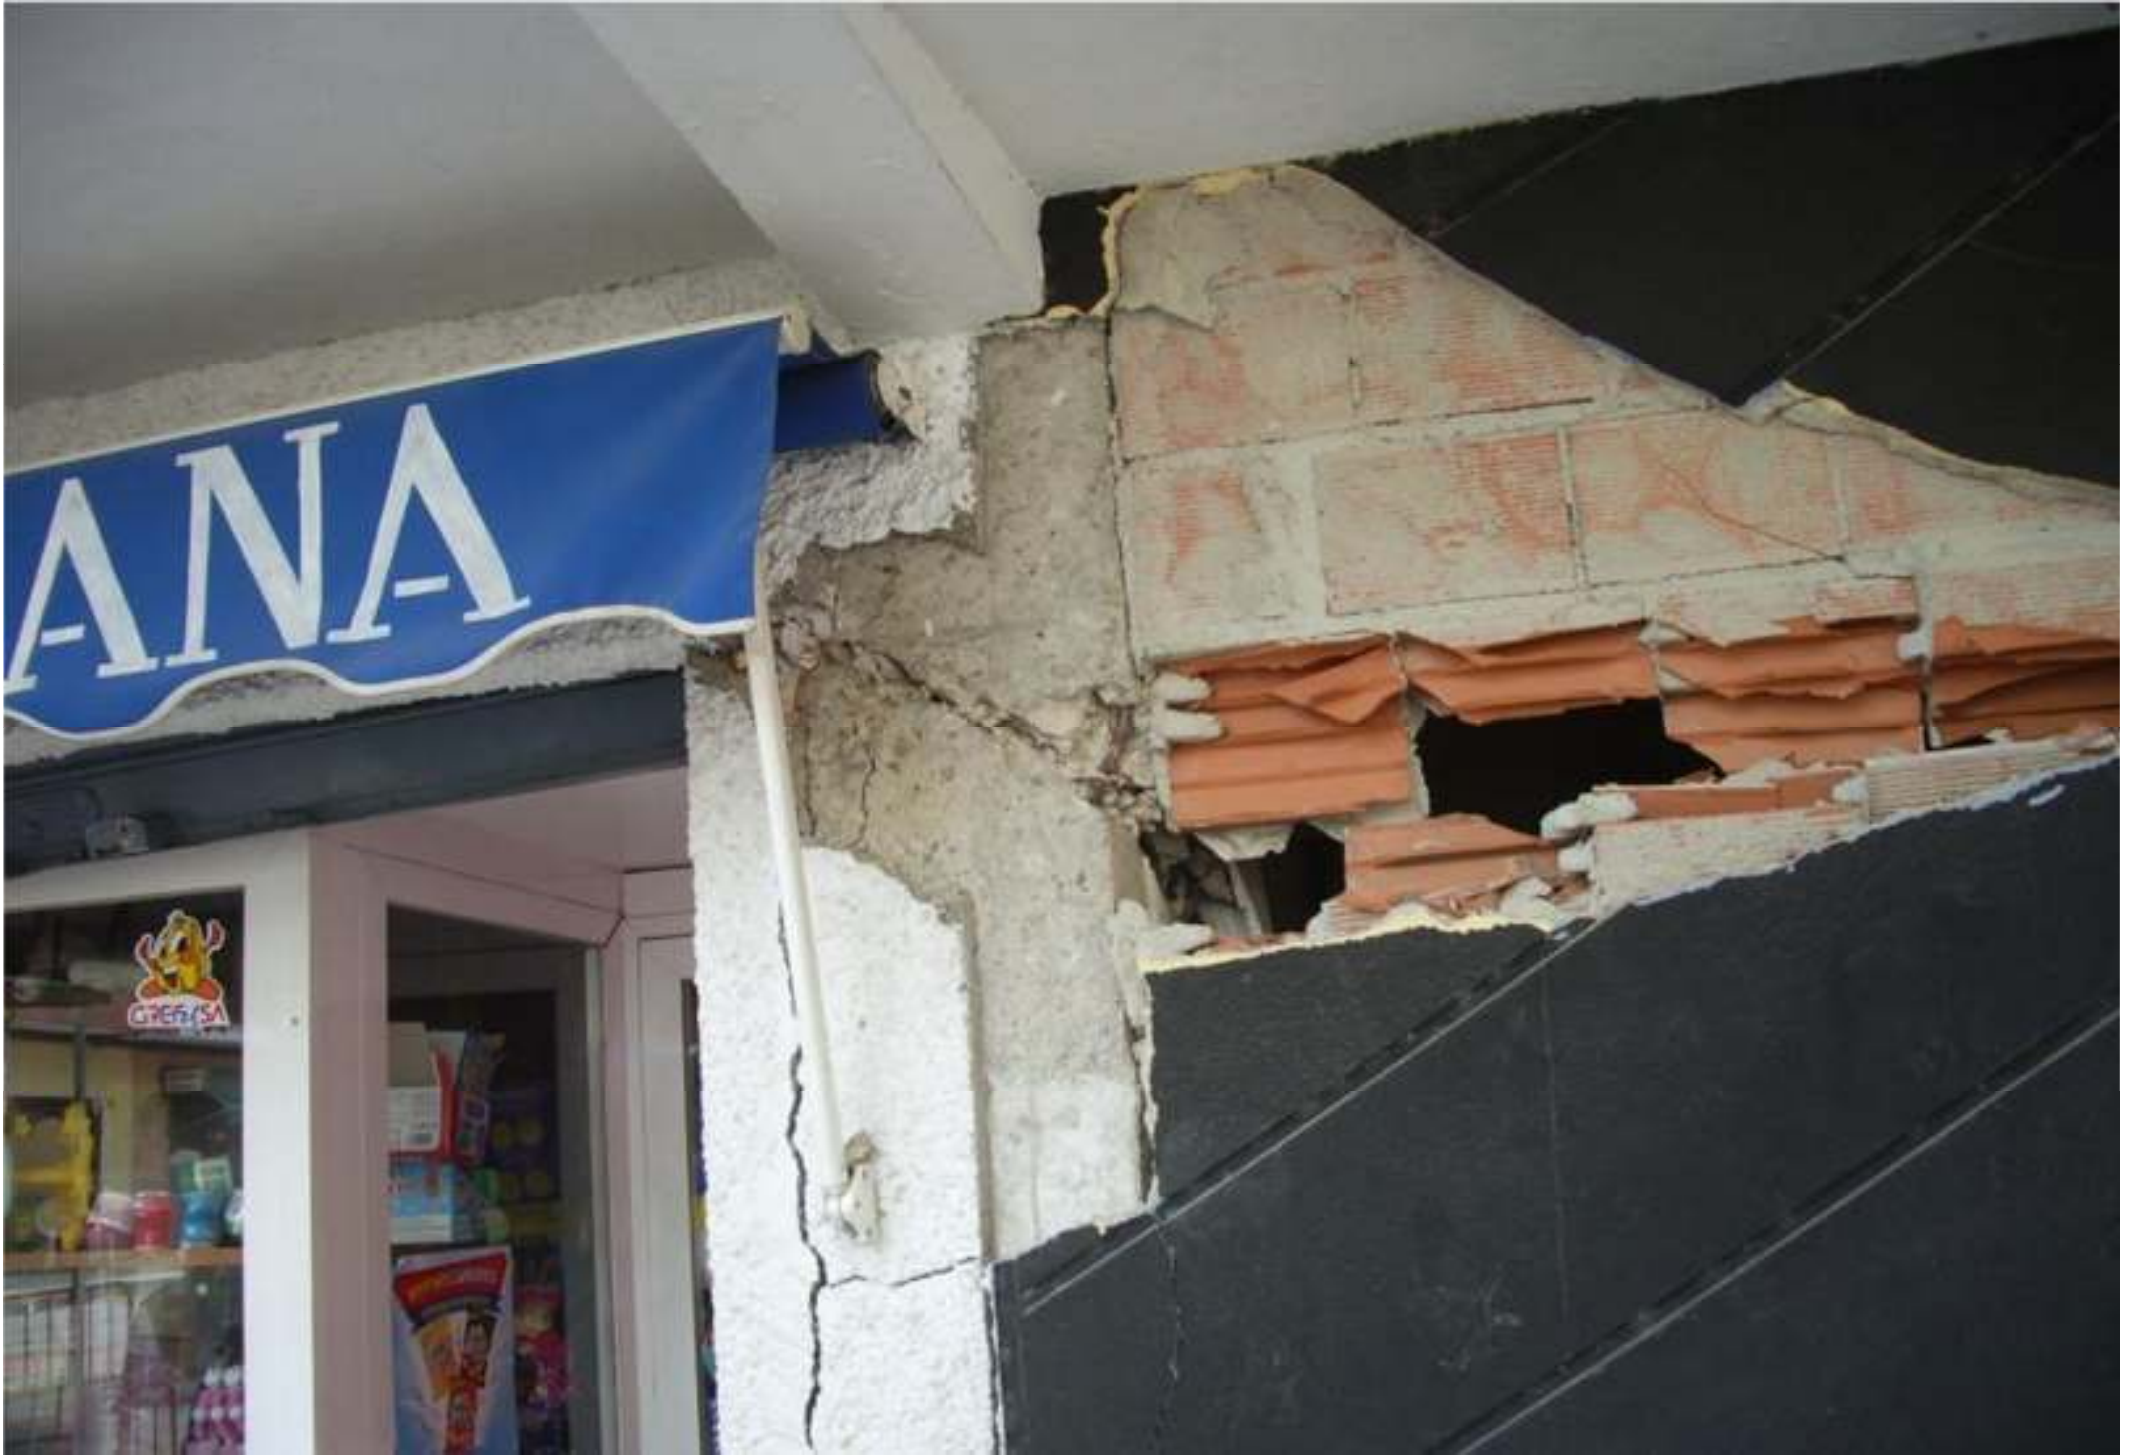
SHEAR FAILURE ON COLUMN HEADS- INADEQUATE LOOPING

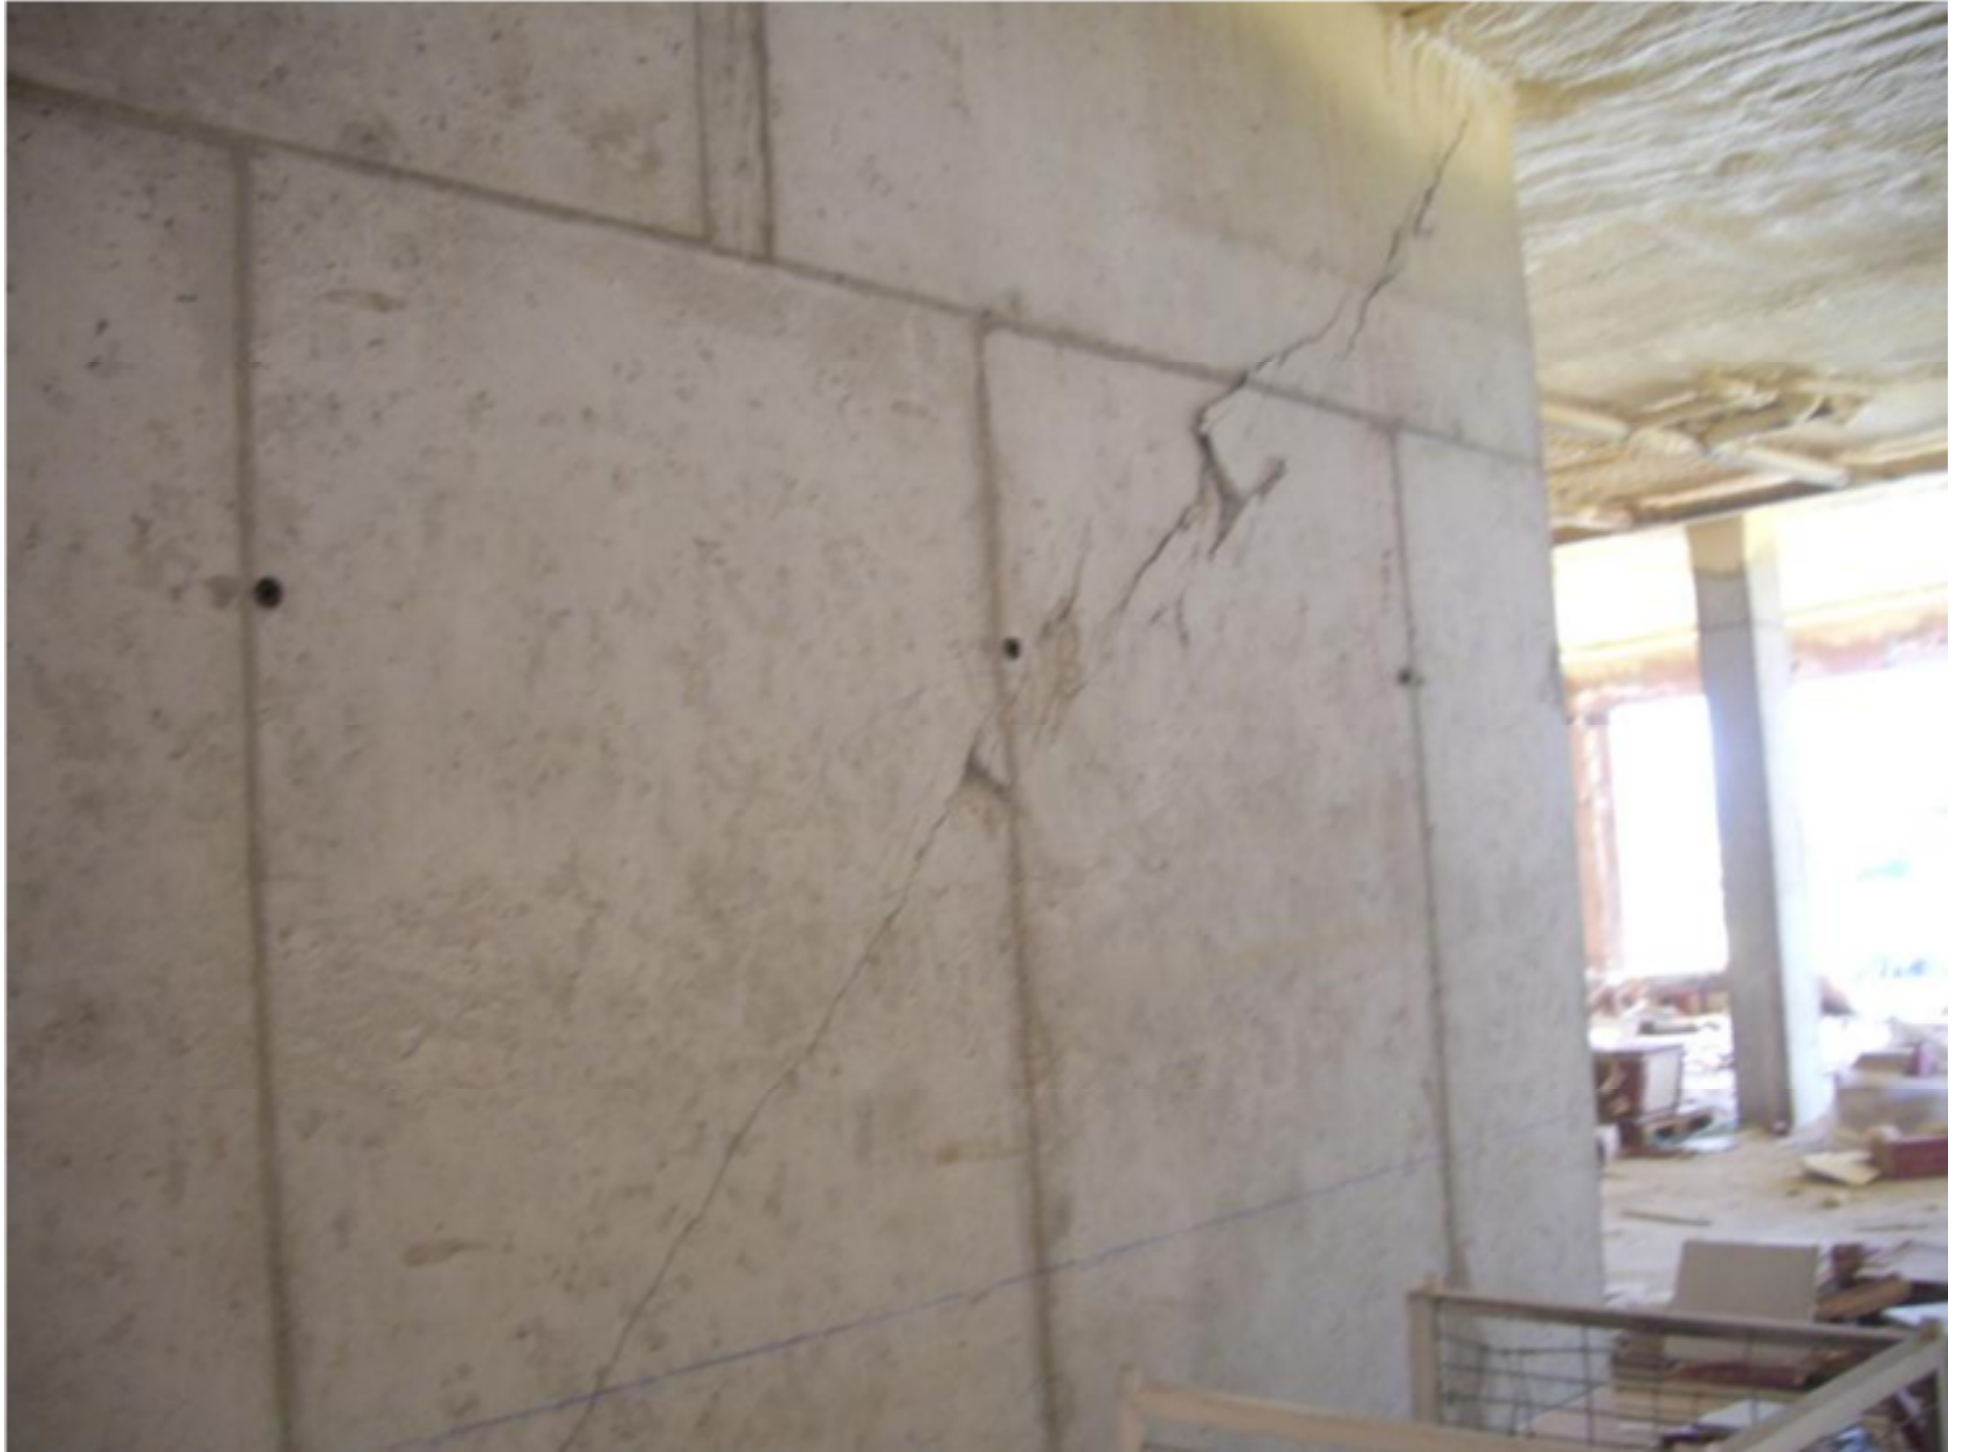
SHEAR DAMAGE ON LIFT SHEAR WALL
