Quick field report

Lorca earthquake 11th May 2011

Patrick Murphy Corella

Broadway Malyan

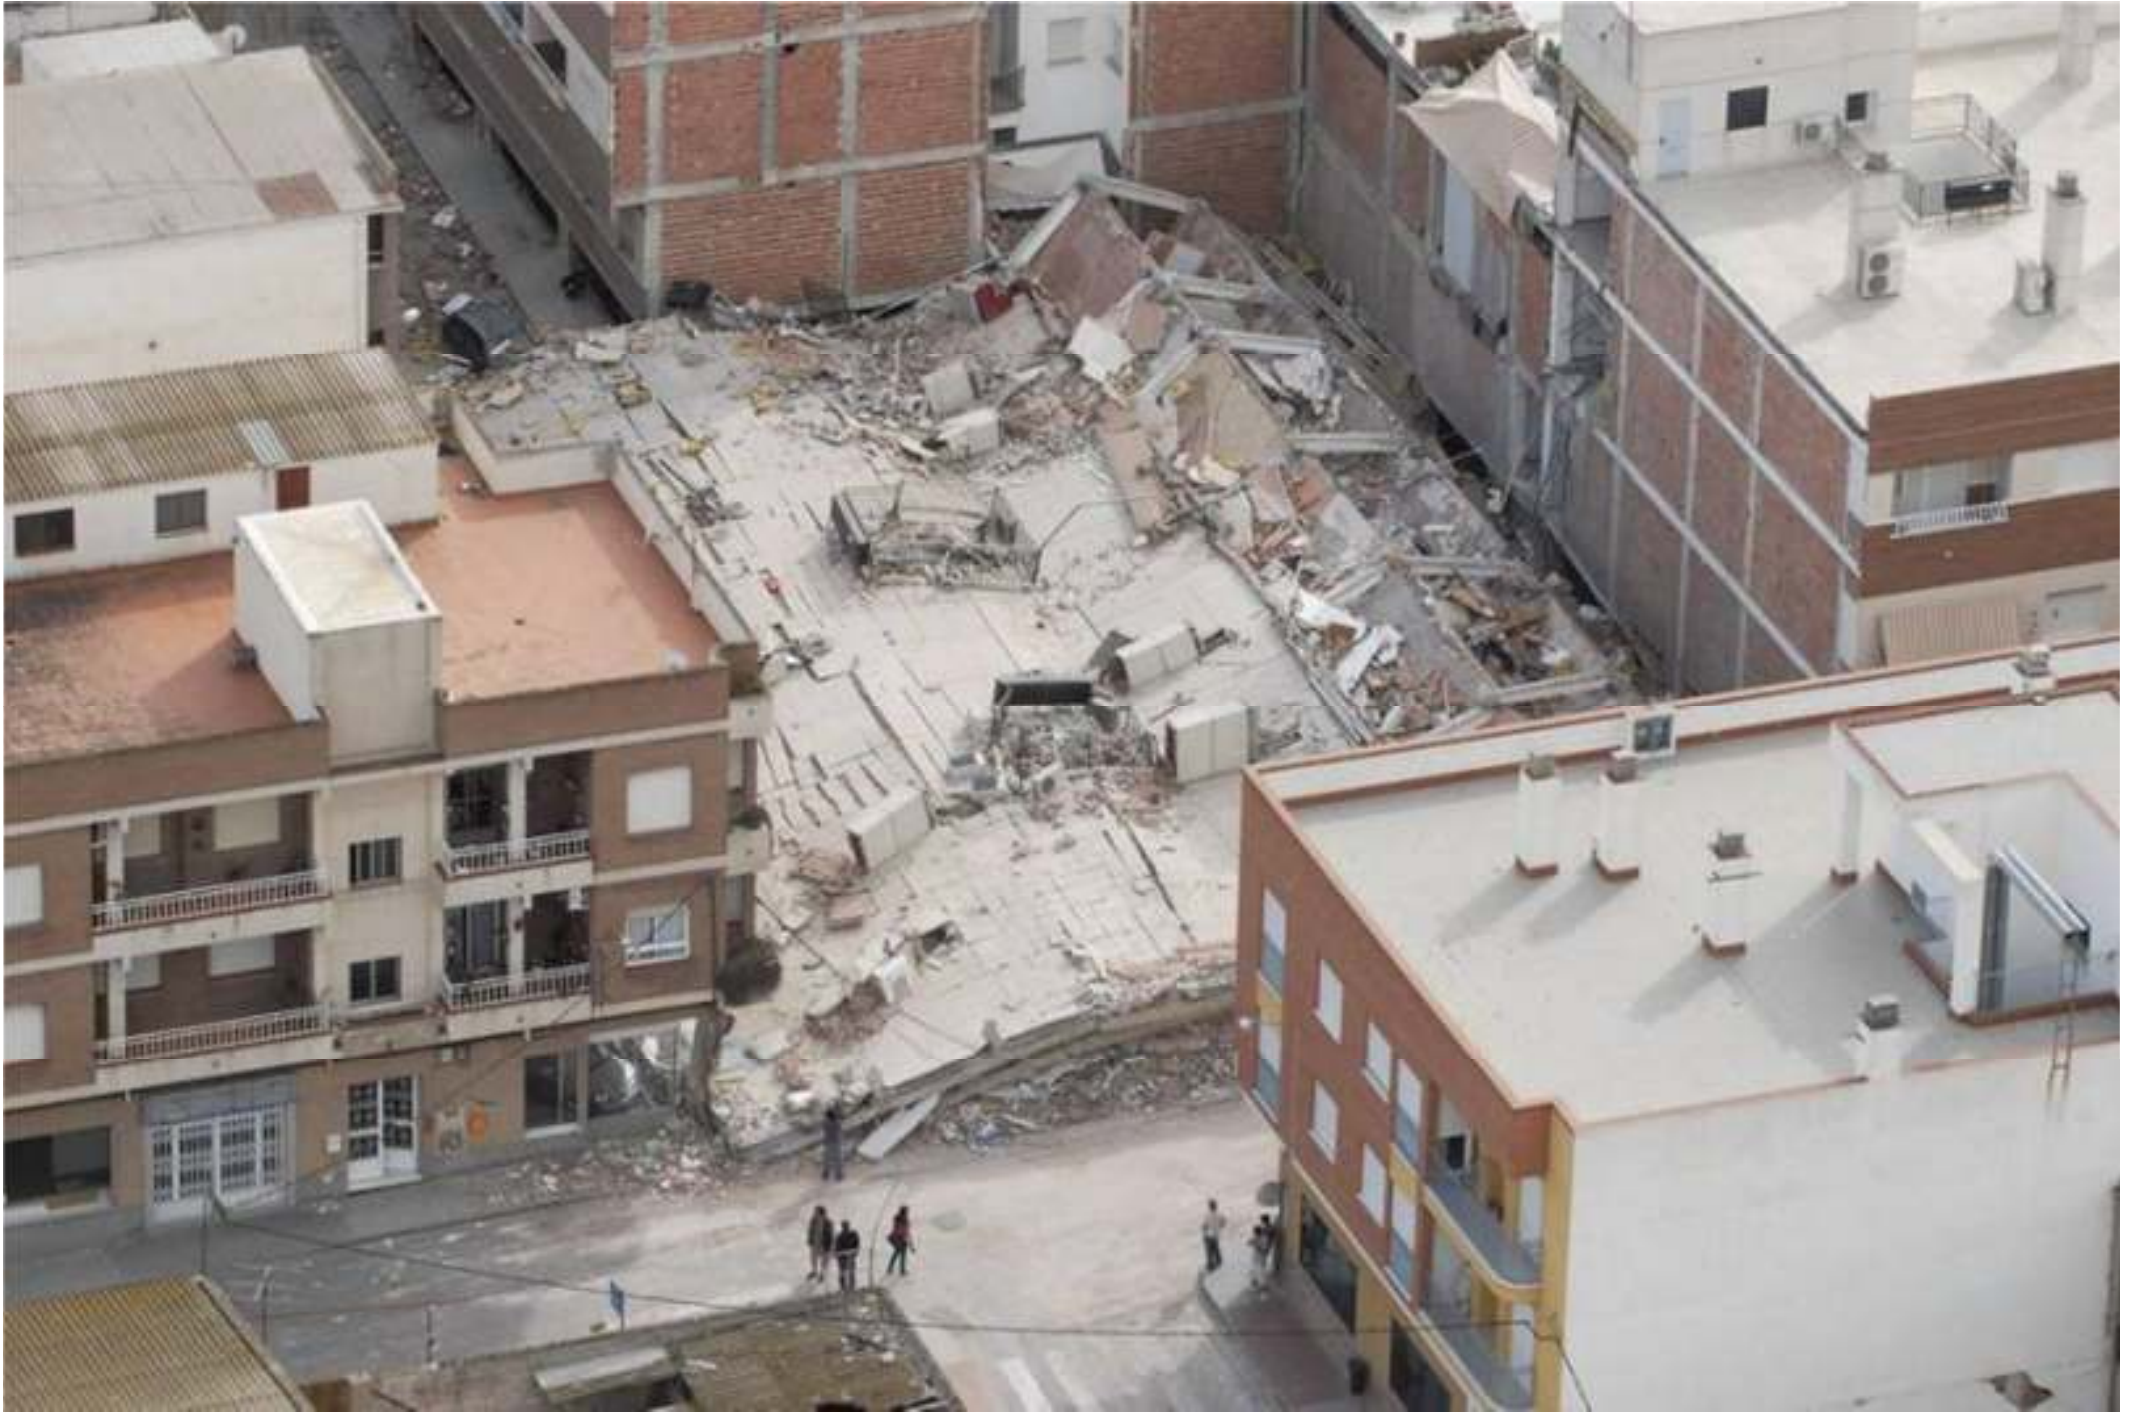
'PANCAKE COLLAPSE'

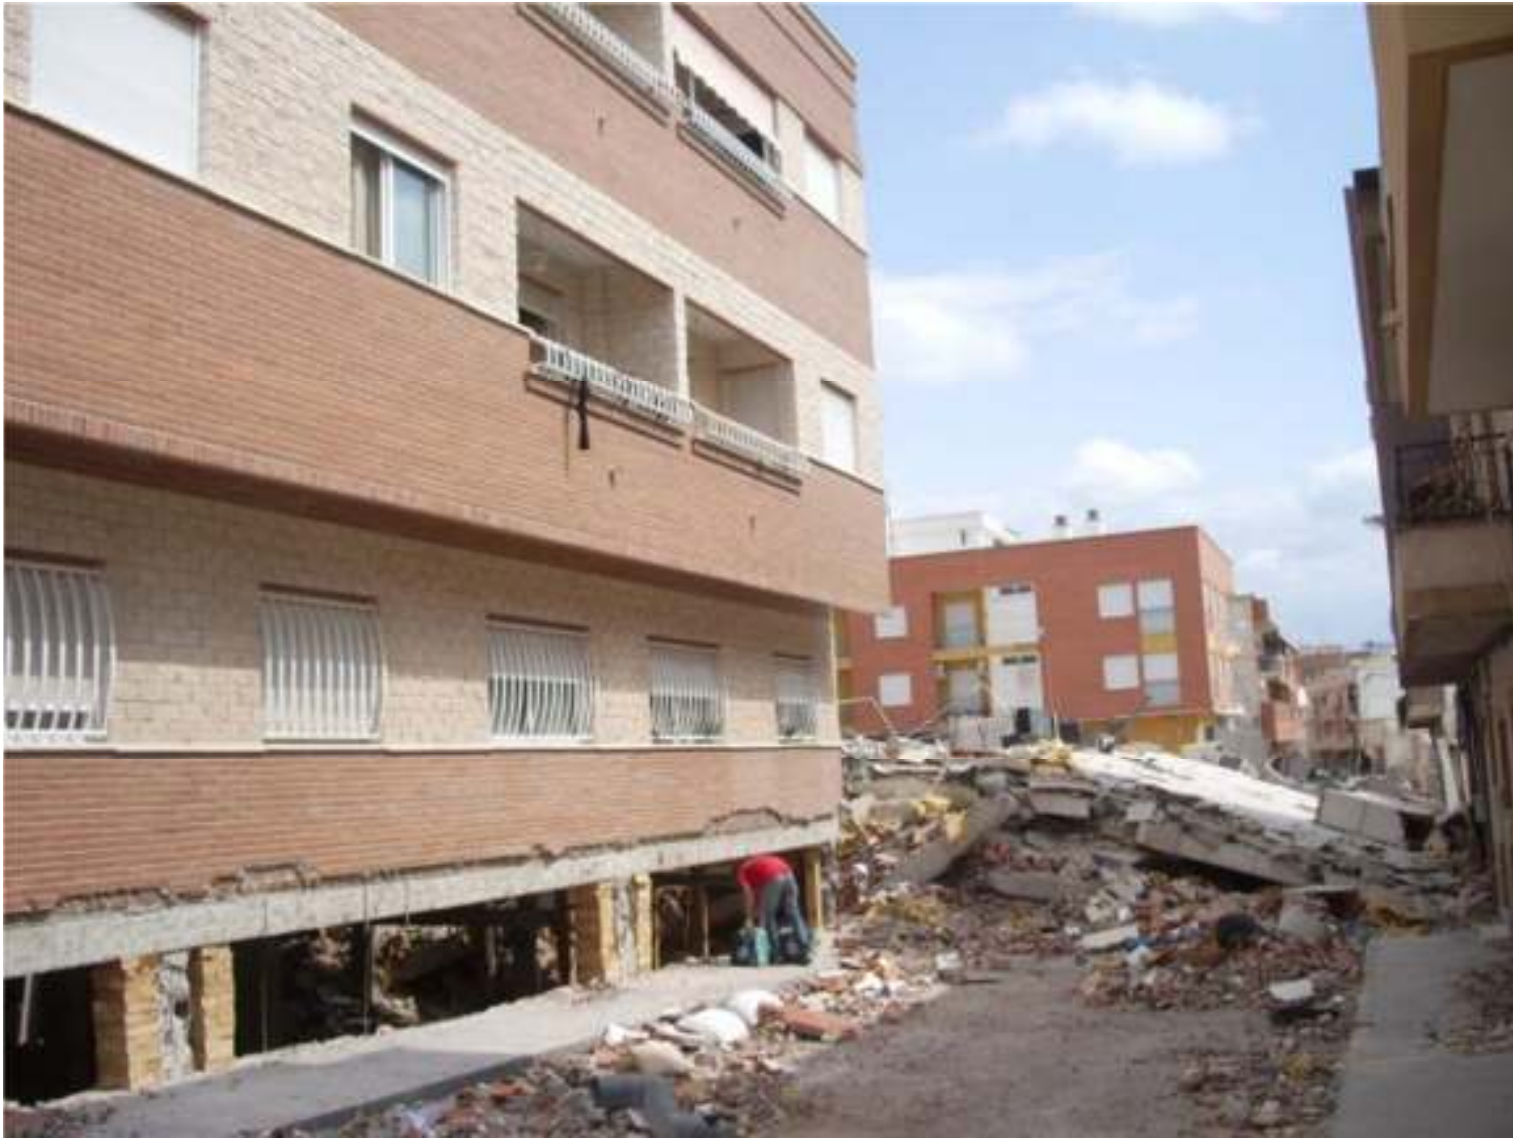
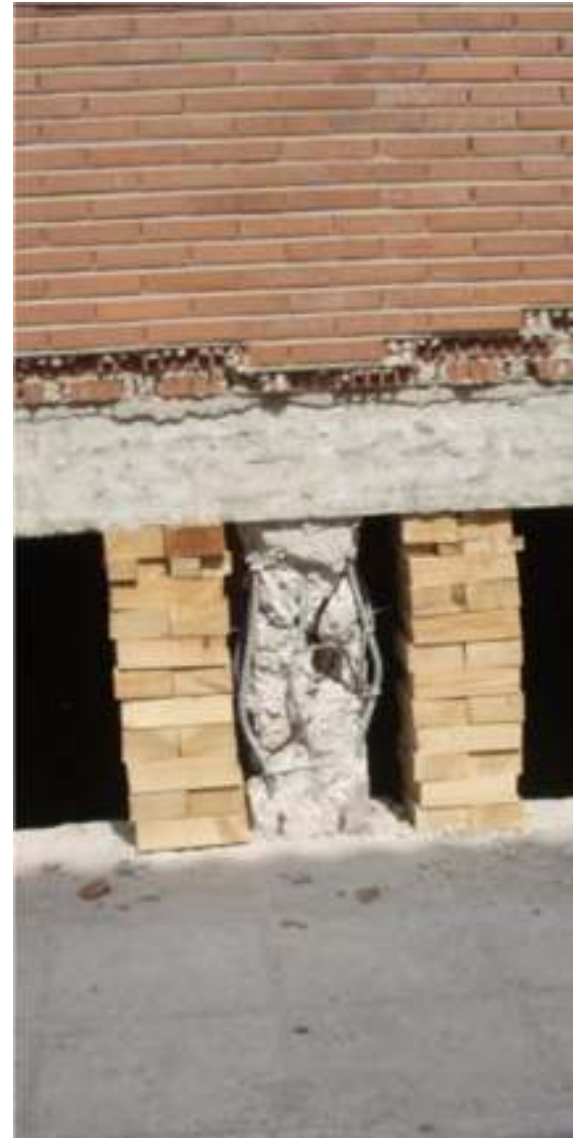
NEIGHBOURING TWIN BUILDING GIVES US A CLUE AS TO THE COLLAPSE MECHANISM – SHORT COLUMNS

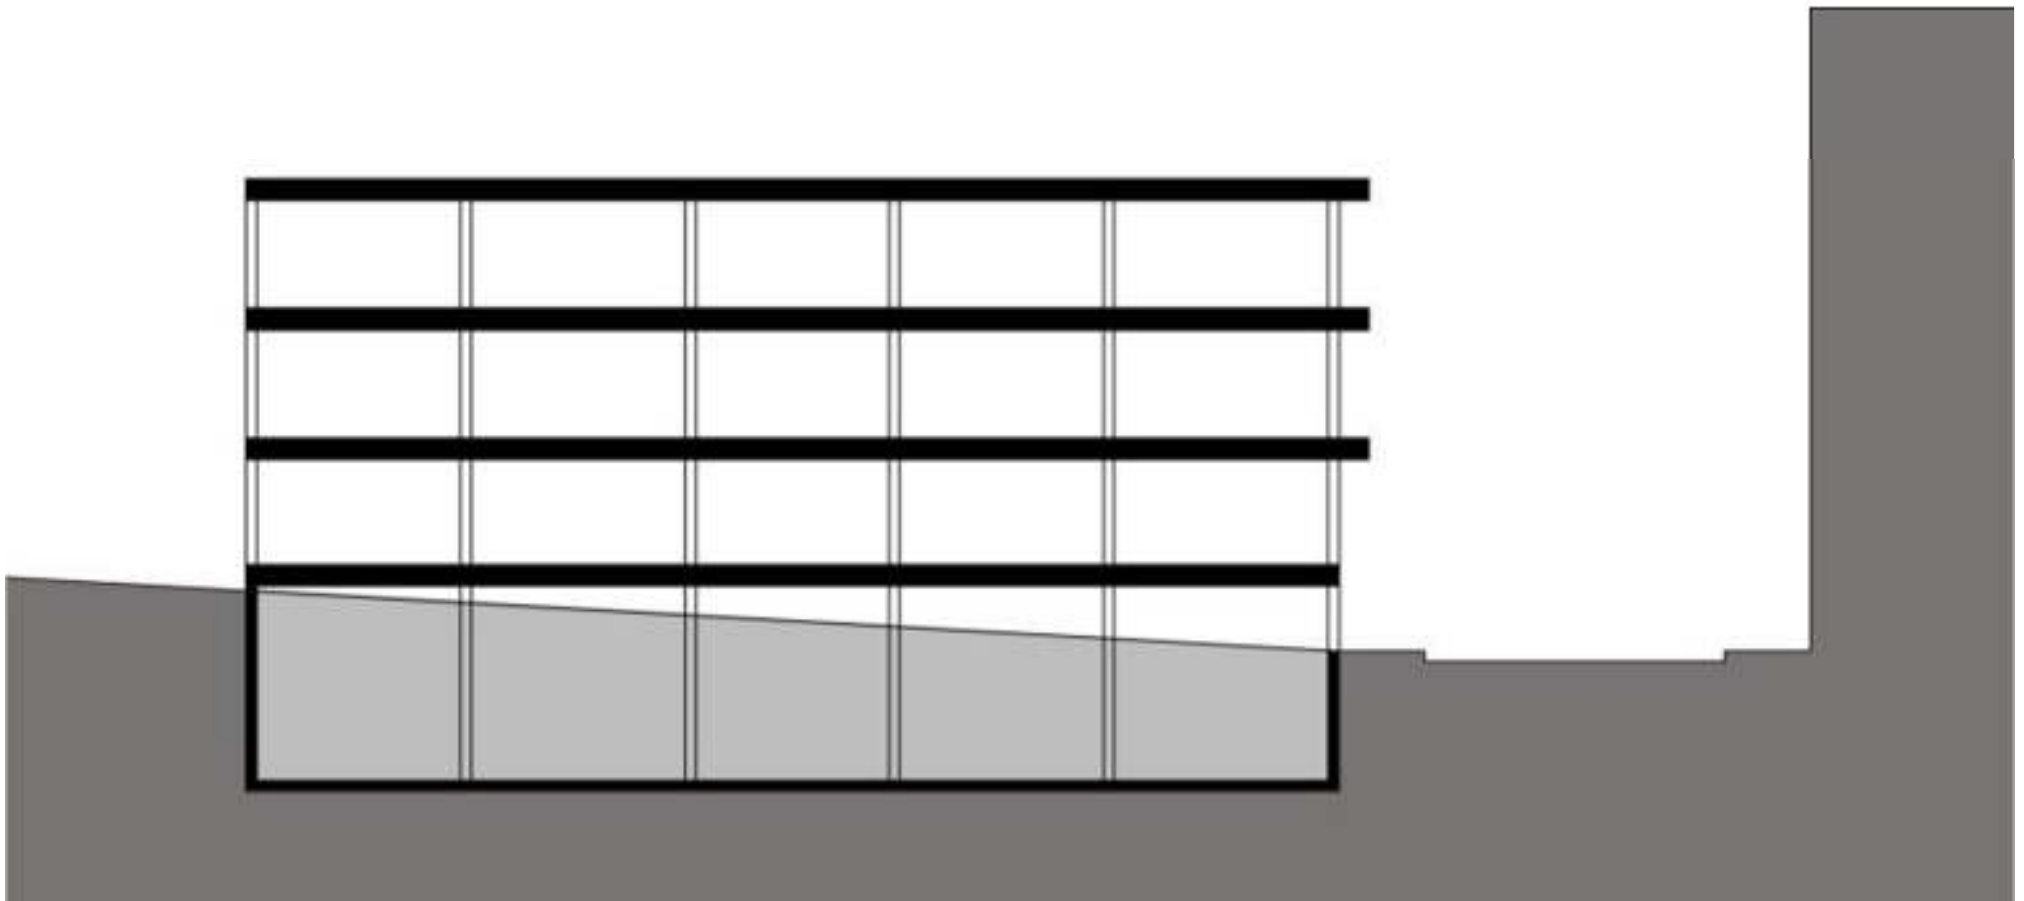
A STATIC BUILDING – SHORT COLUMNS EMERGING FROM BASEMENT

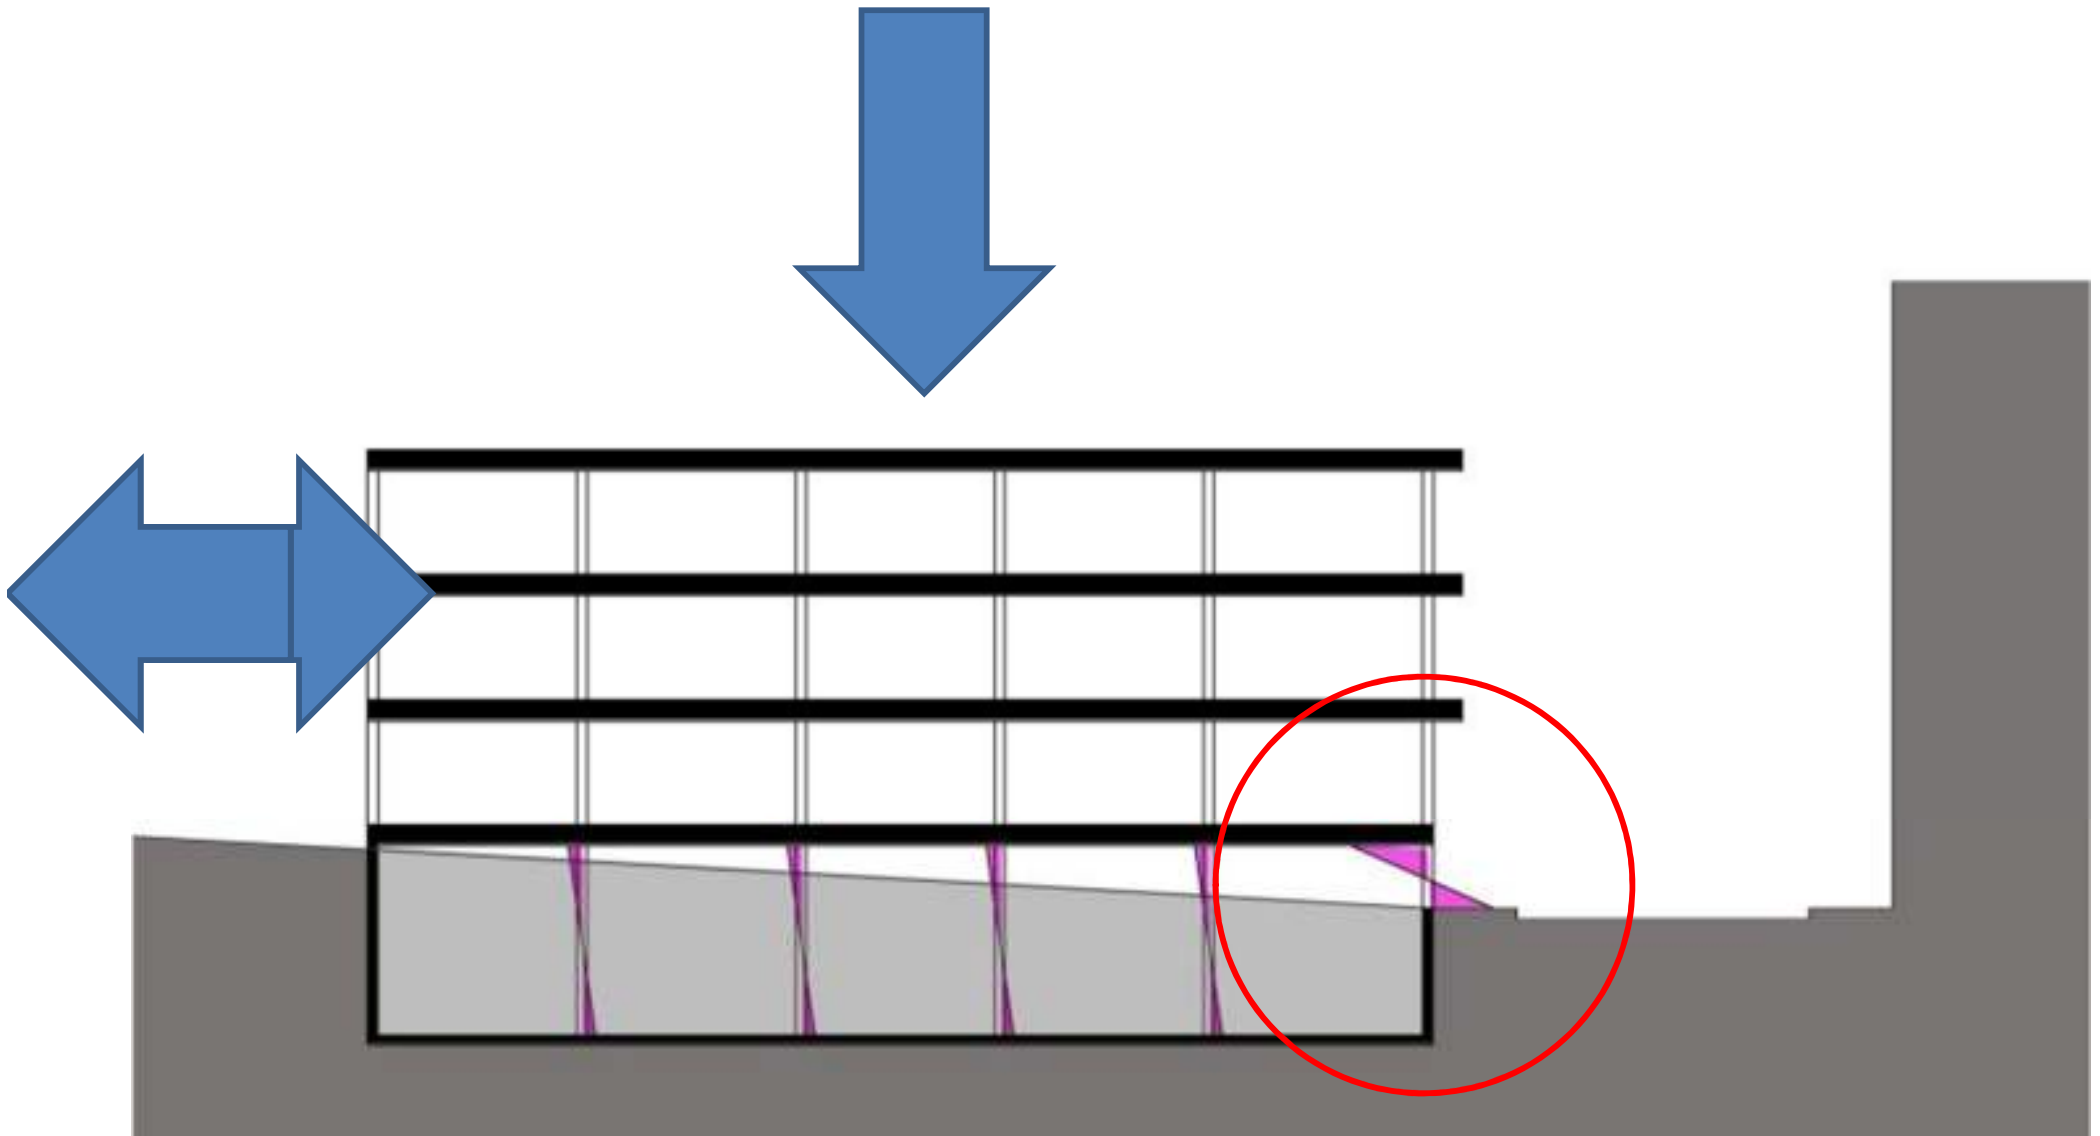
PERIMETER SHORT COLUMNS ARE VERY STIFF AND ATTRACT ALL SHEAR FORCE

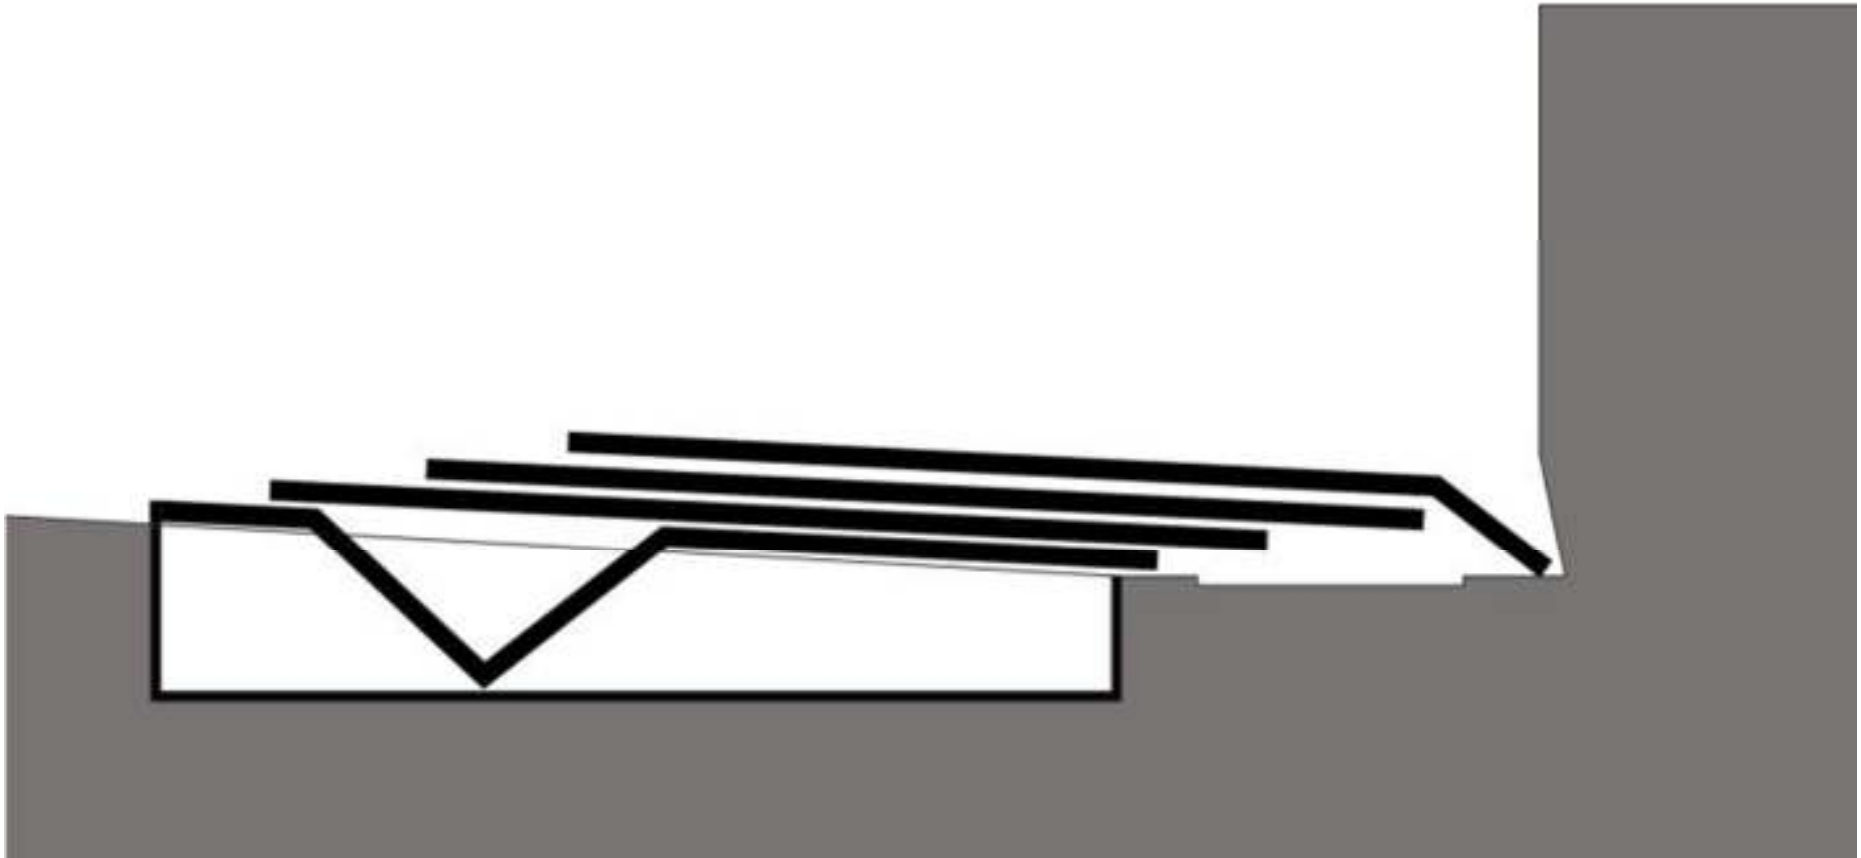
CRUSHED SHORT COLUMNS CAUSE BUILDING FAILURE

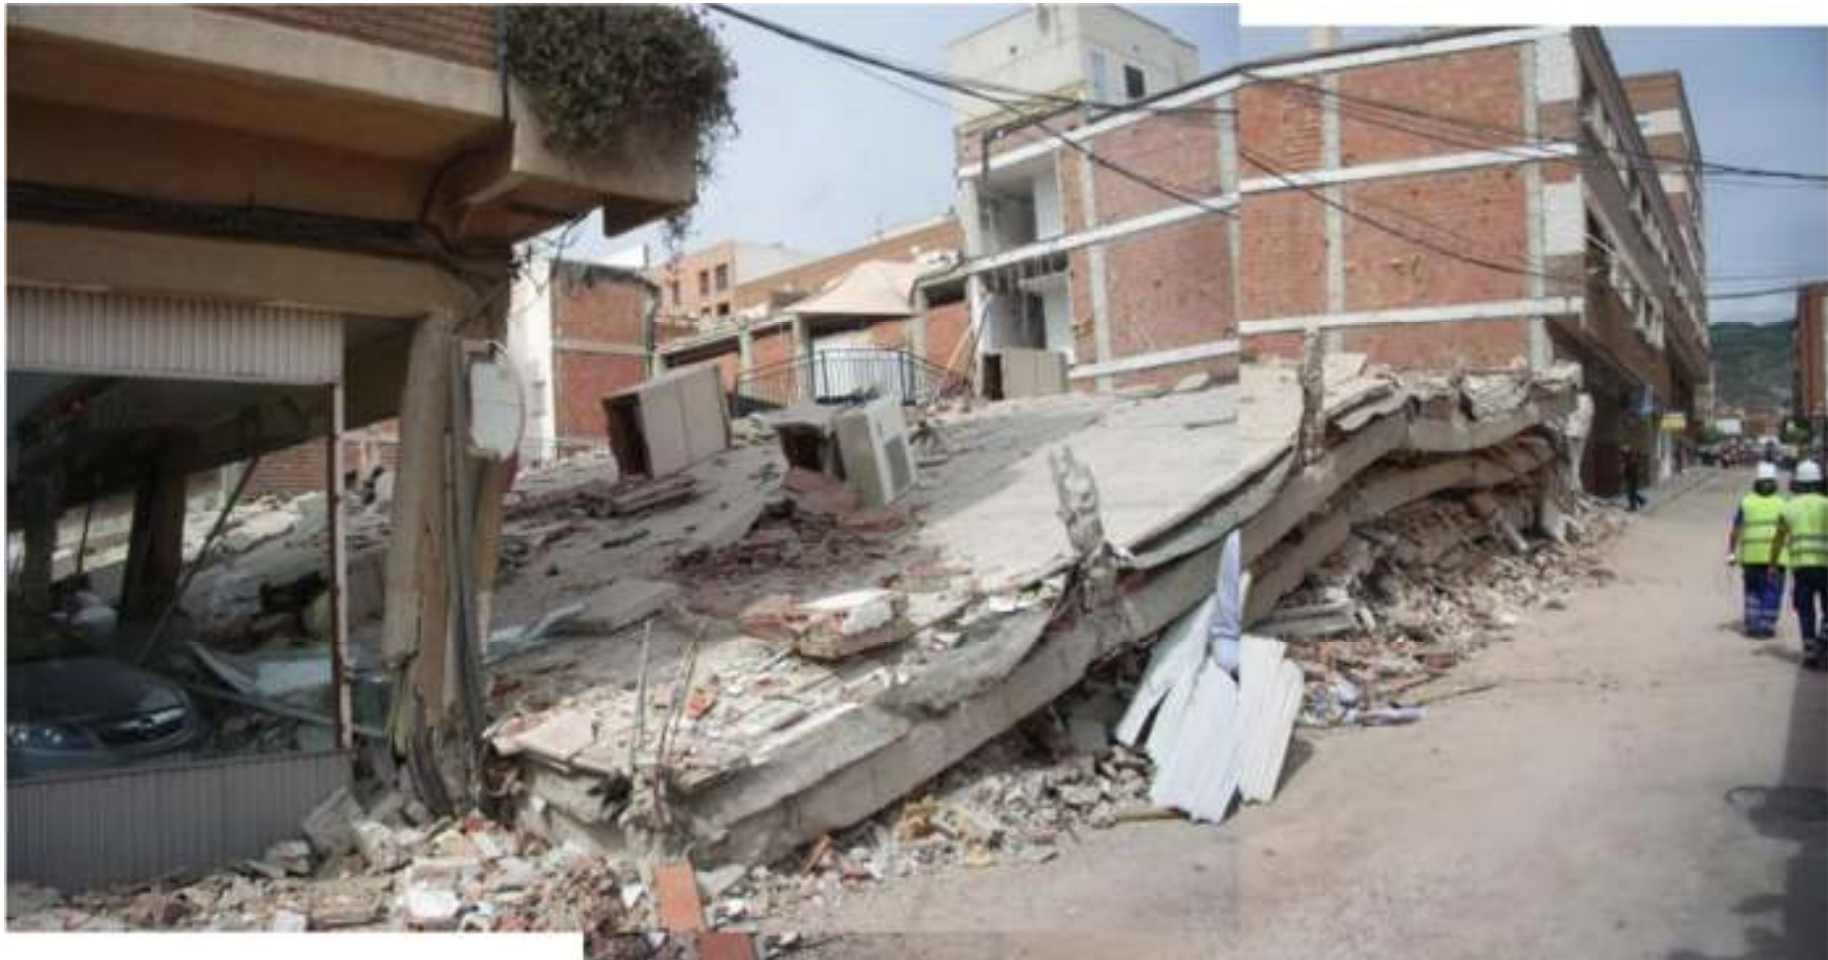
NEIGHBOUR IS ALMOST KNOCKED DOWN TOO

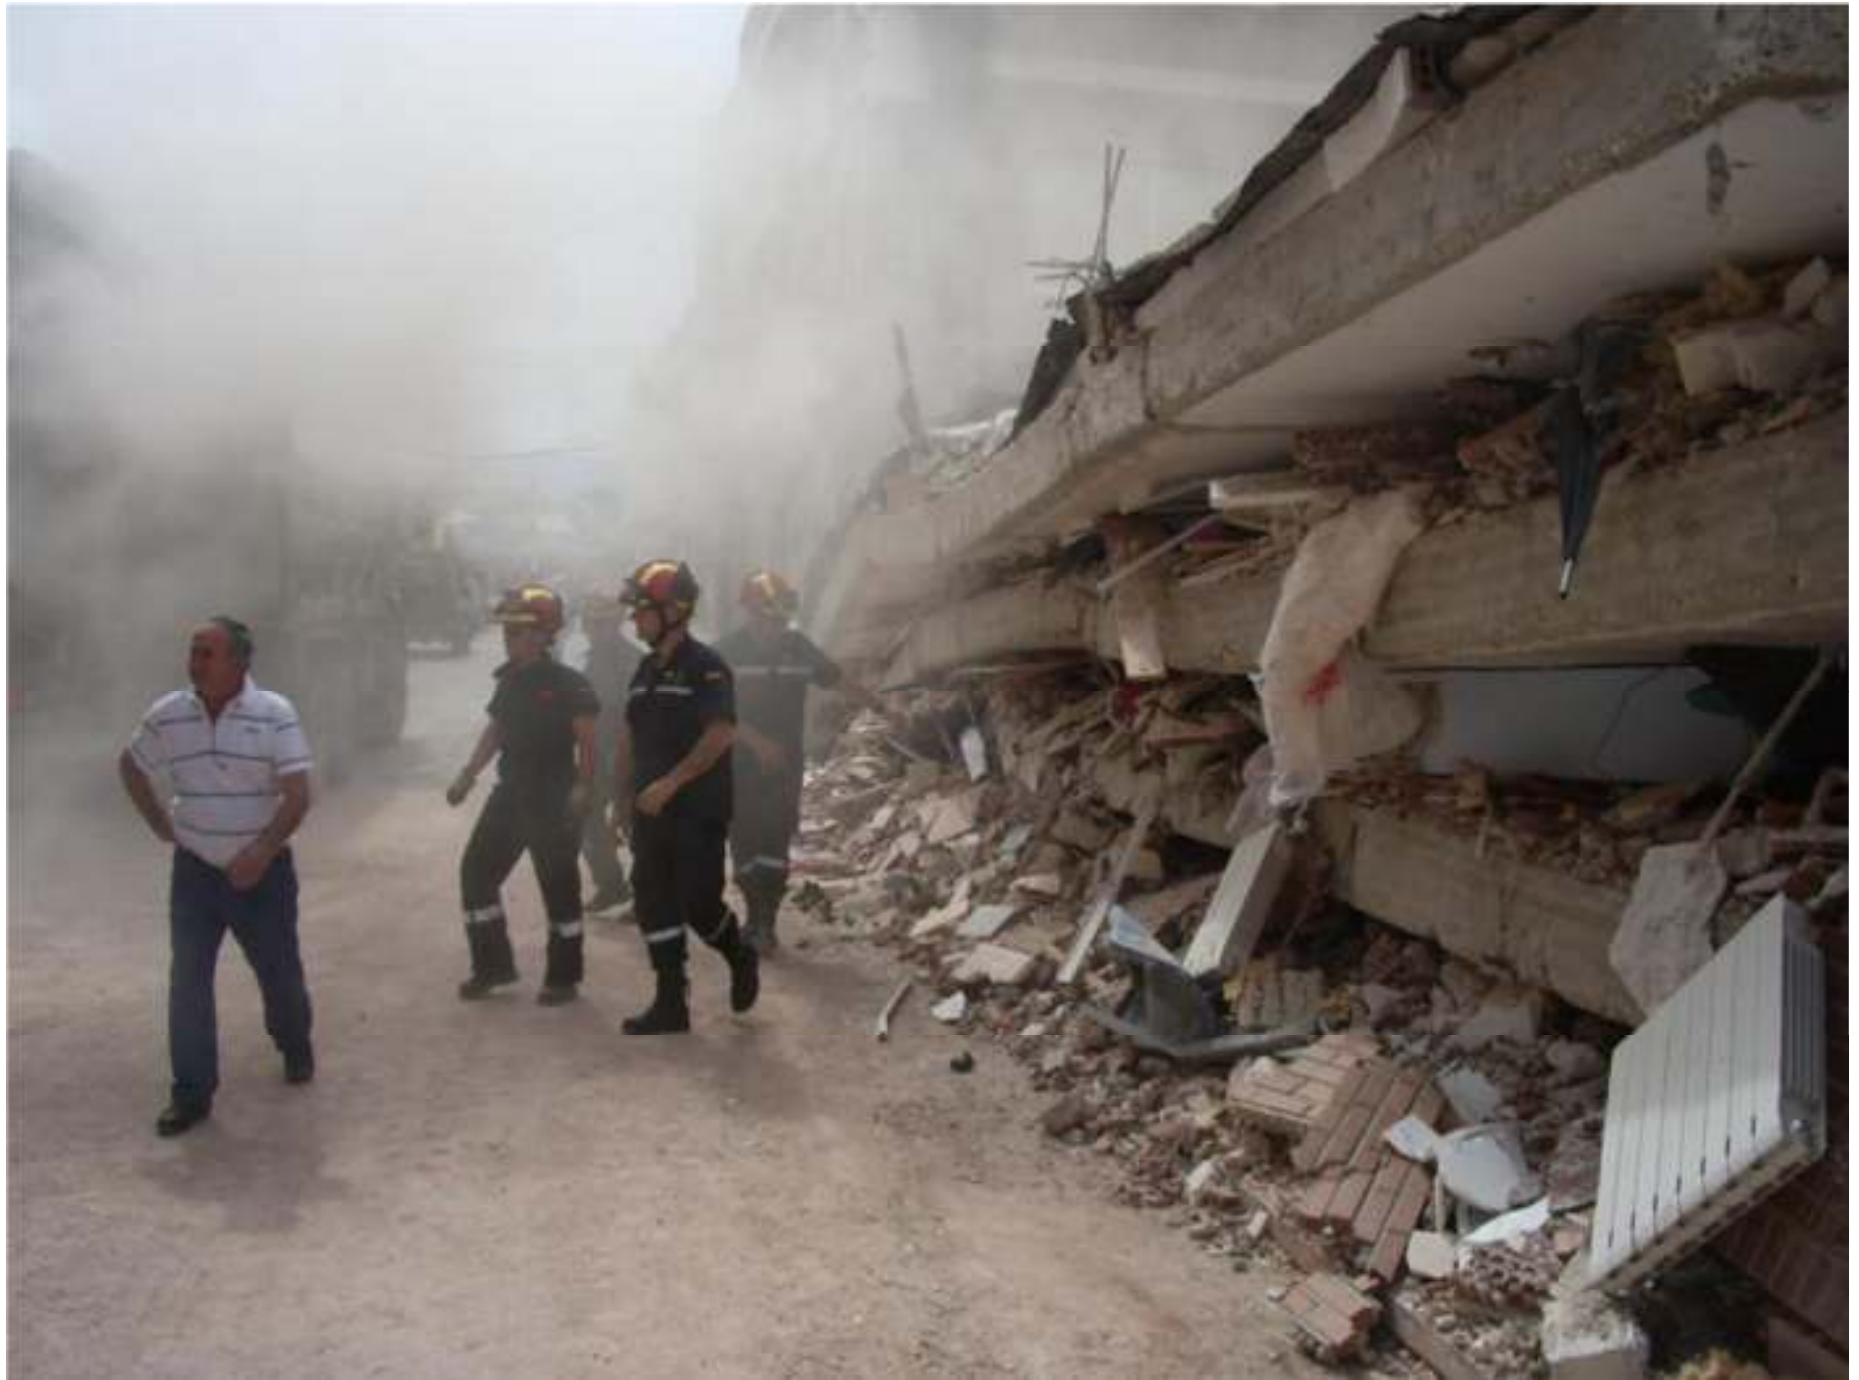
THANK GOD THERE HAD BEEN A 4,5 EVENT BEFORE
AND PEOPLE HAD LEFT THE BUILDING

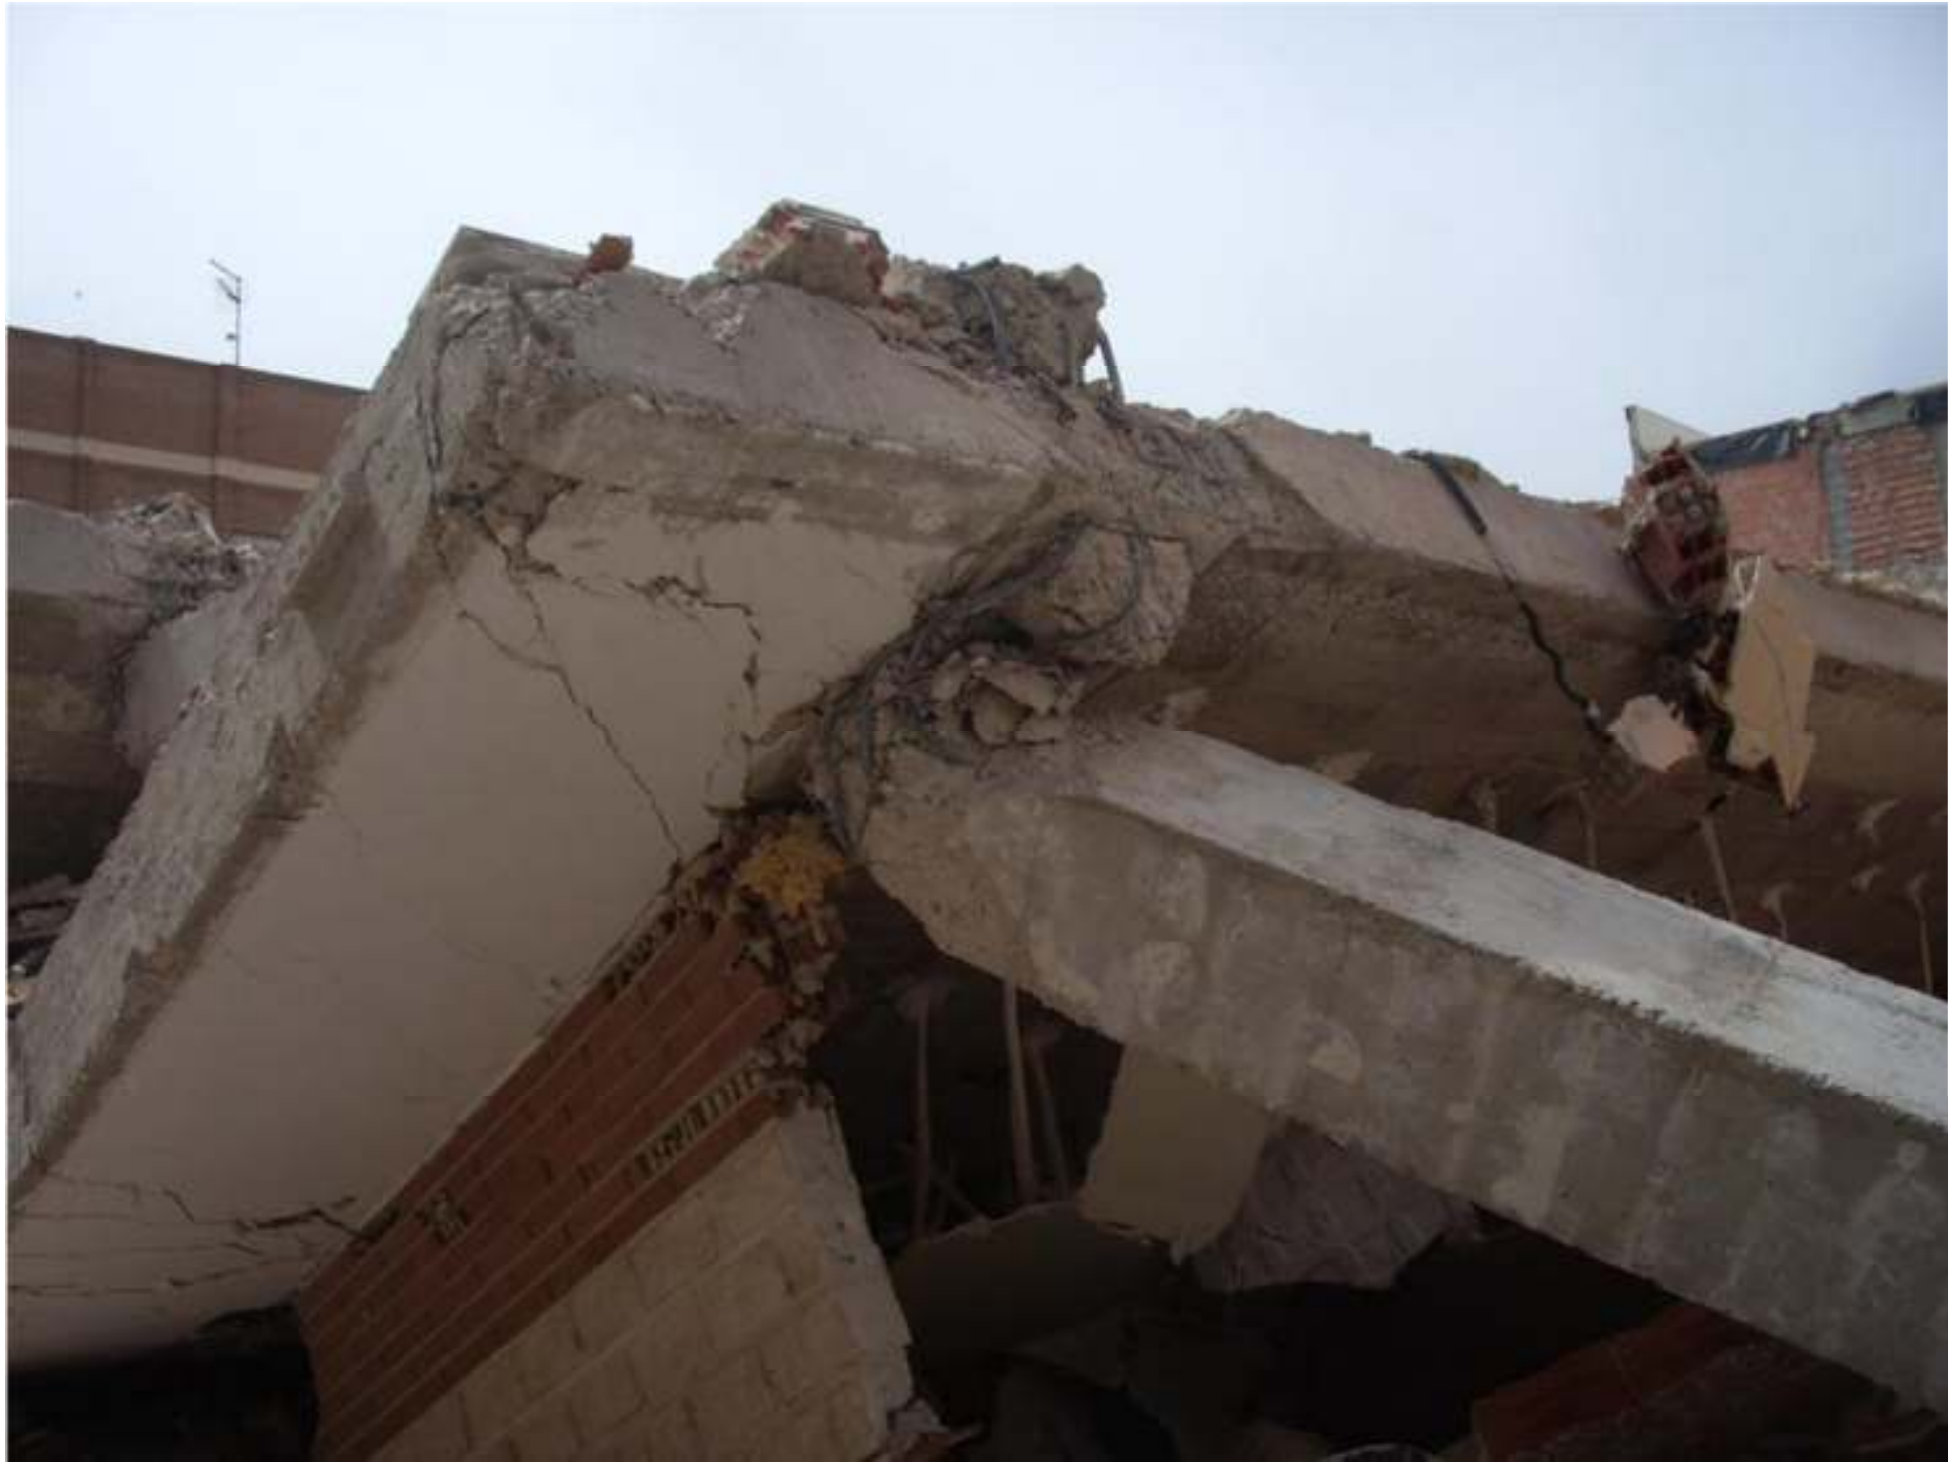
INADEQUATE HOOP CONFINEMENT

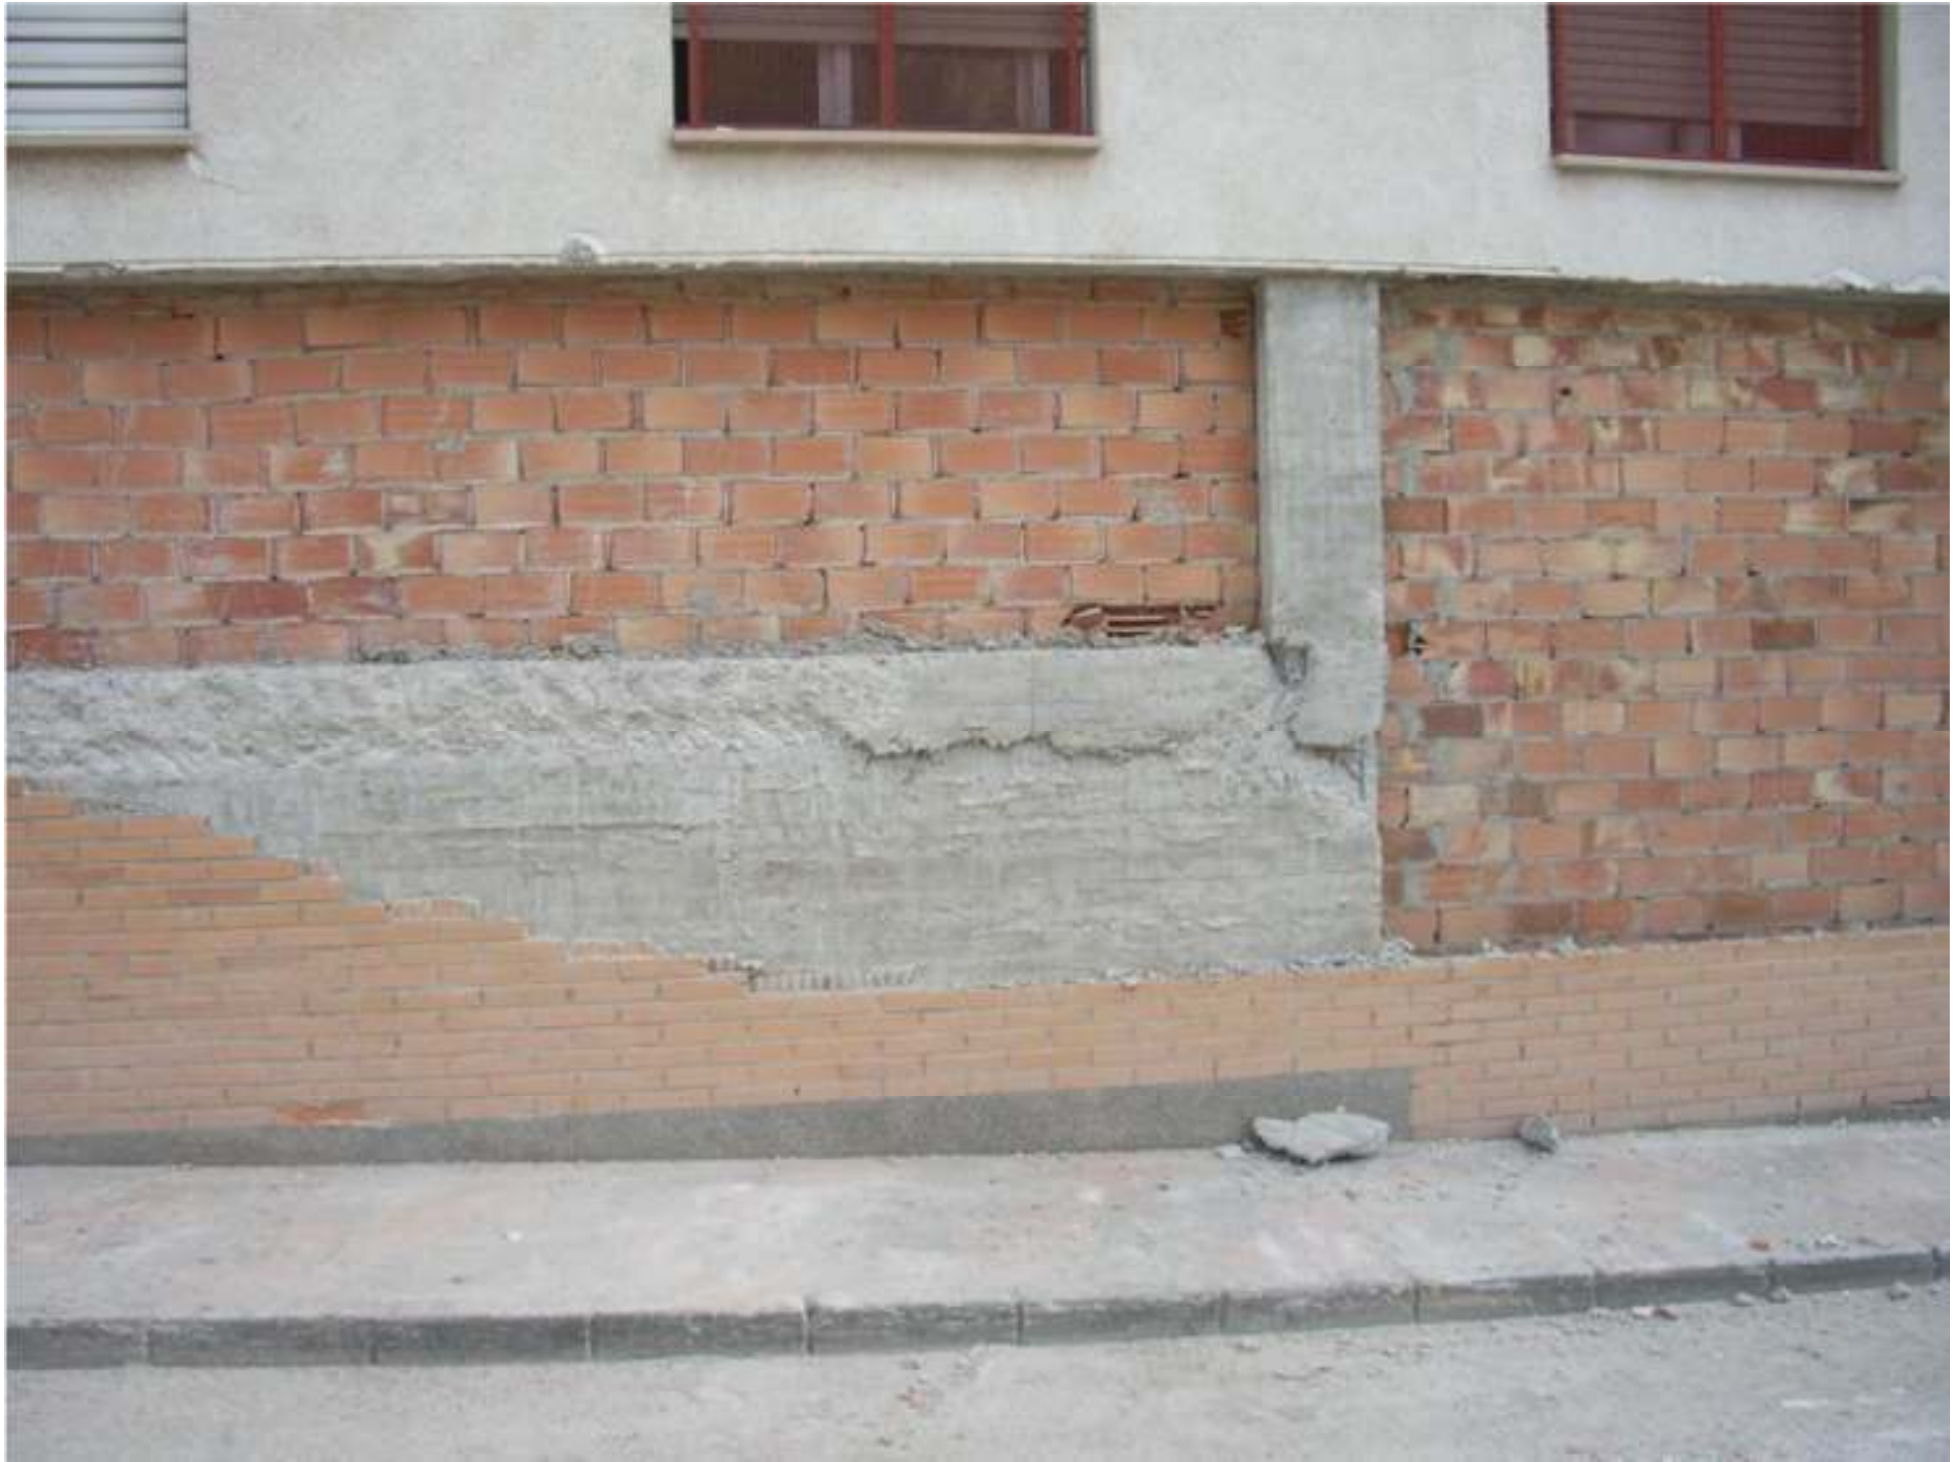
DAMAGED SHORT COLUMNS EVERYWHERE
