Quick field report

Lorca earthquake 11th May 2011

Patrick Murphy Corella

Broadway Malyan

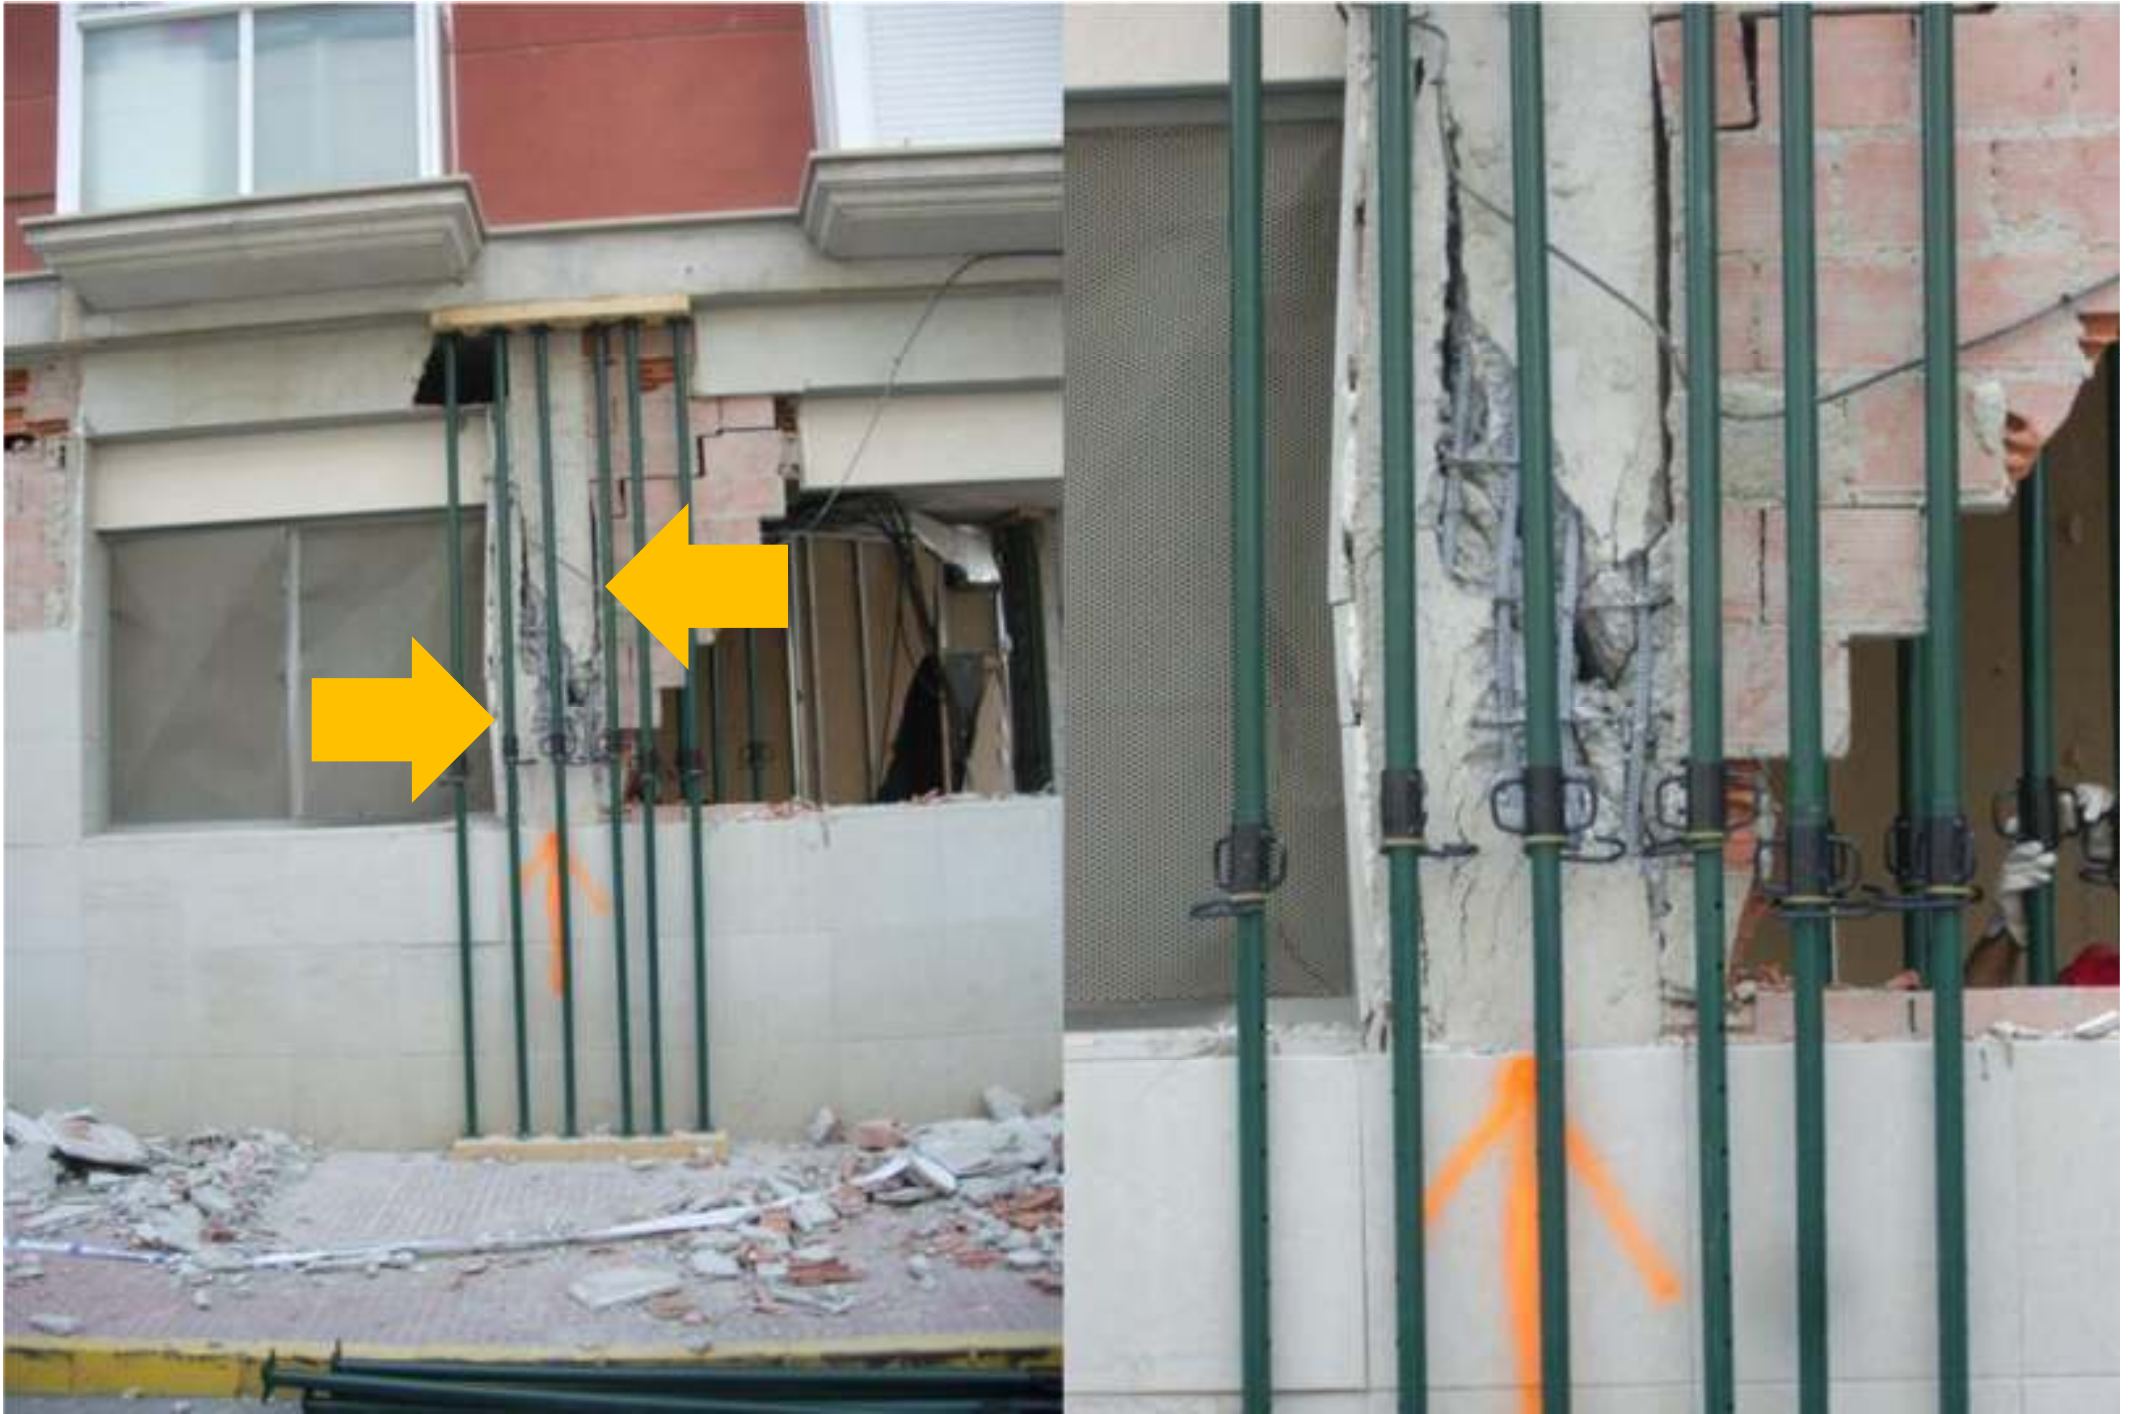
CAPTURED COLUMN MADE SHORT BY MASONRY INTERACTION

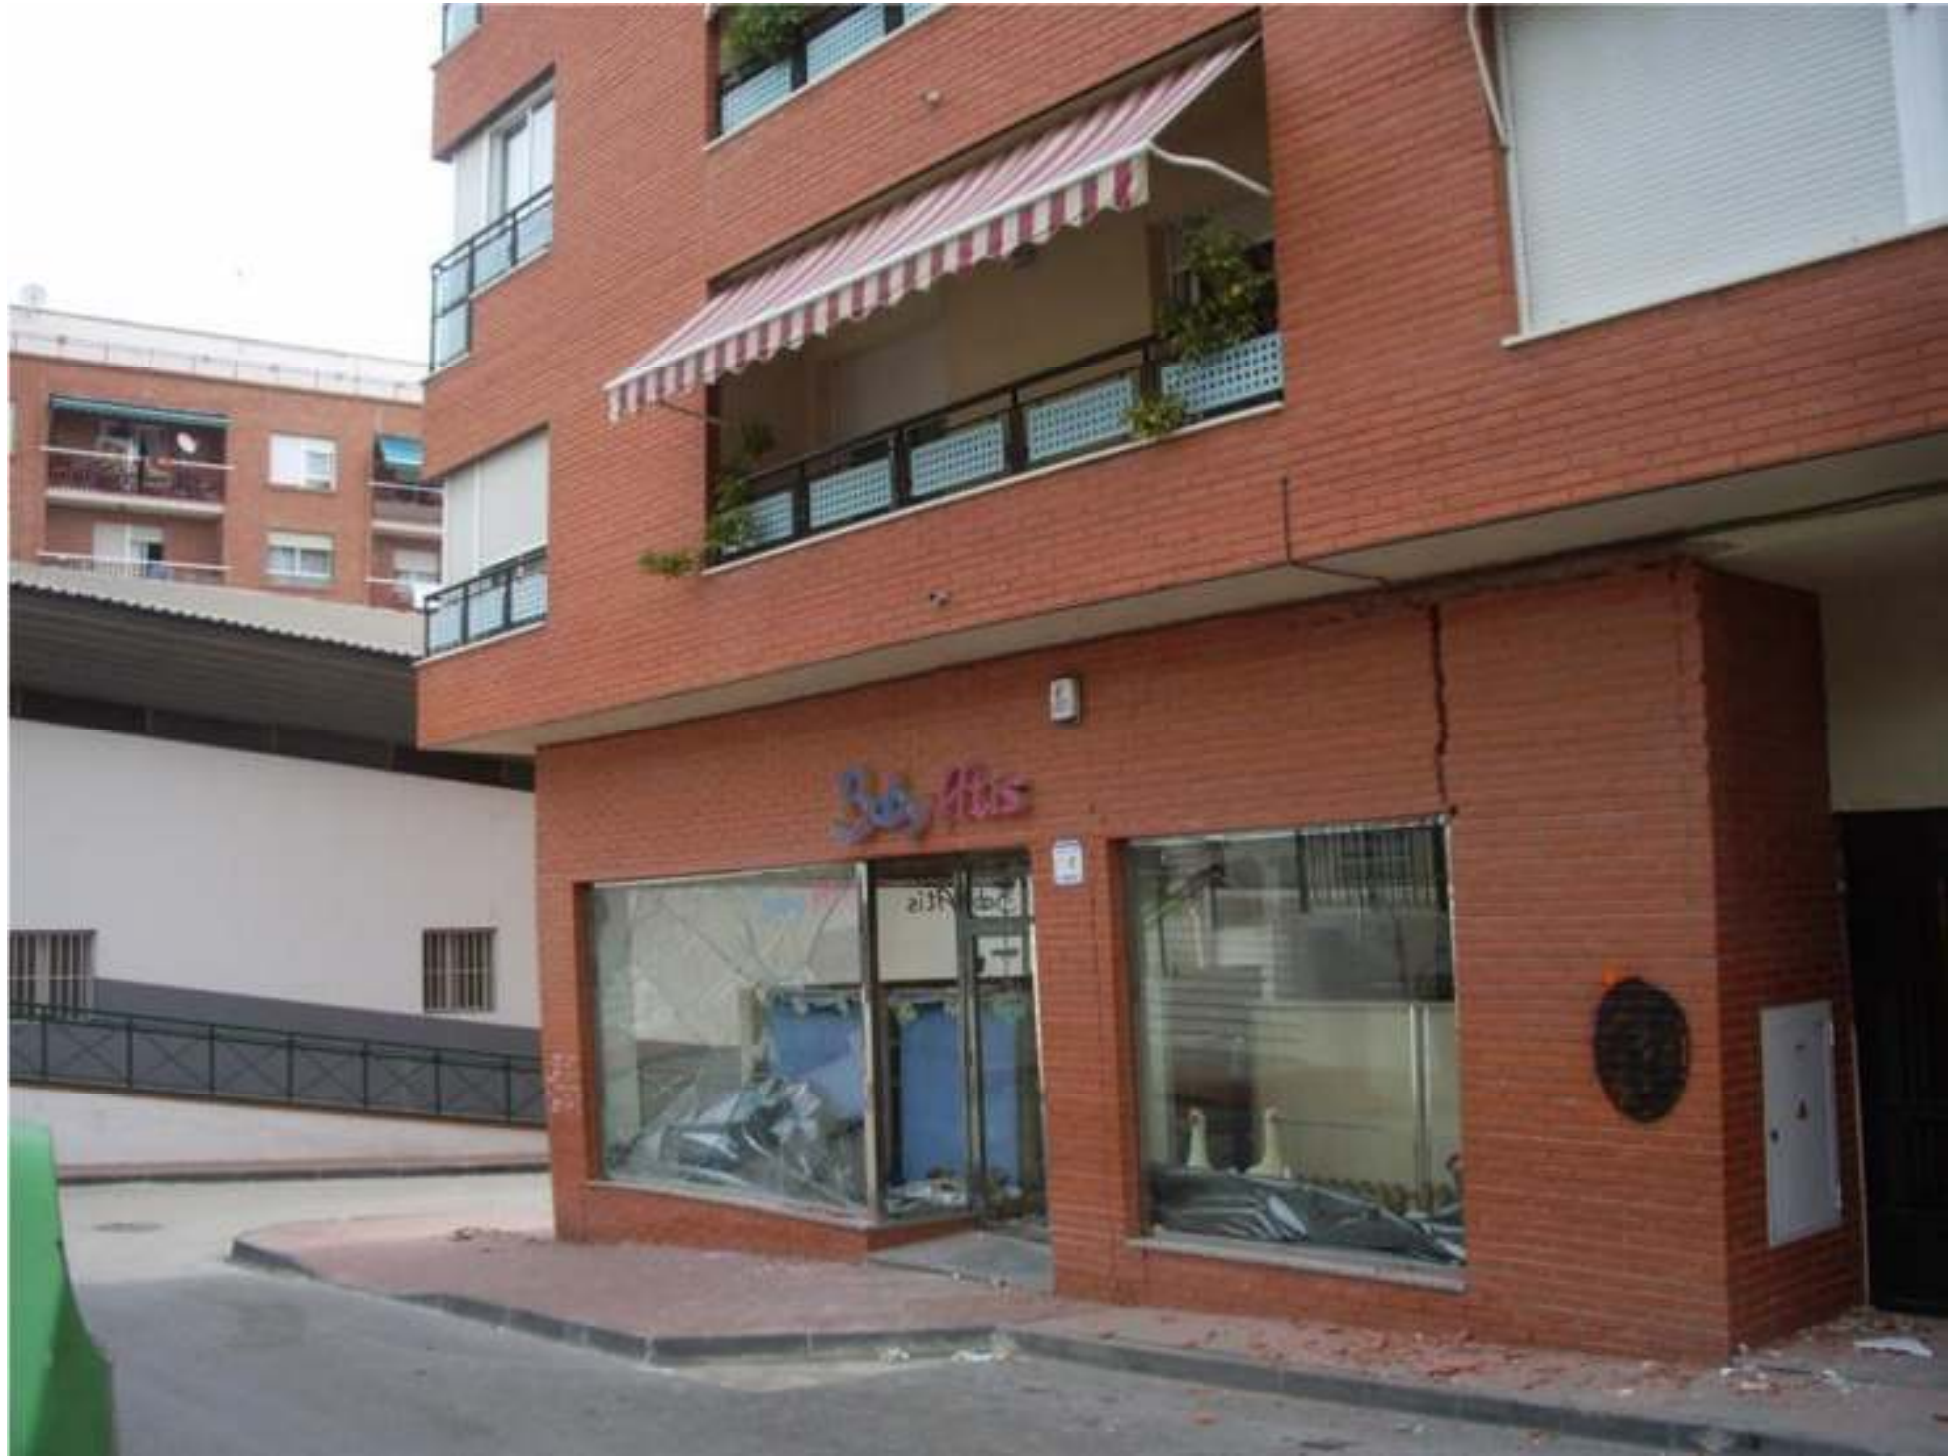
PLAZA DE LOS APRENDICES – THE RED BUILDING

SEVERELY DEFORMED GROUND FLOOR

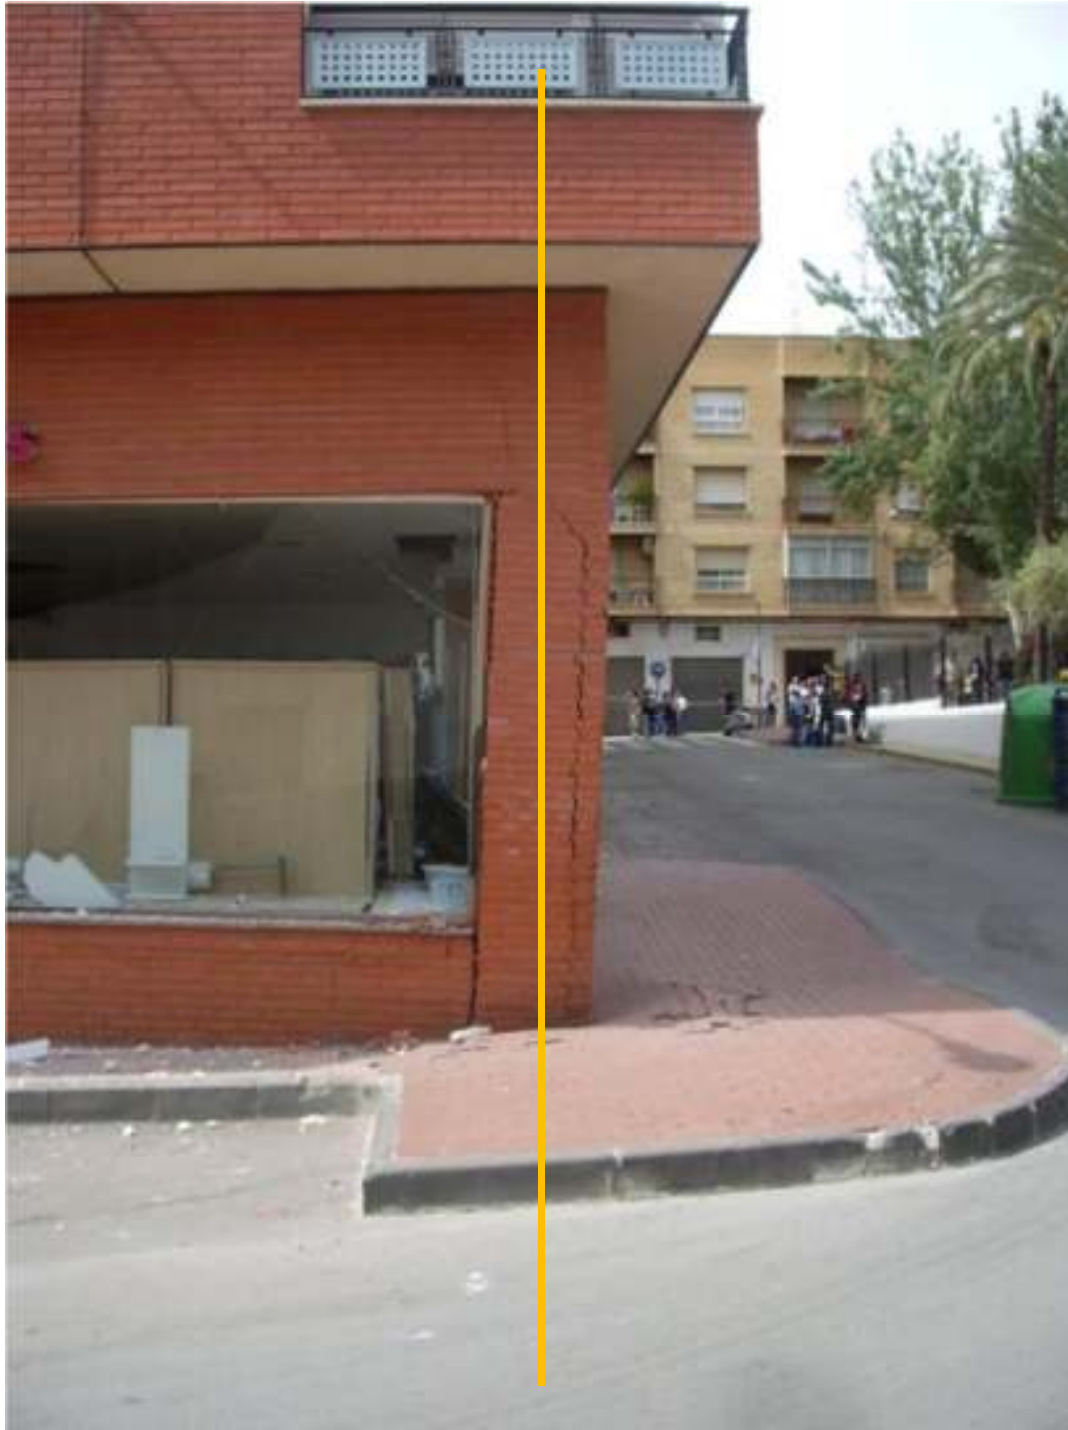
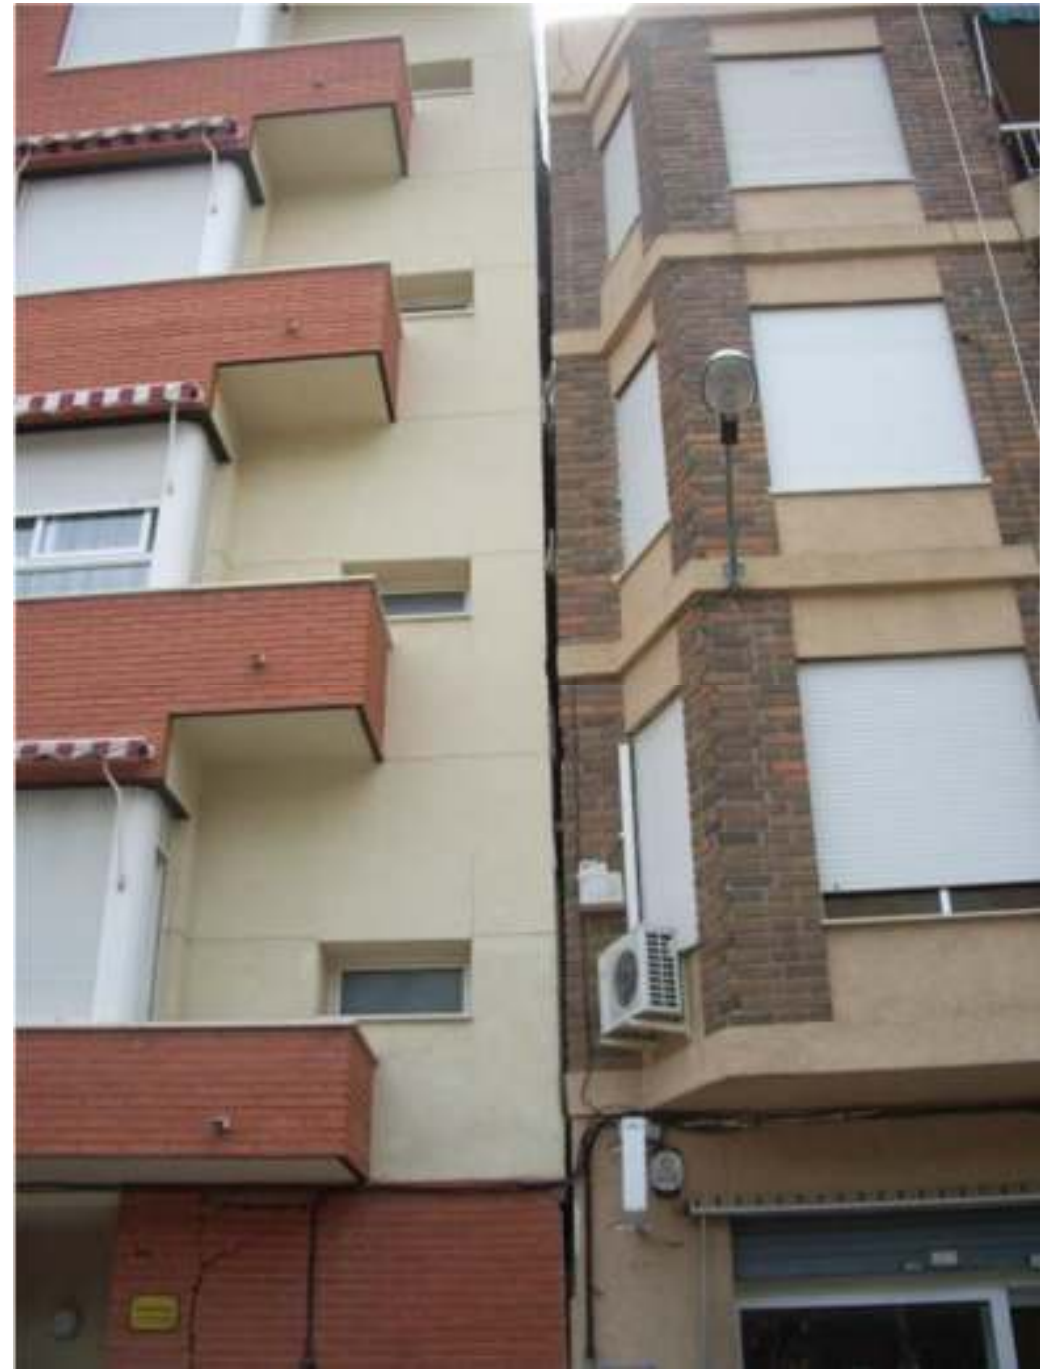
BUILDING LISTING TO THE NORTH

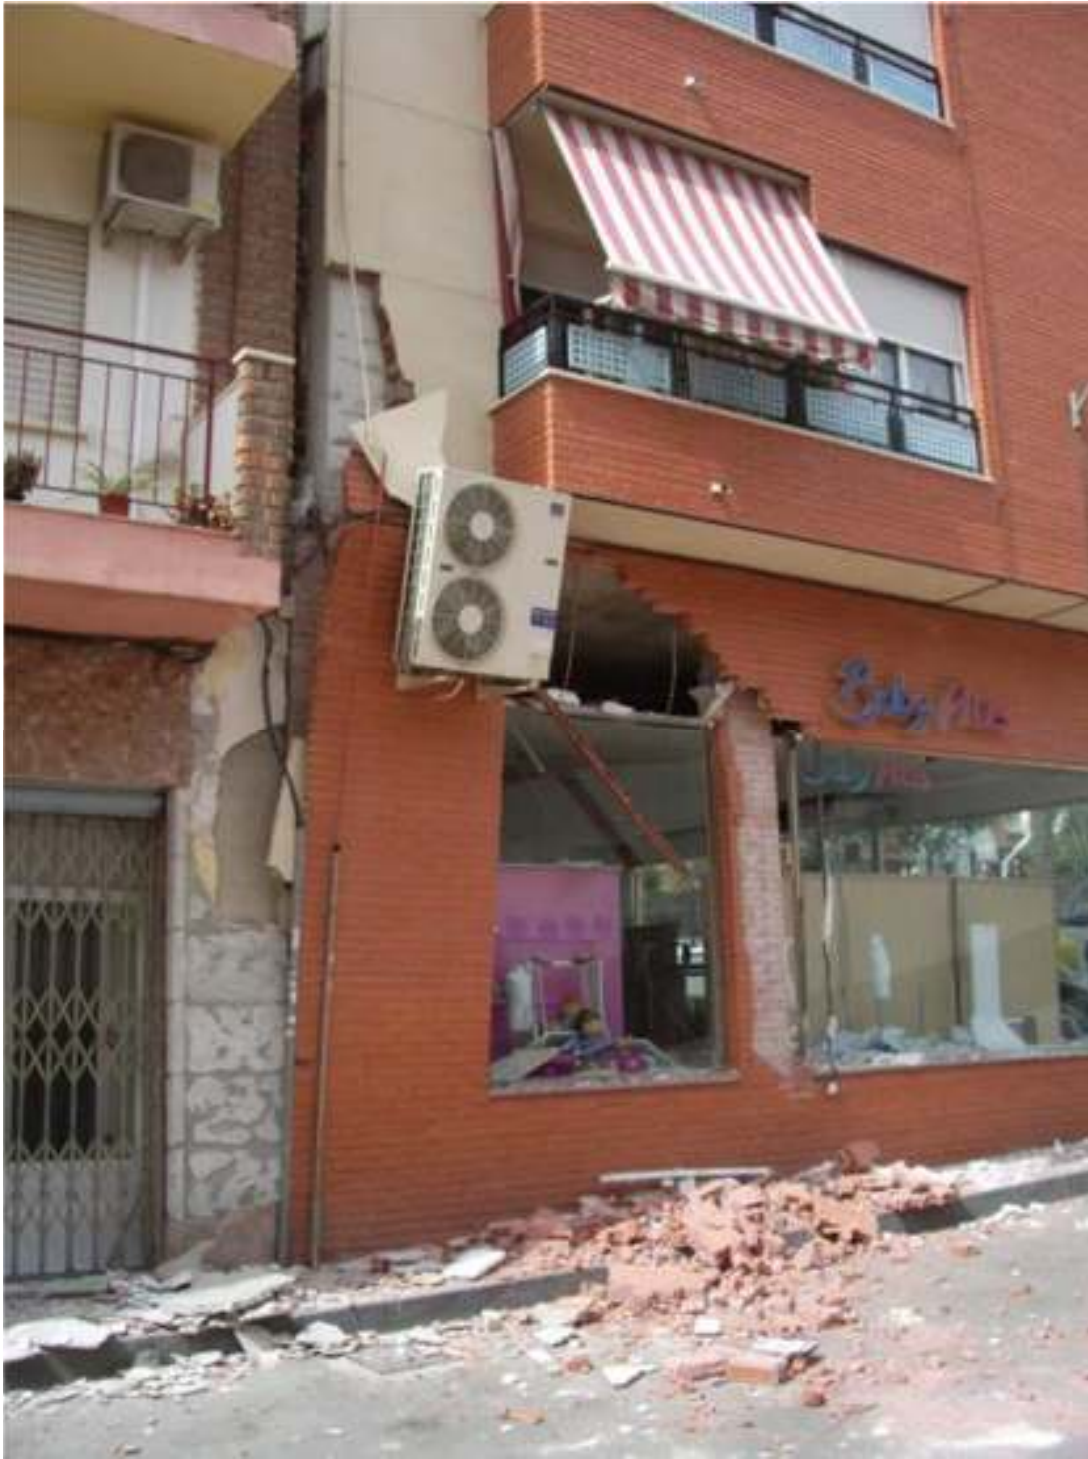
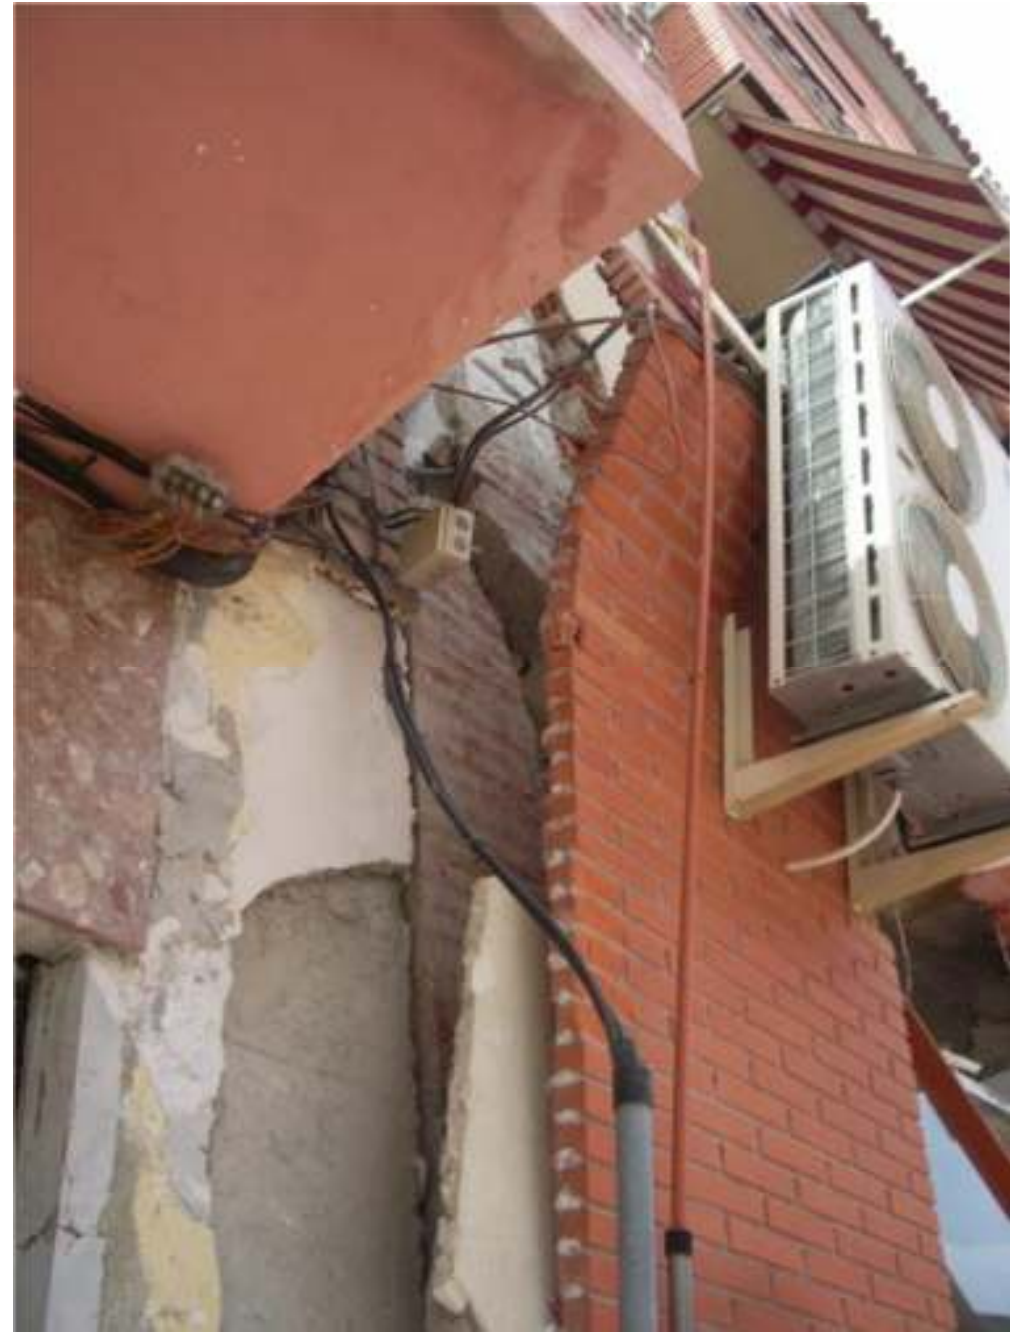
GROUND FLOOR COLUMN FAILURES

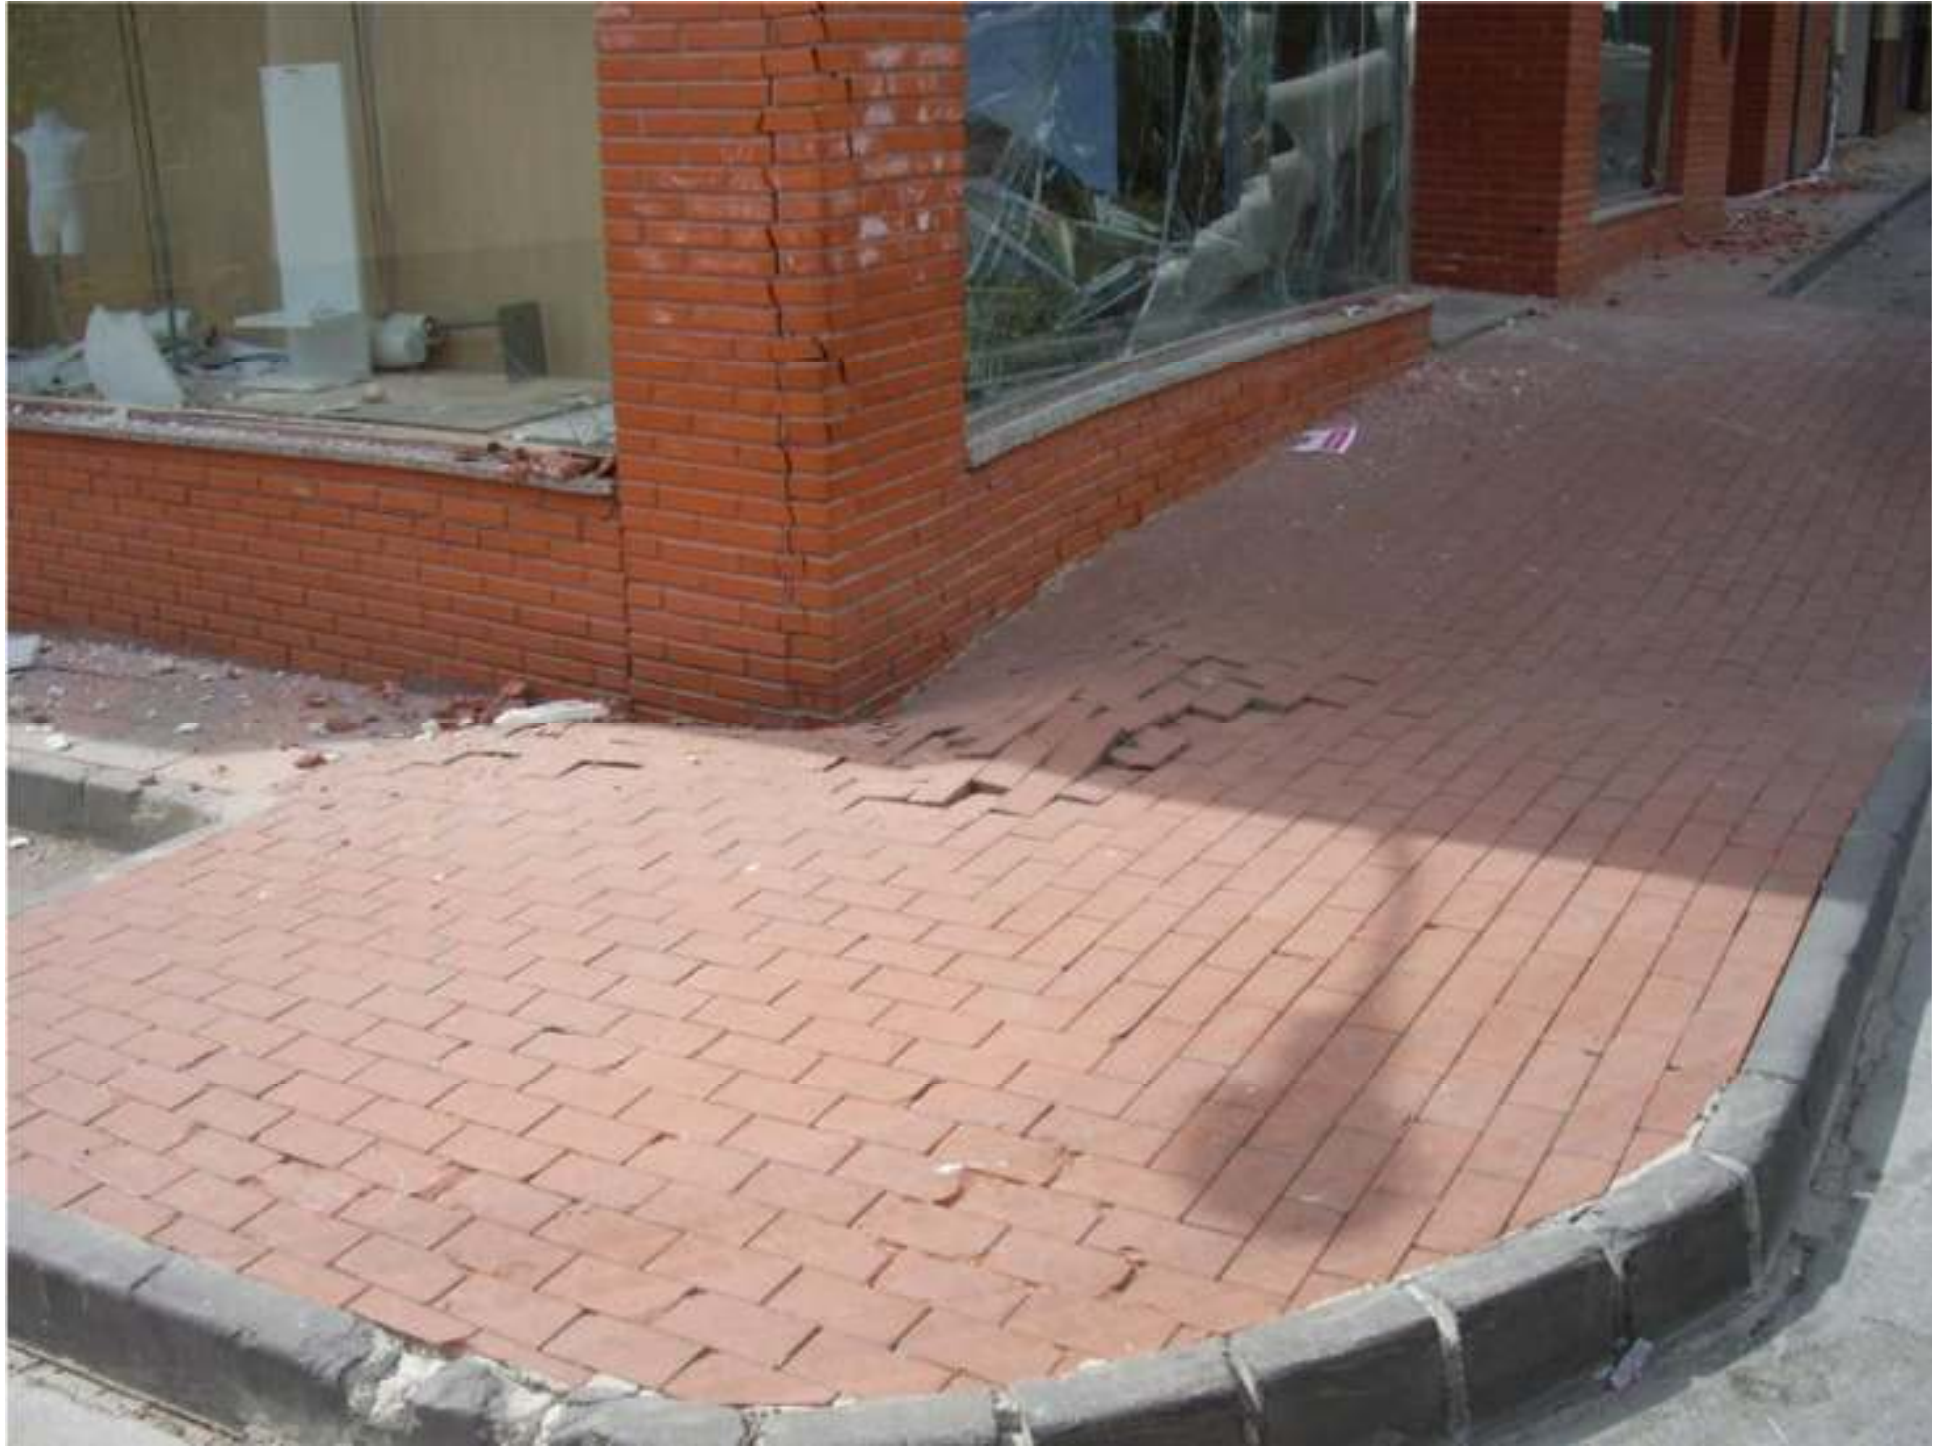
GEOTECHNICAL FAILURE?

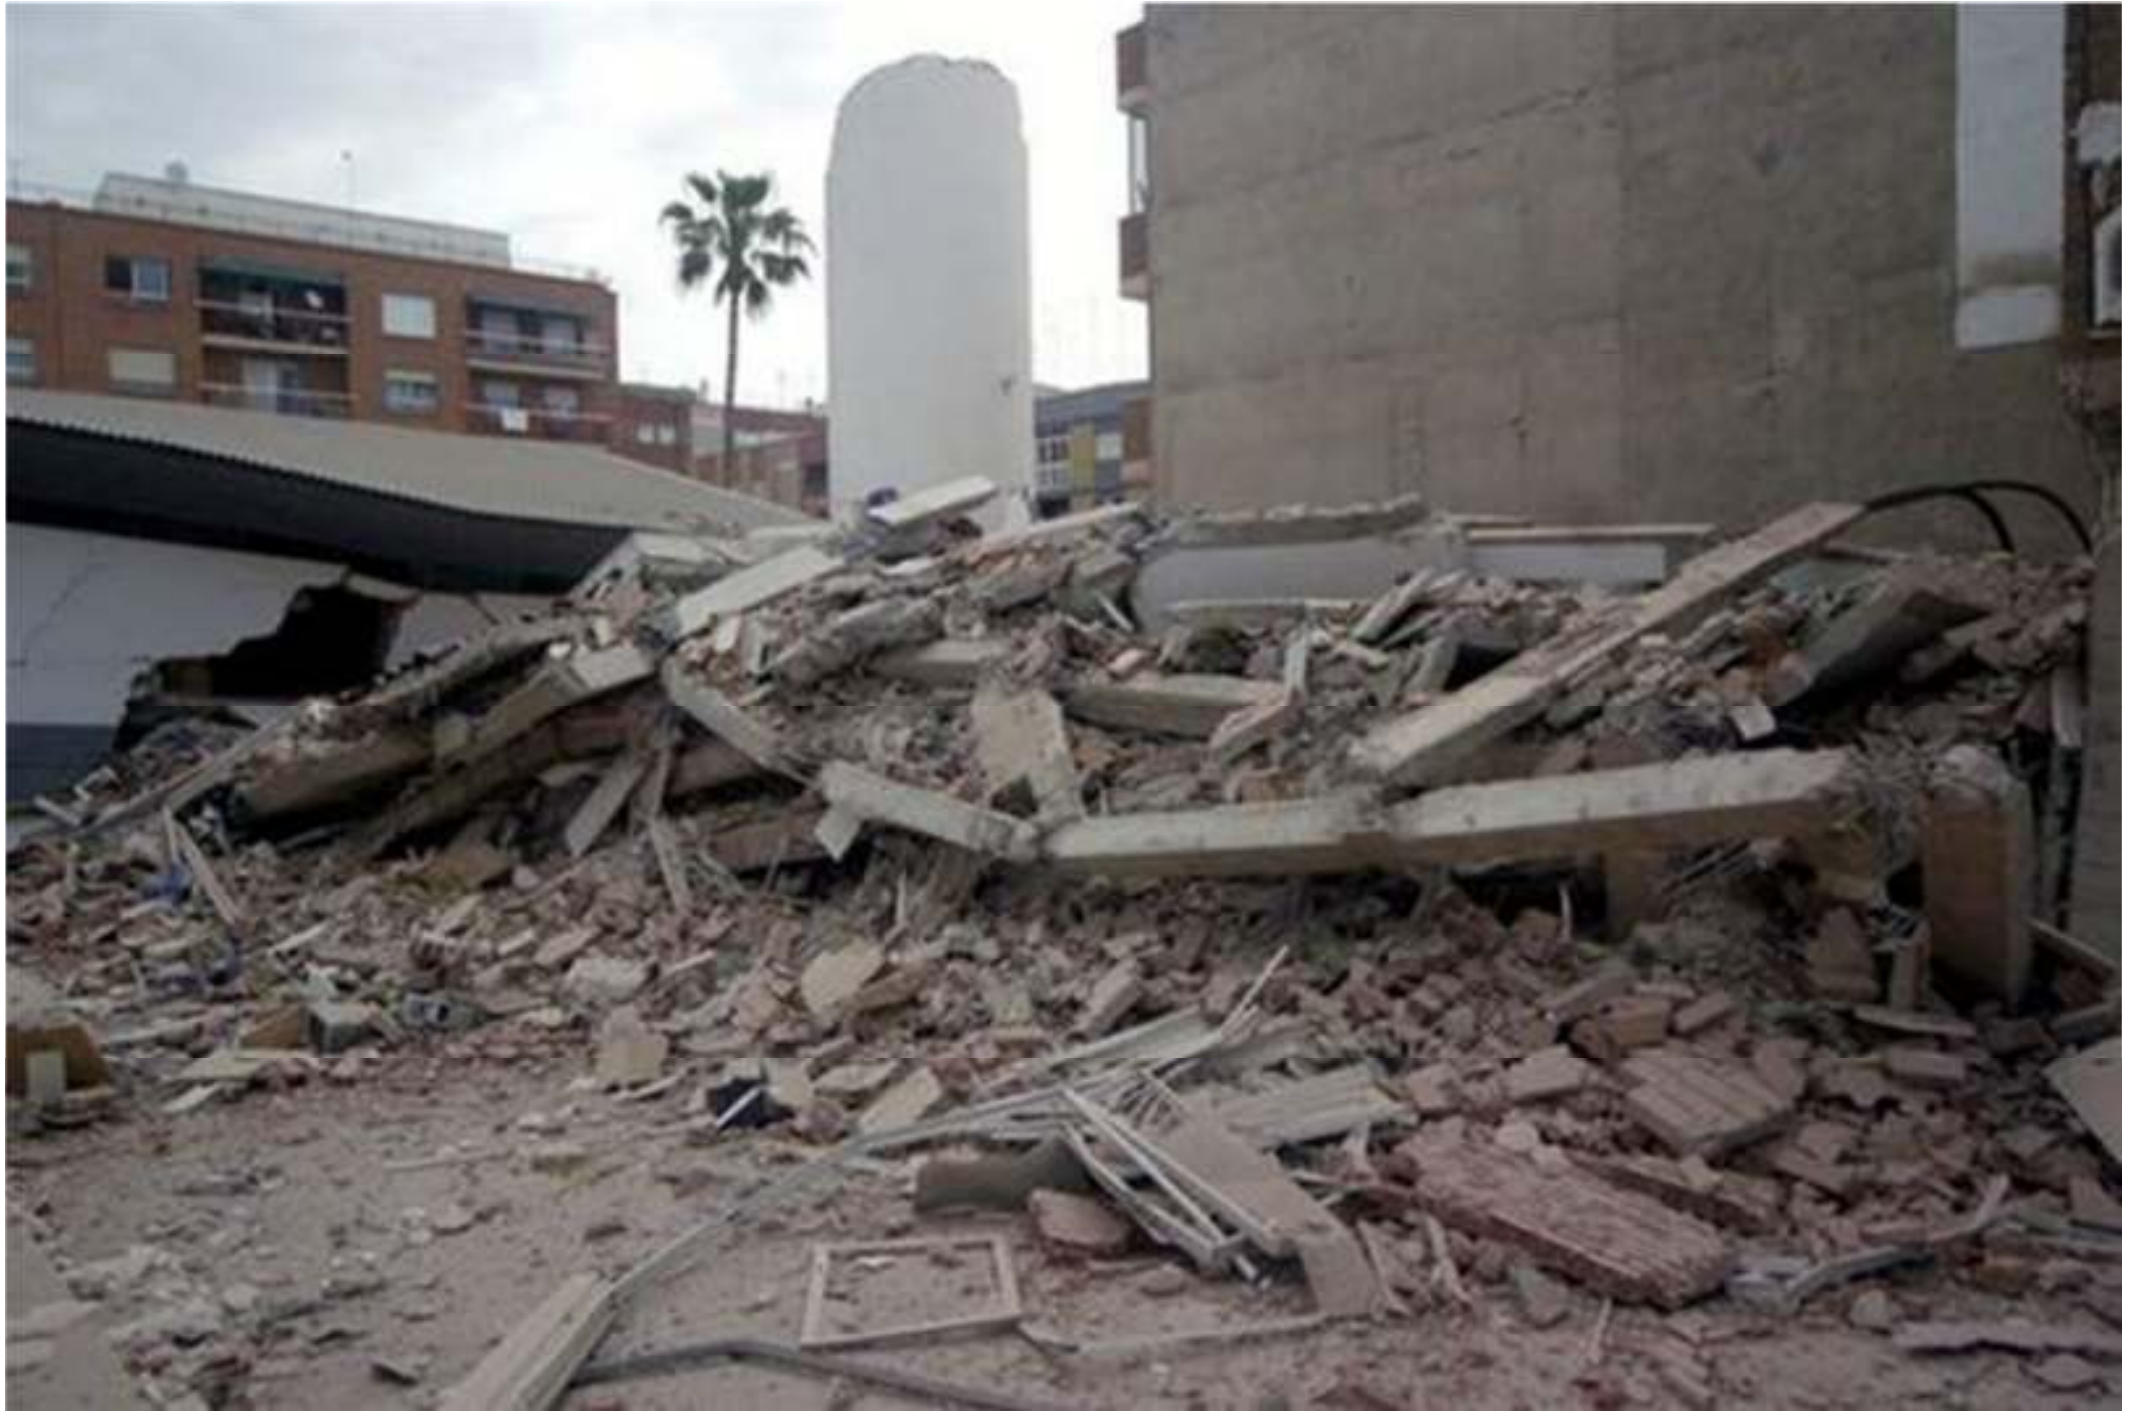
IT FELL DOWN BY ITSELF

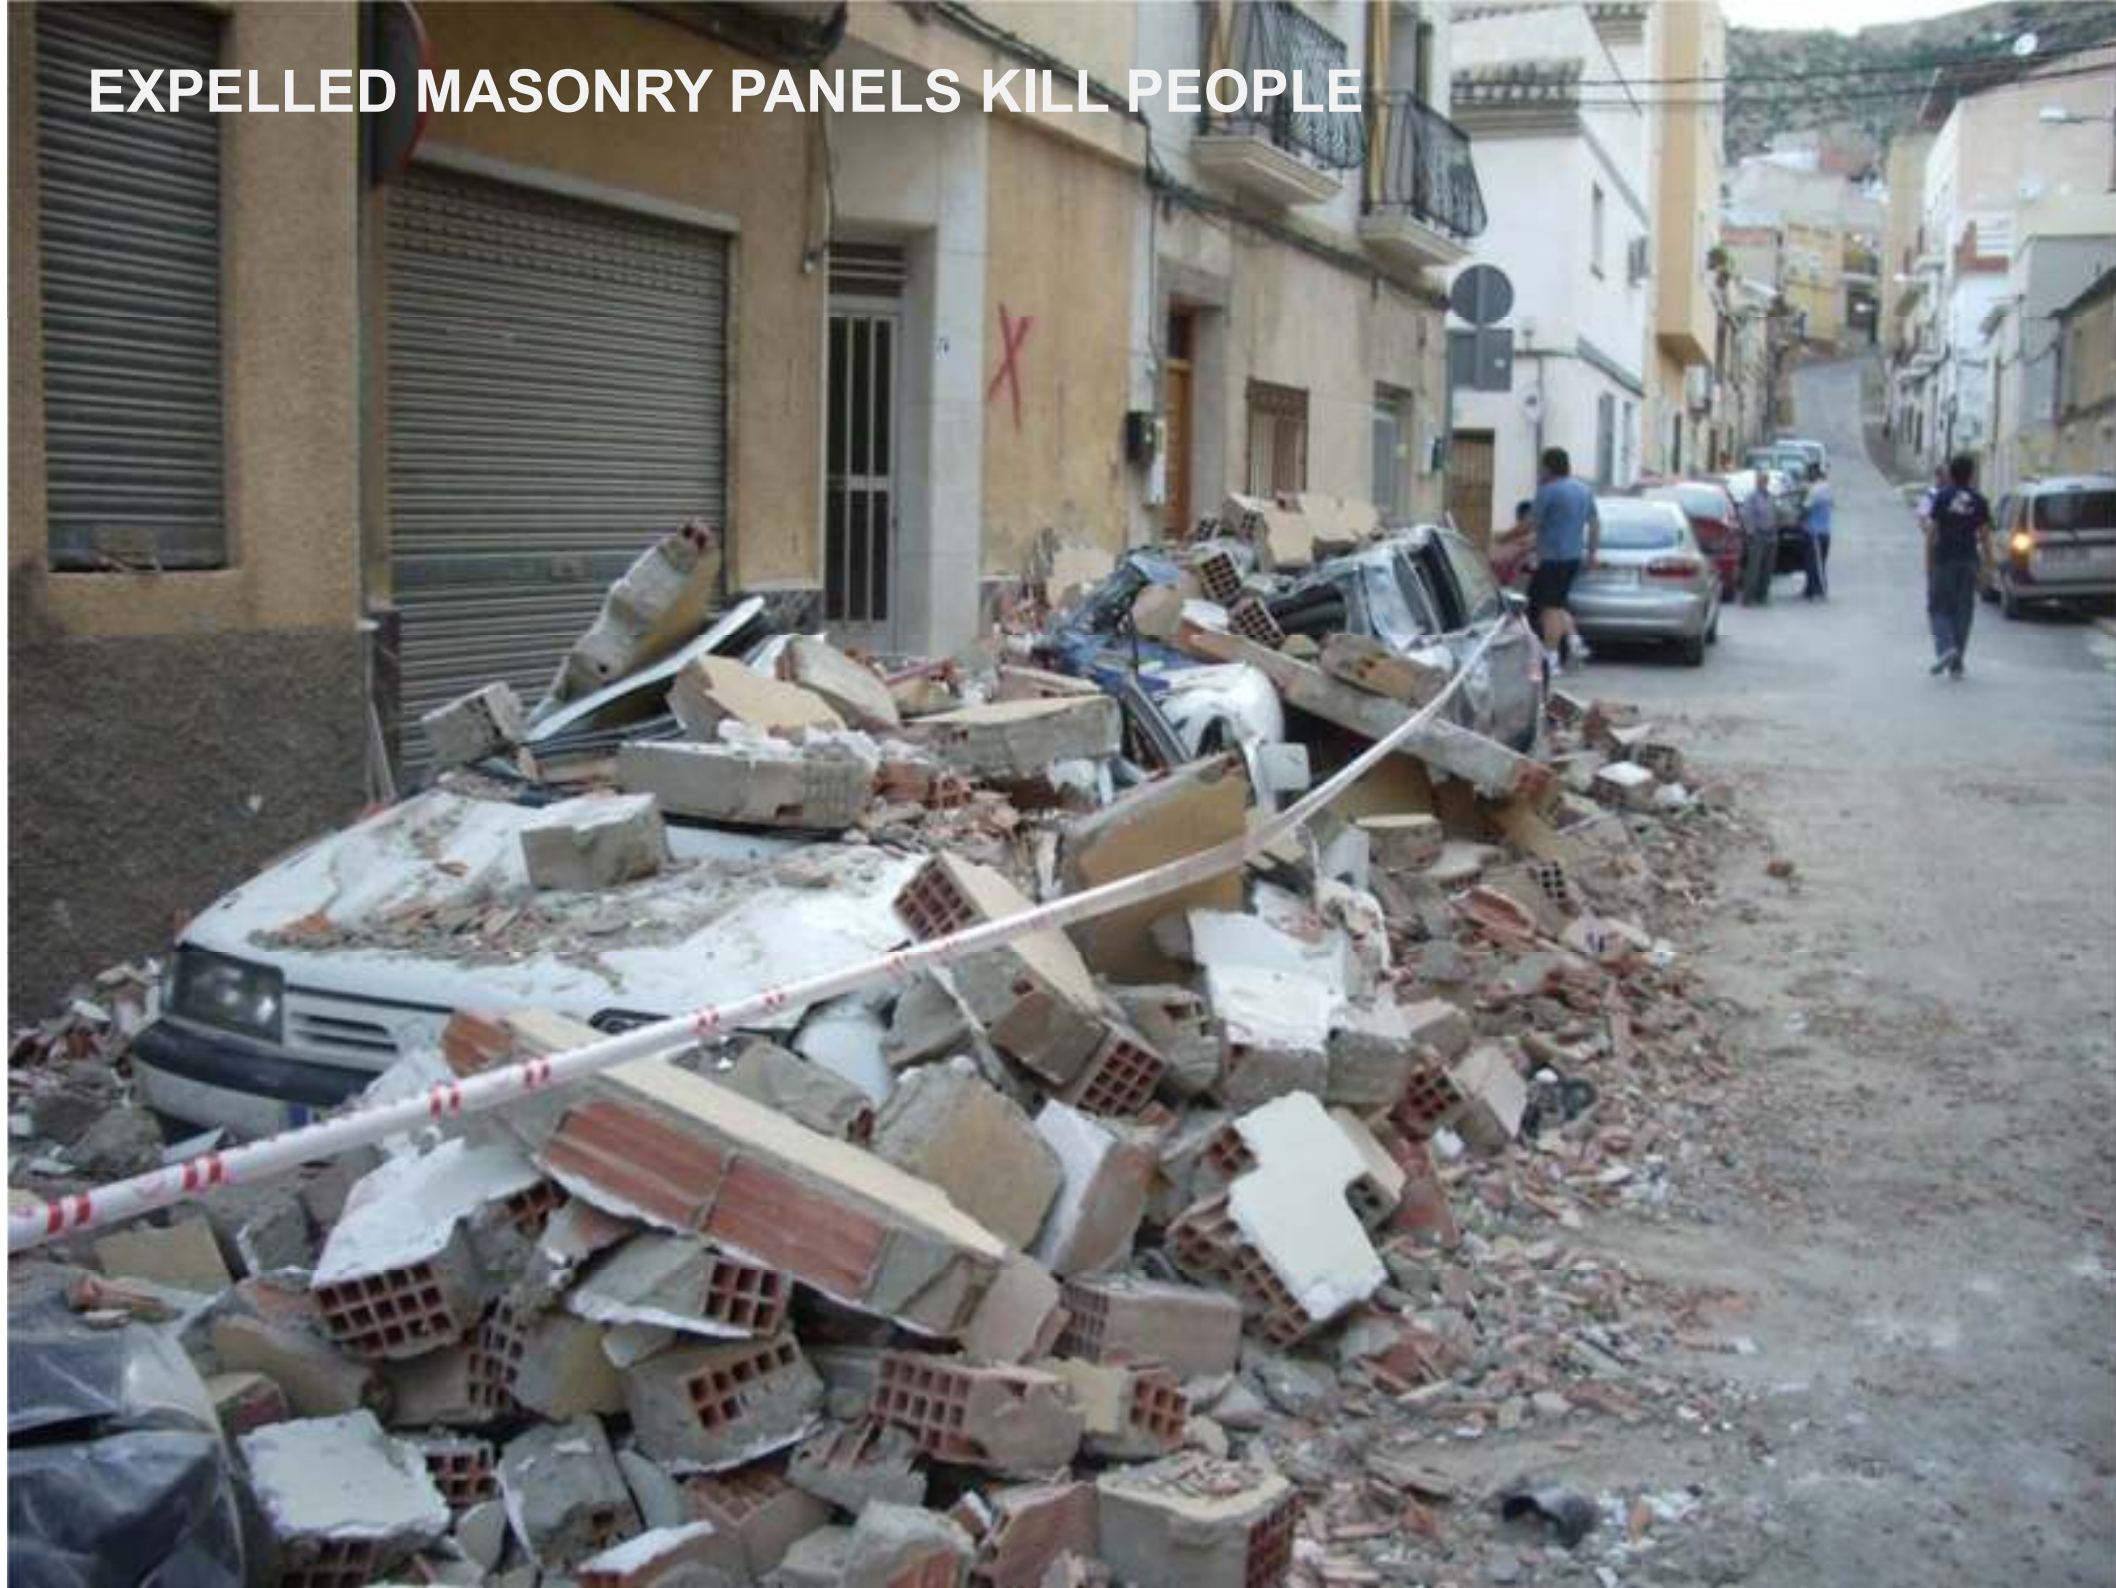
EXPELLED MASONRY PANELS KILL PEOPLE
