Quick field report

Lorca earthquake 11th May 2011

Patrick Murphy Corella

Broadway Malyan

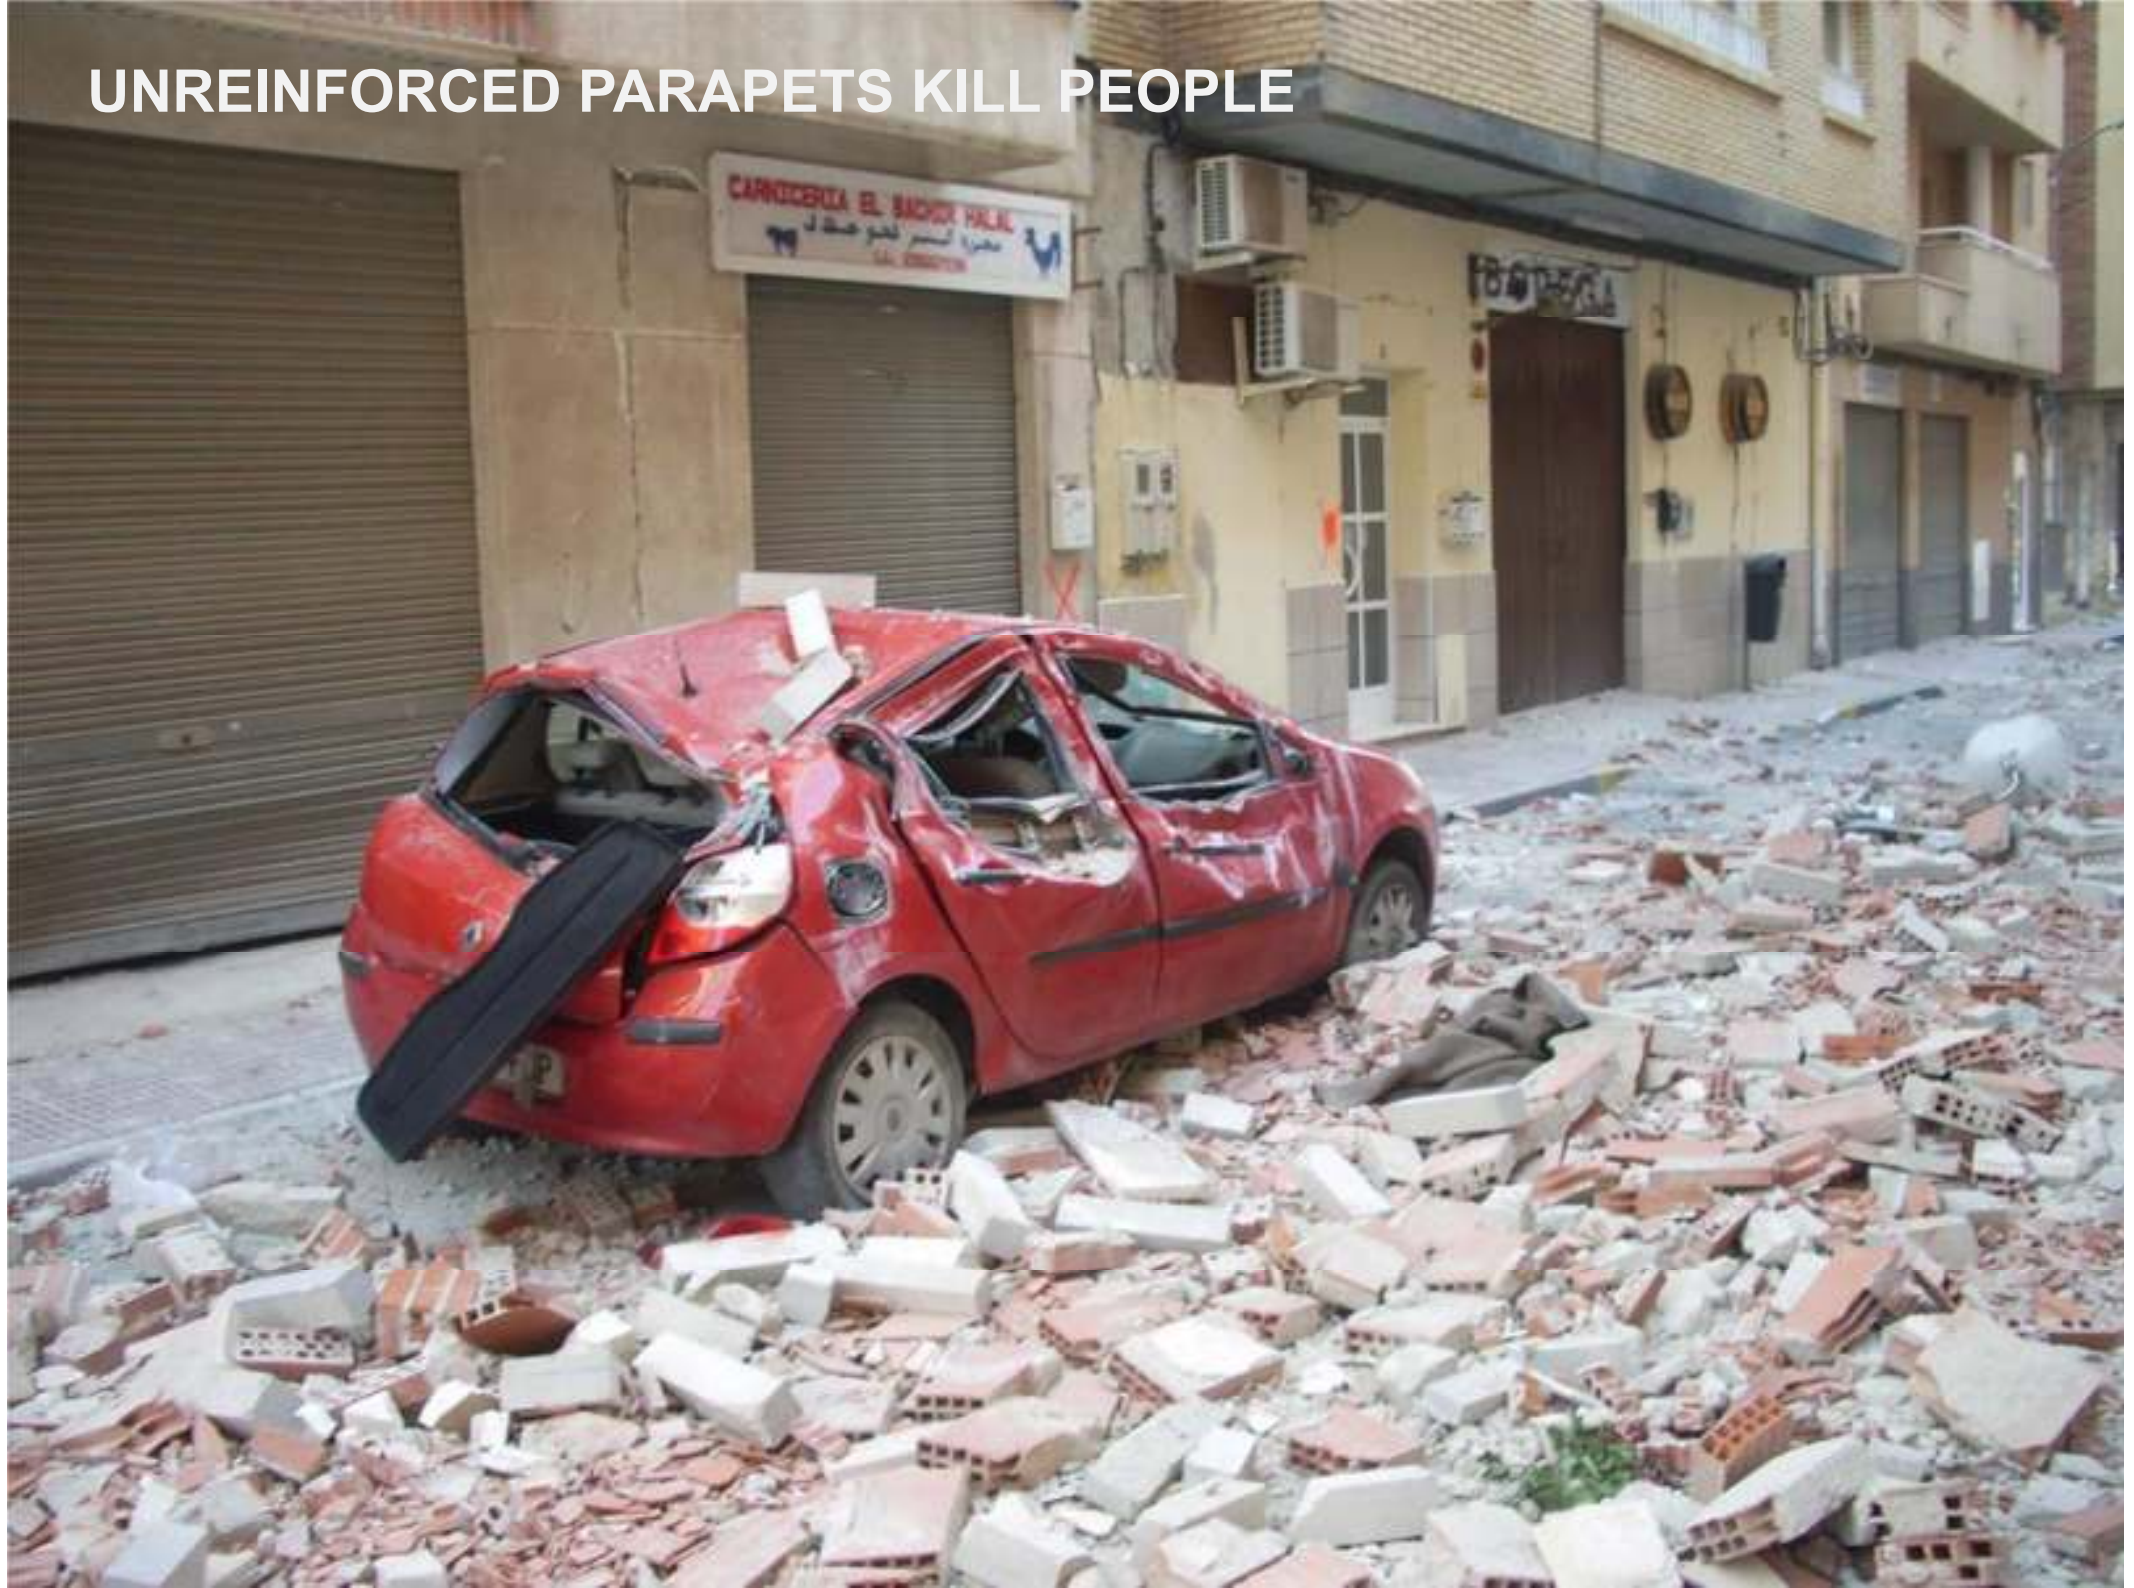
UNREINFORCED PARAPETS KILL PEOPLE

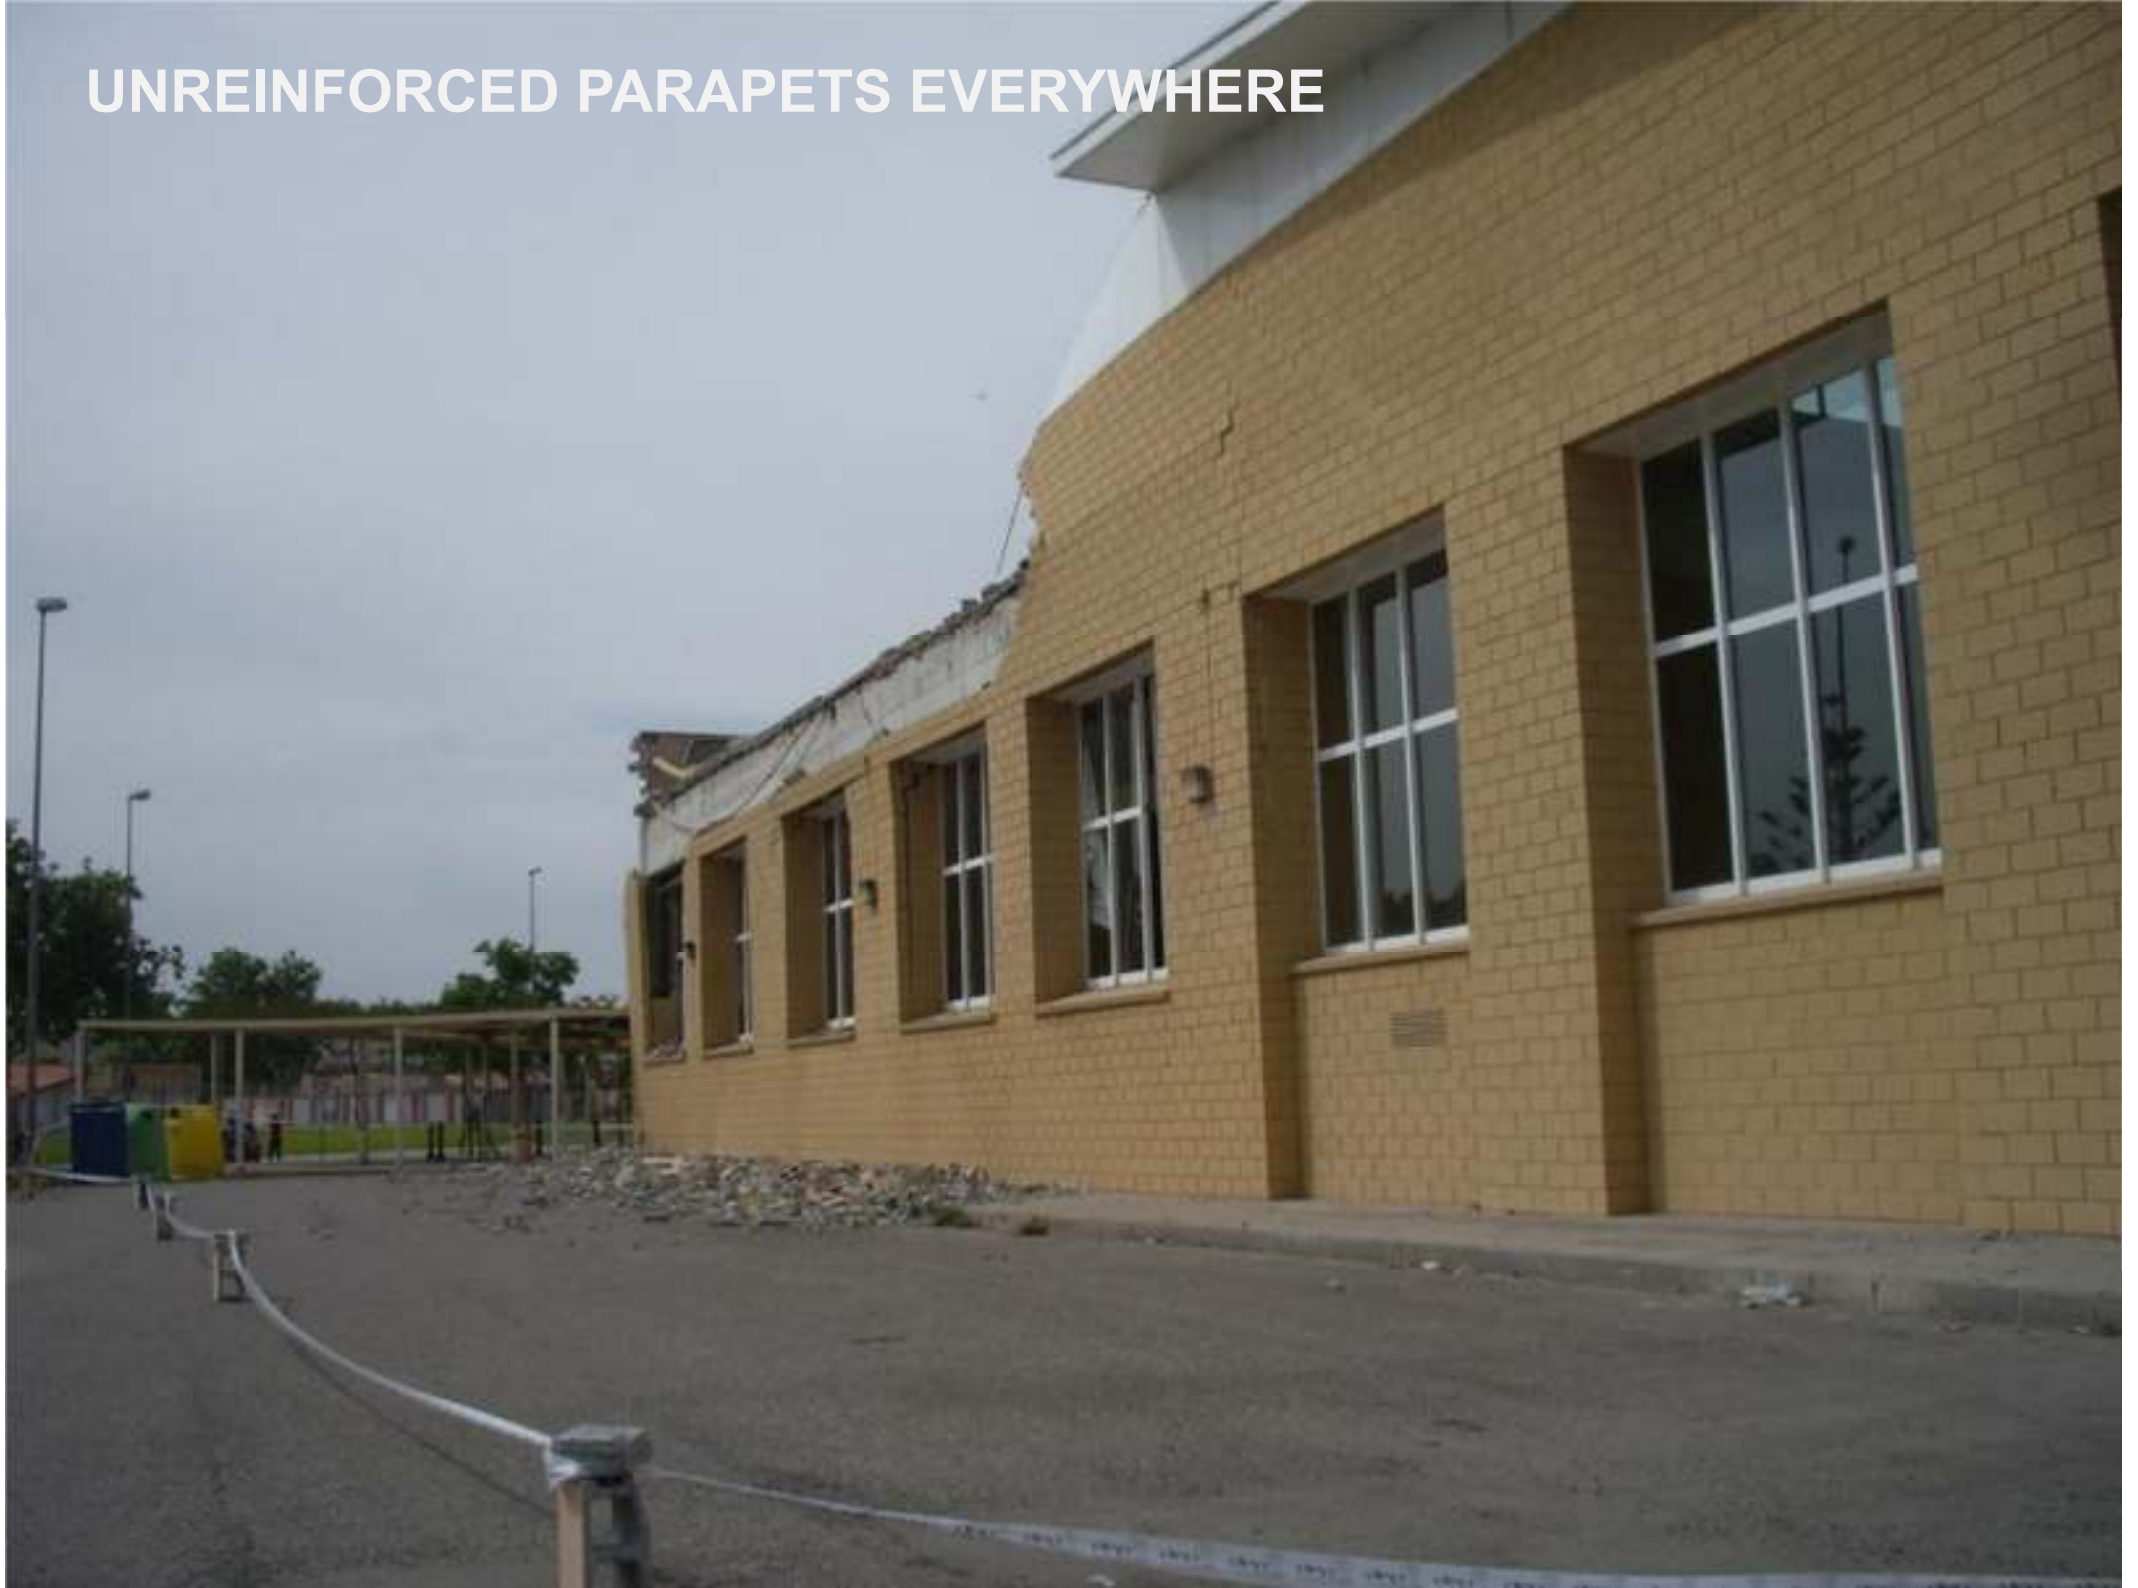
UNREINFORCED PARAPETS EVERYWHERE

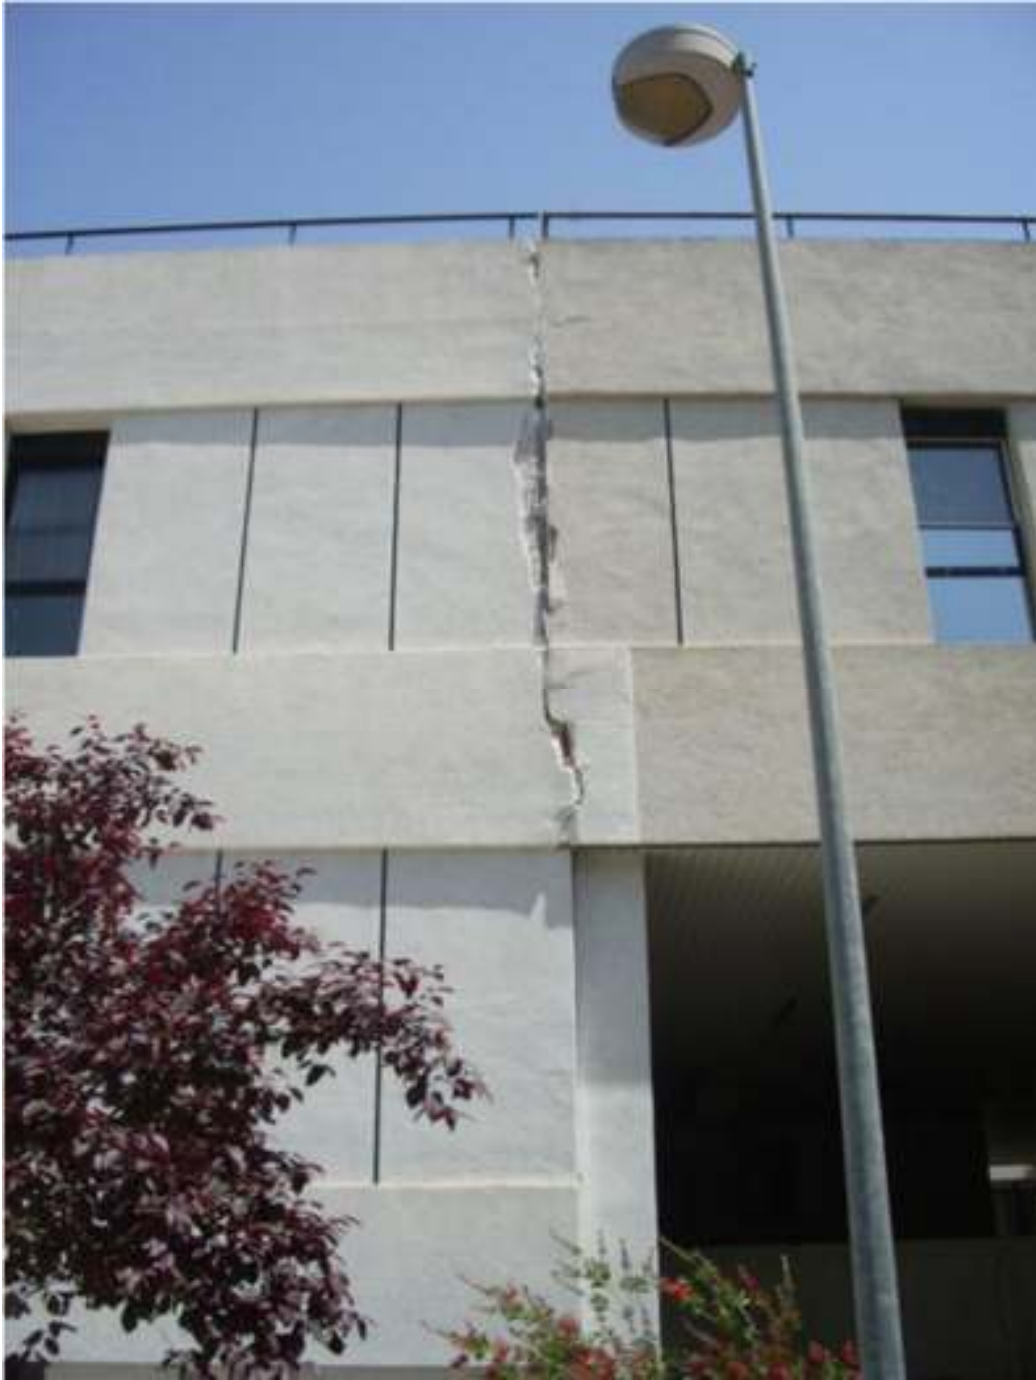
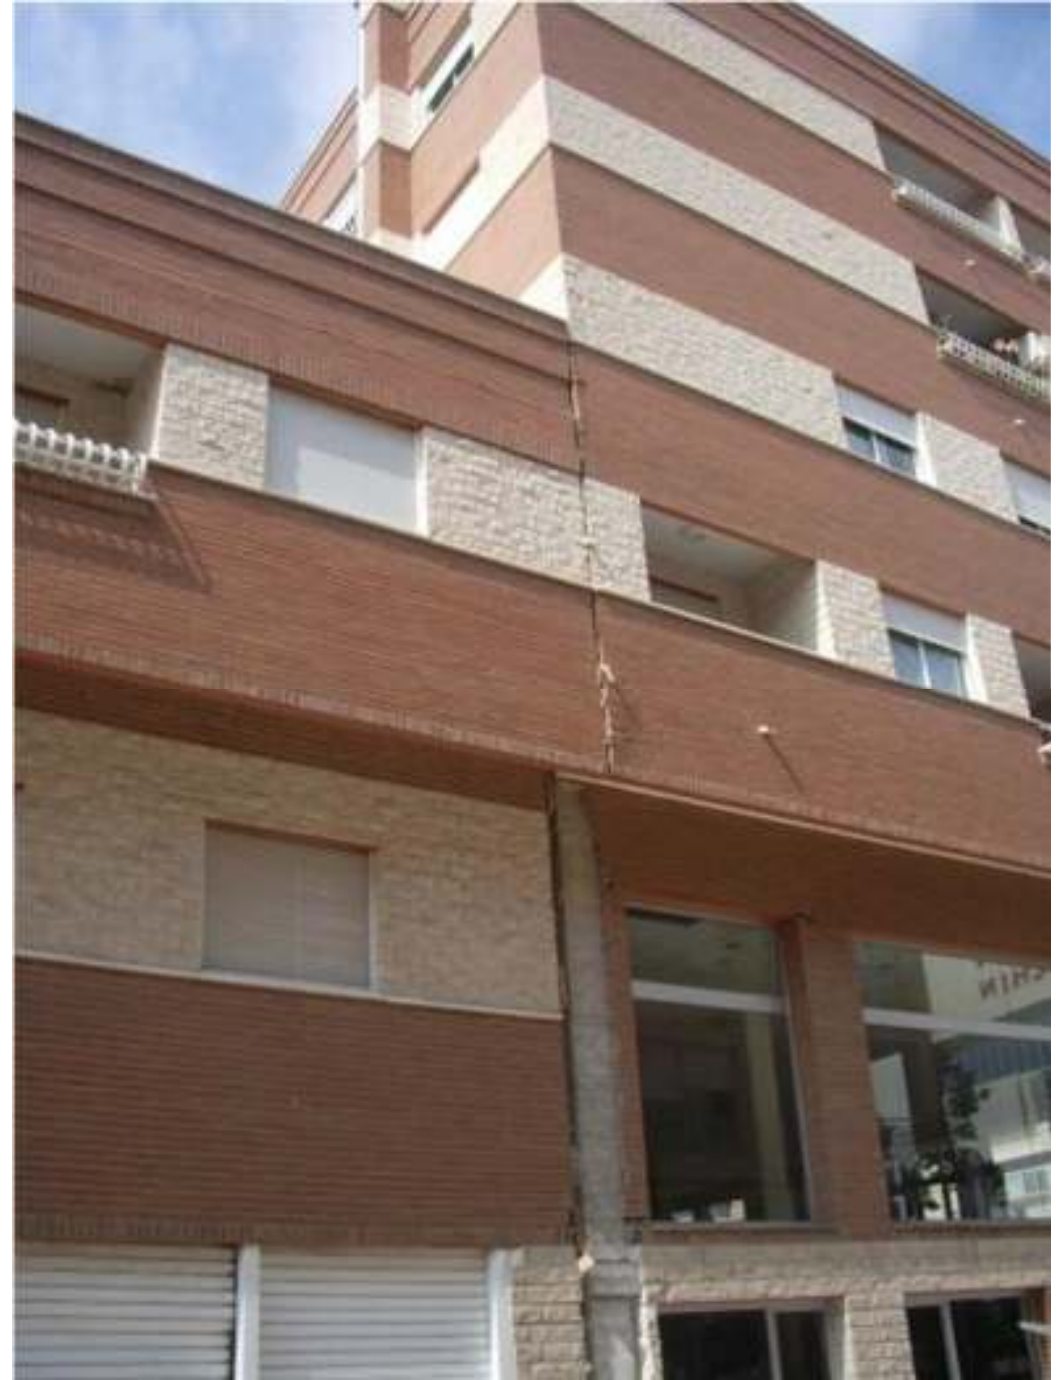
A THERMAL JOINT IS NOT A SEISMIC JOINT

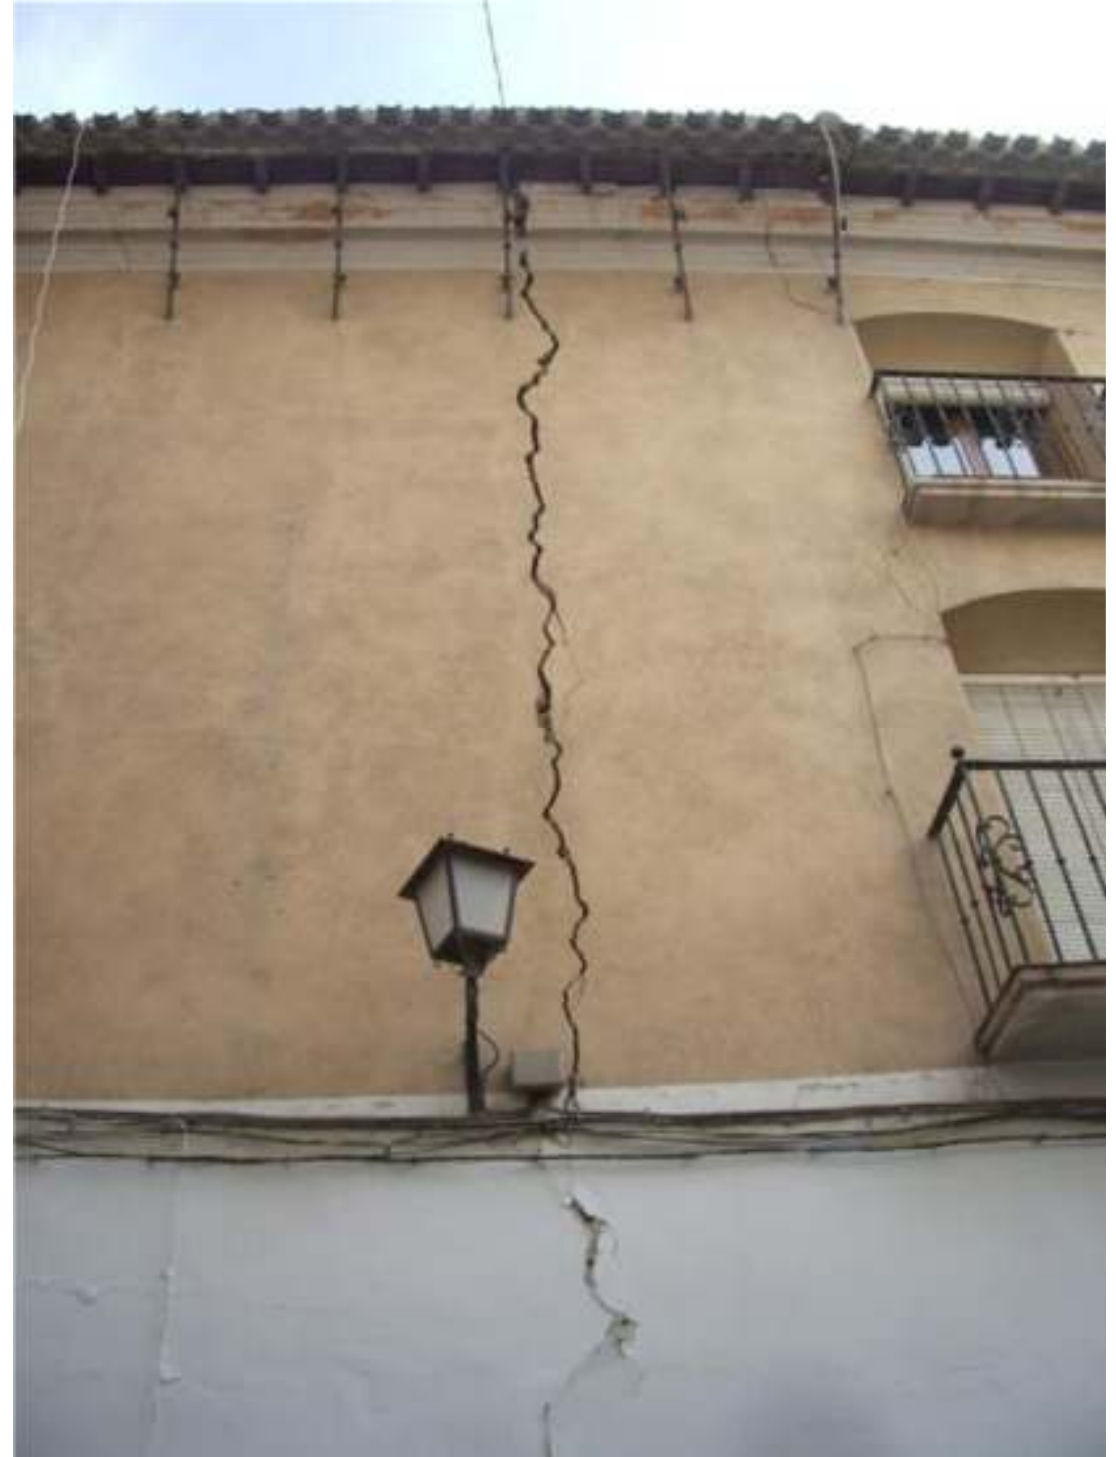
EARTHQUAKE – INDUCED JOINTING

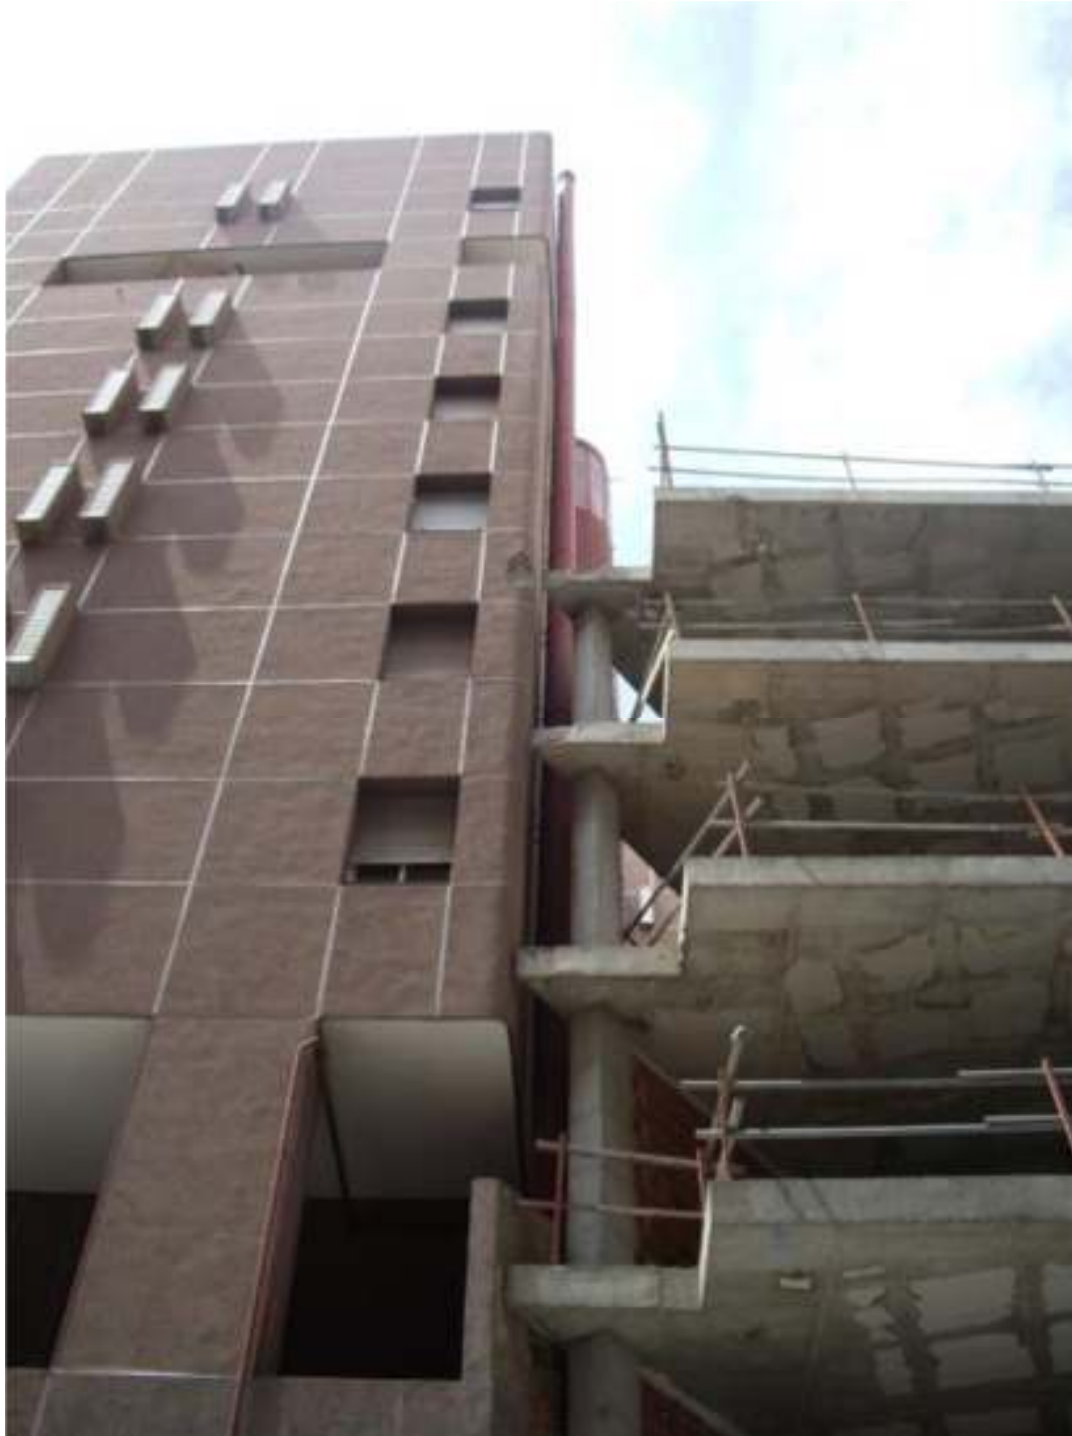
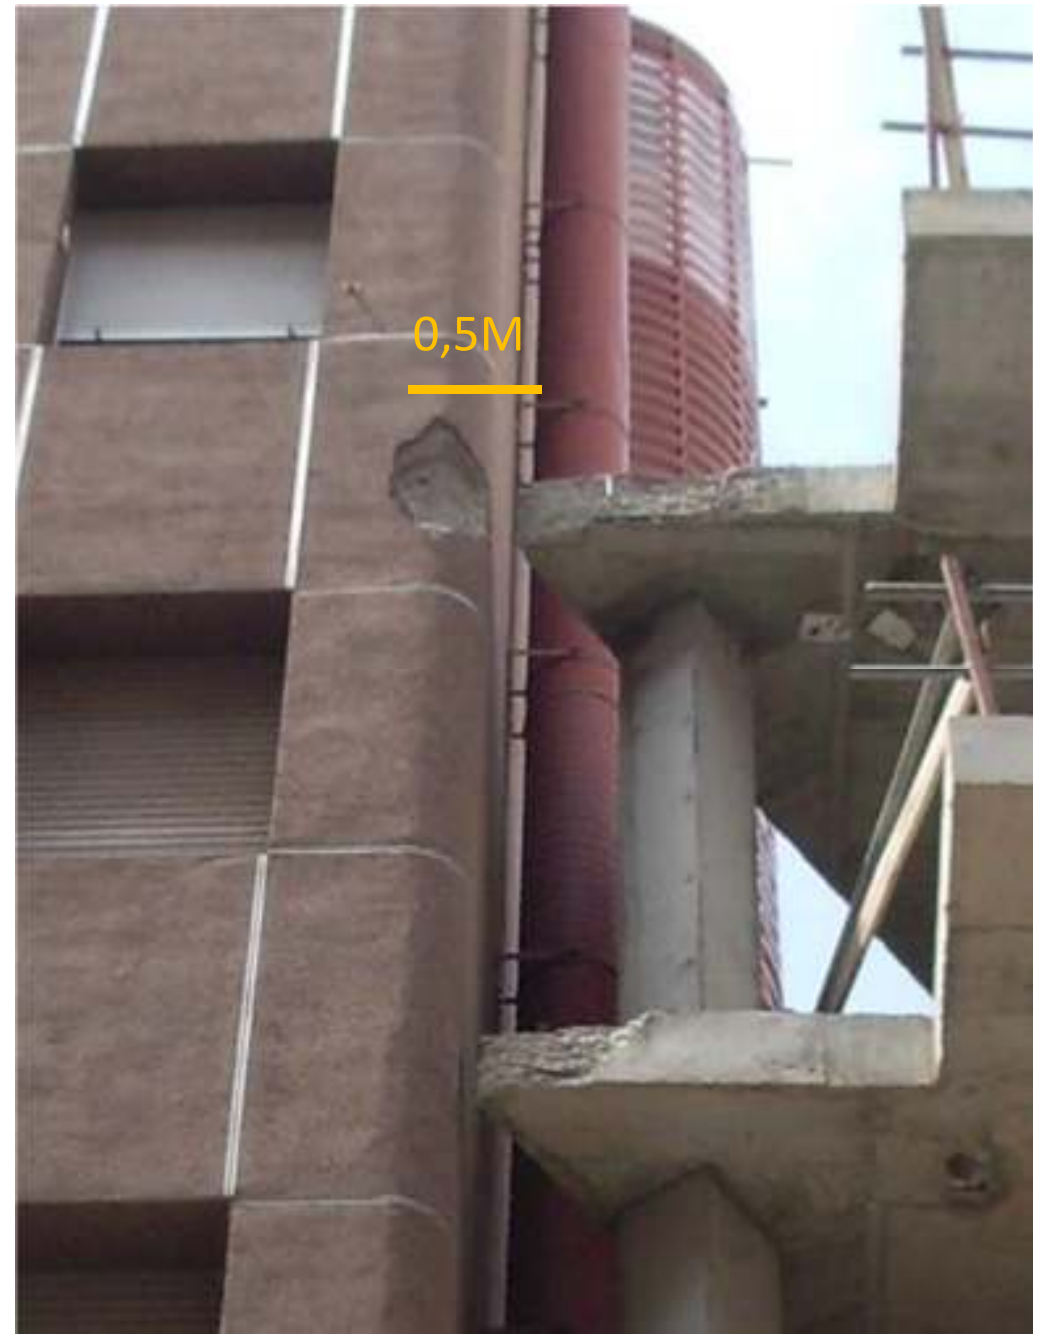
SWAYING AND POUNDING

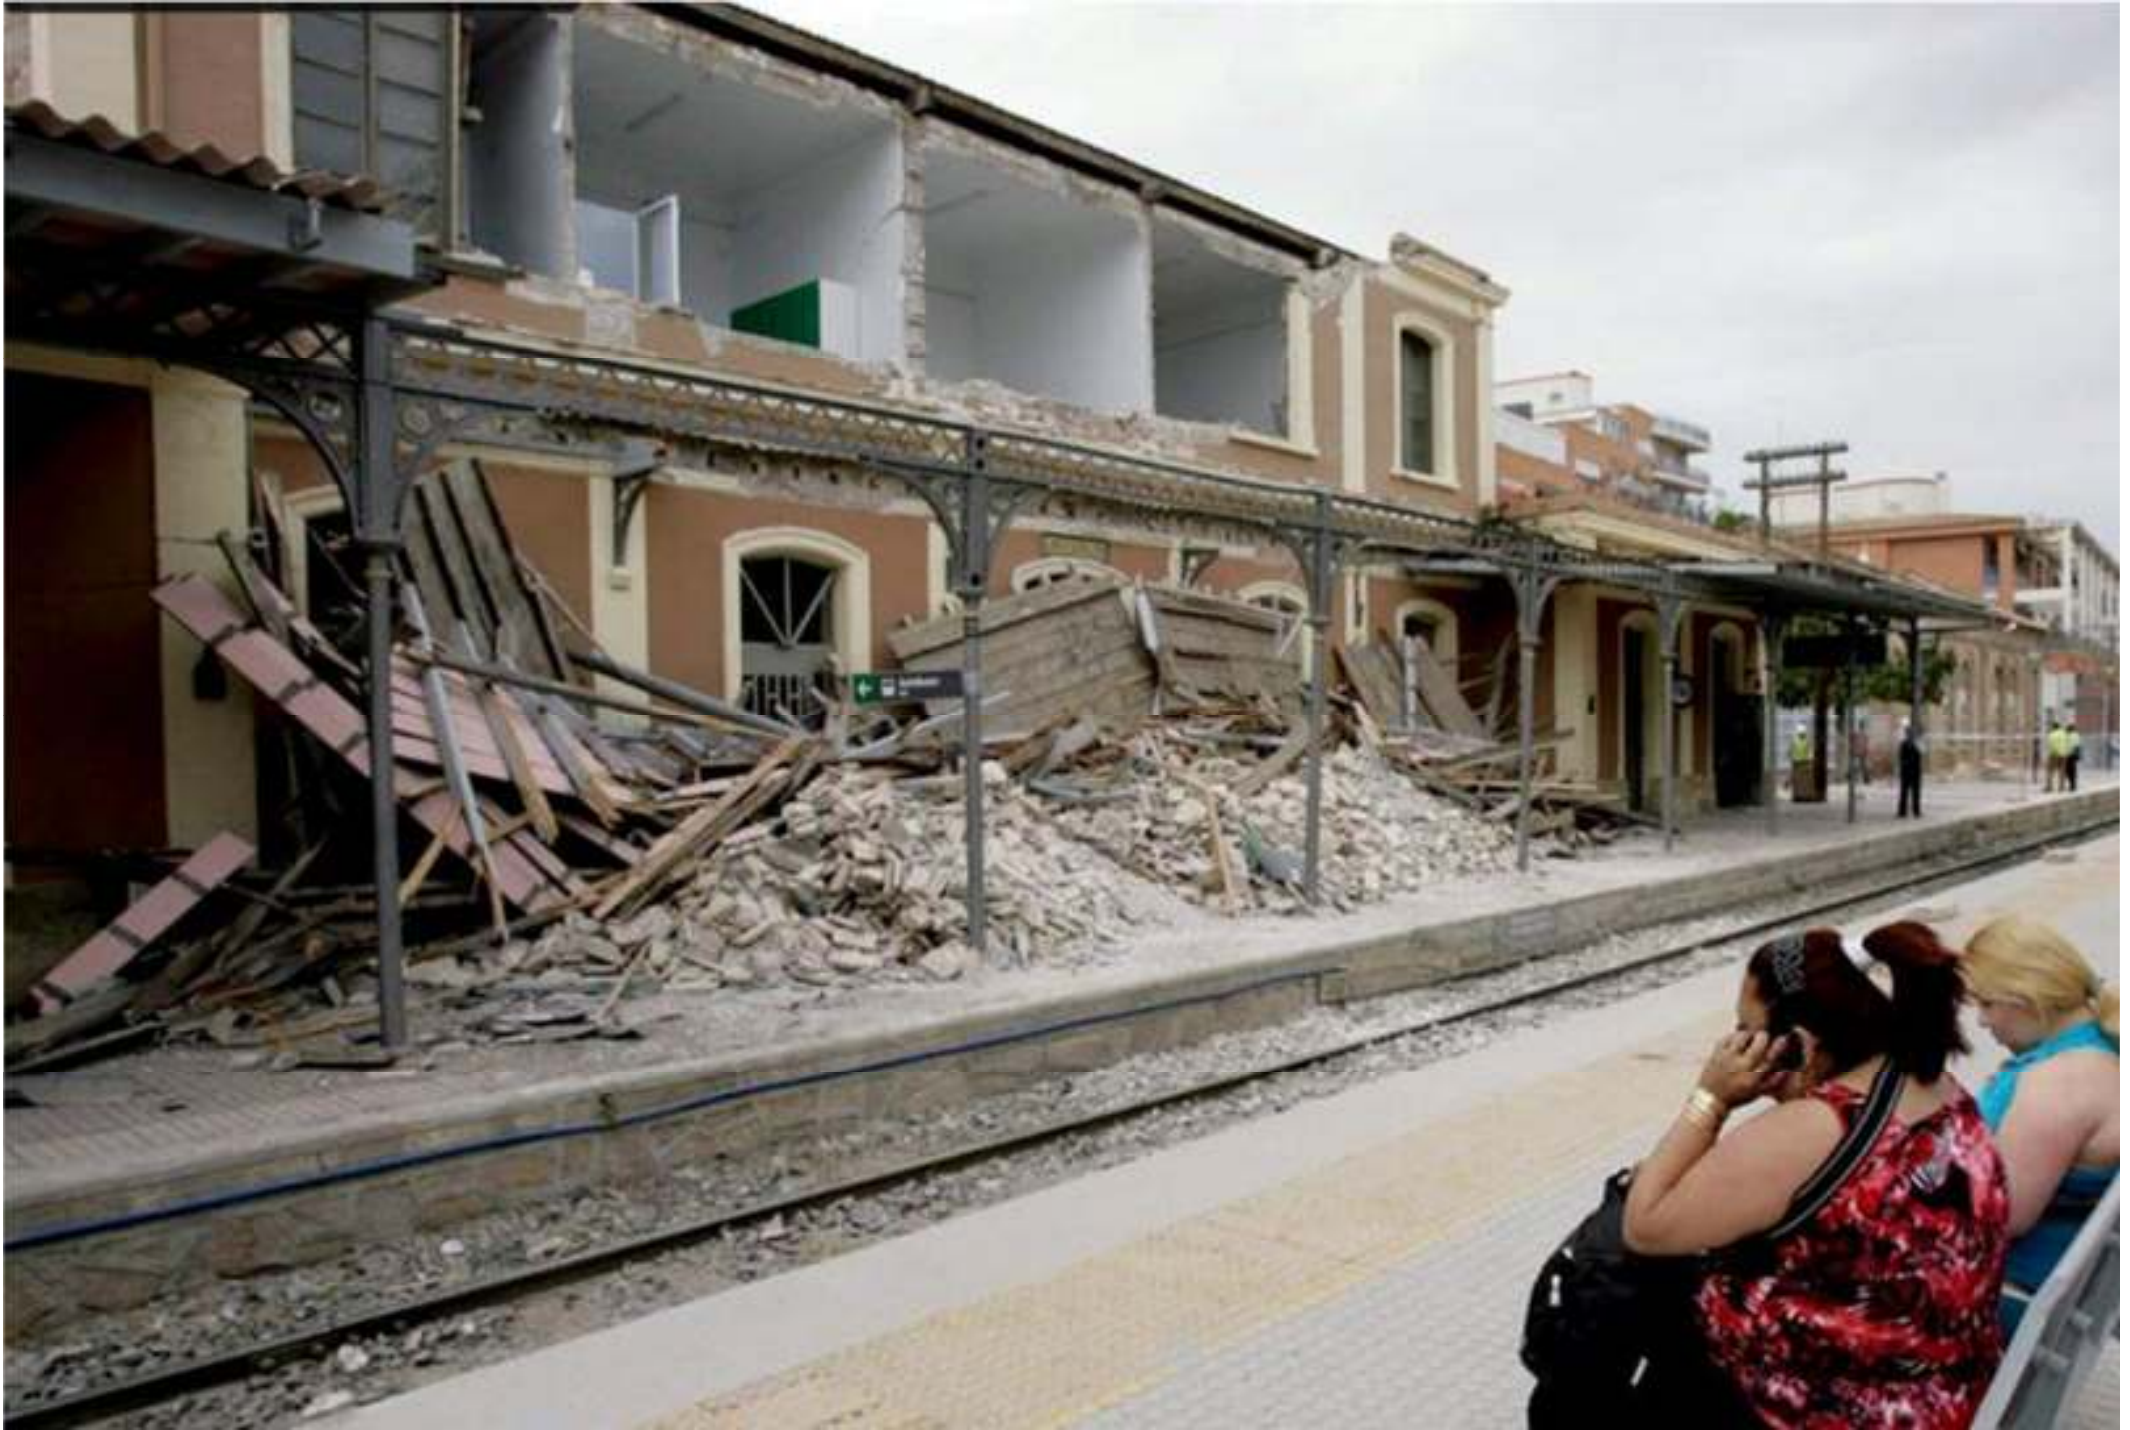
OUT OF PLANE COLLAPSE OF TRAIN STATION MASONRY BEARING WALL

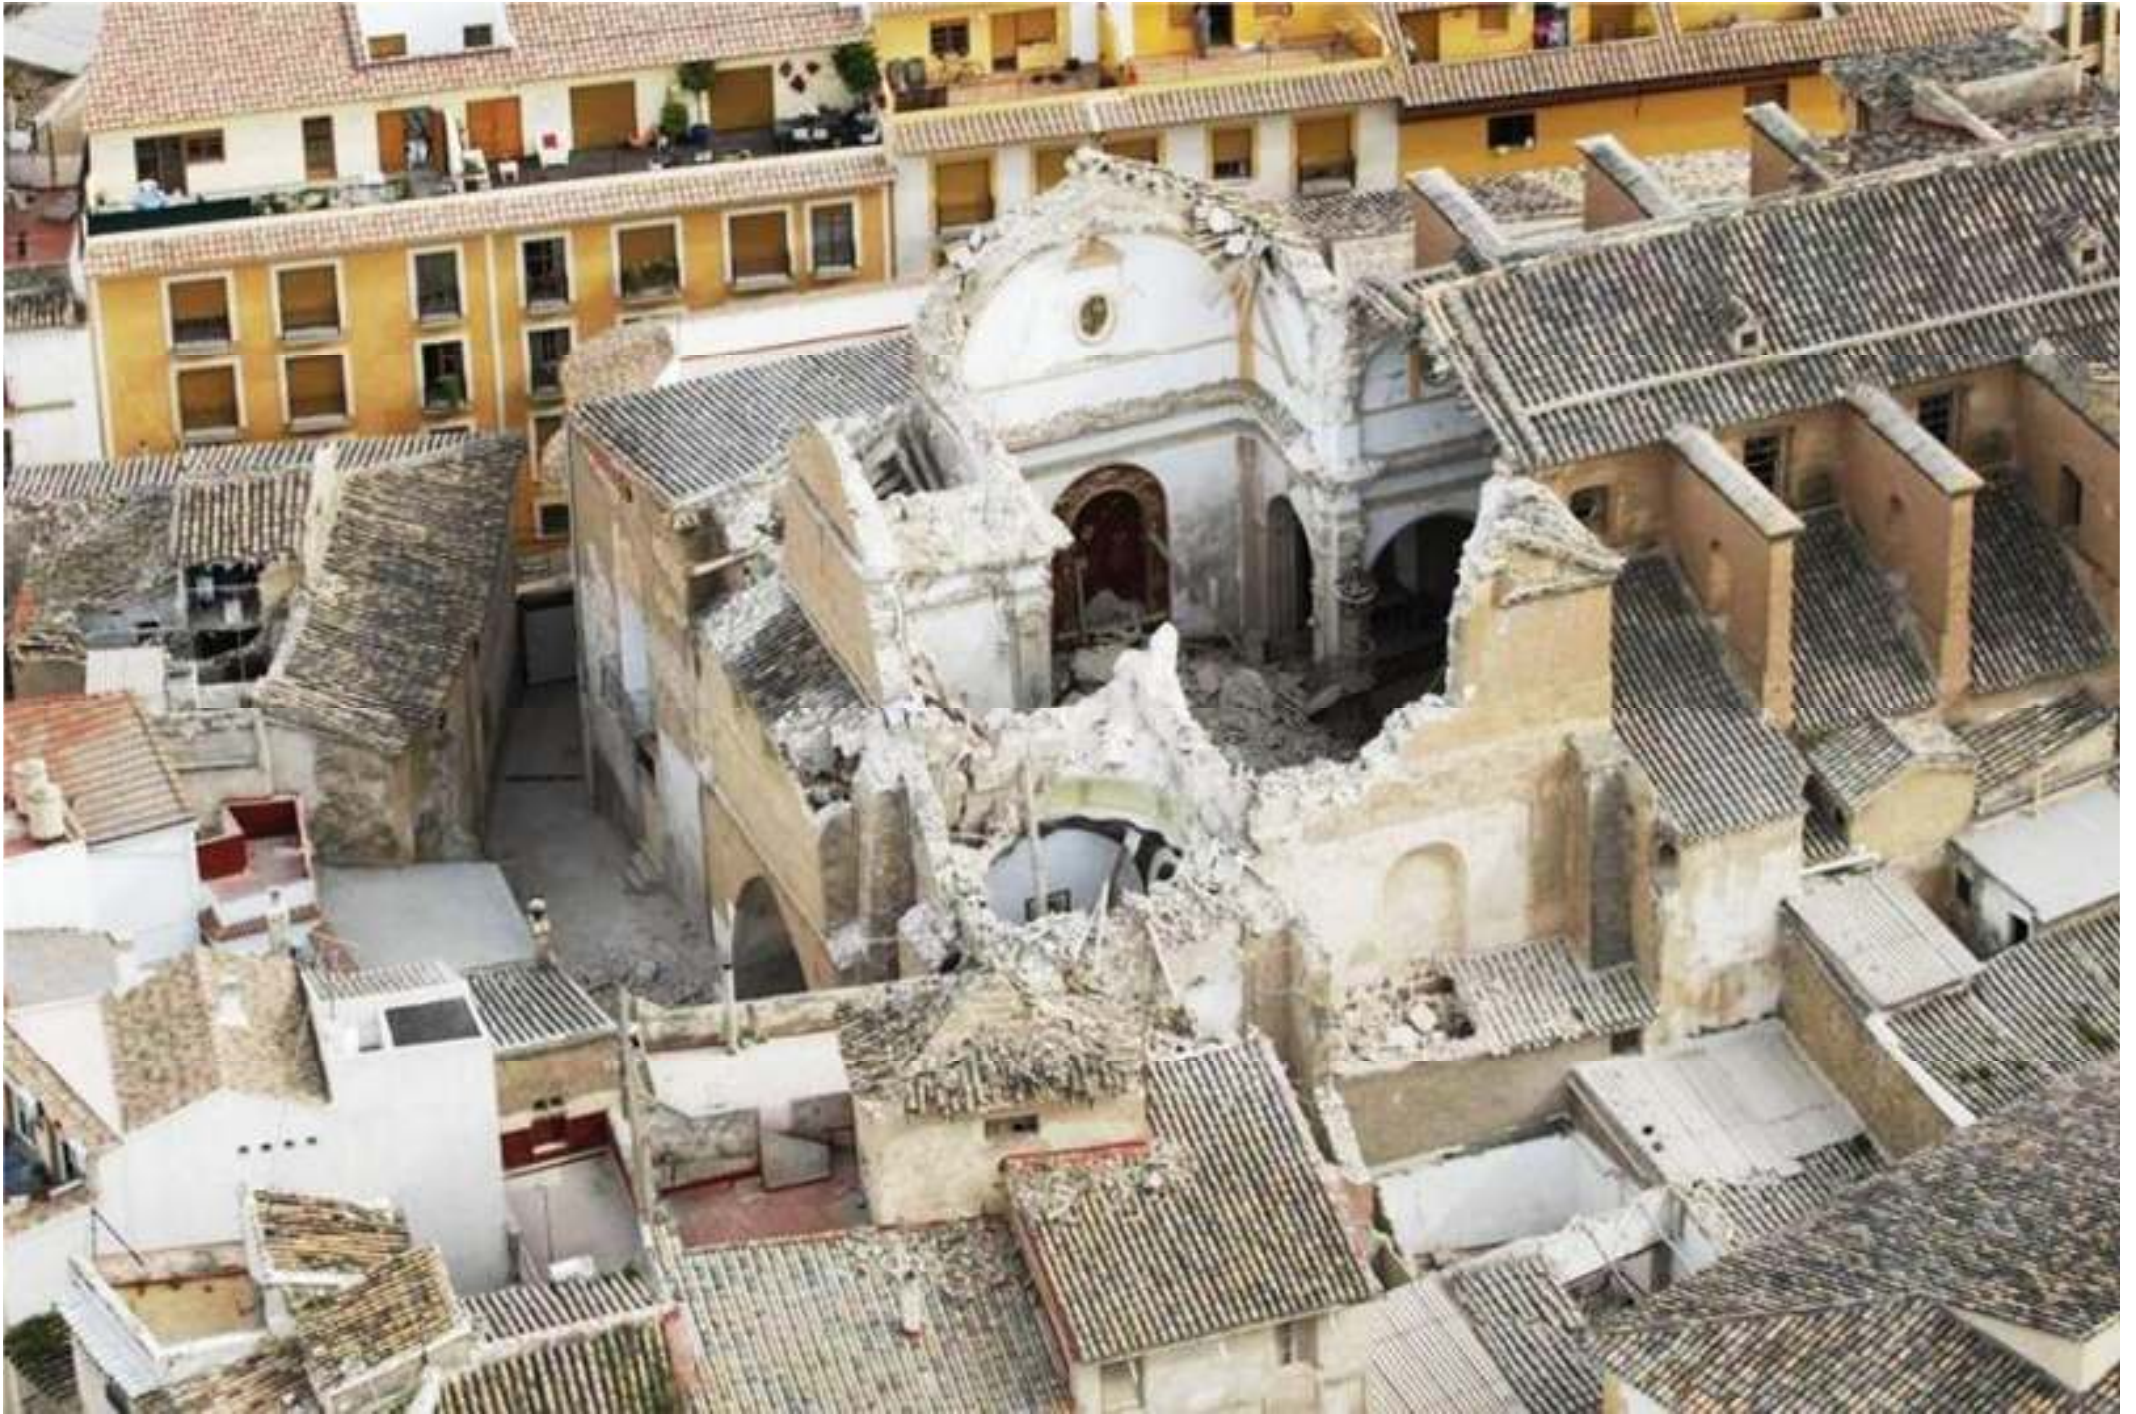
SANTIAGO CHURCH NAVE COLLAPSE

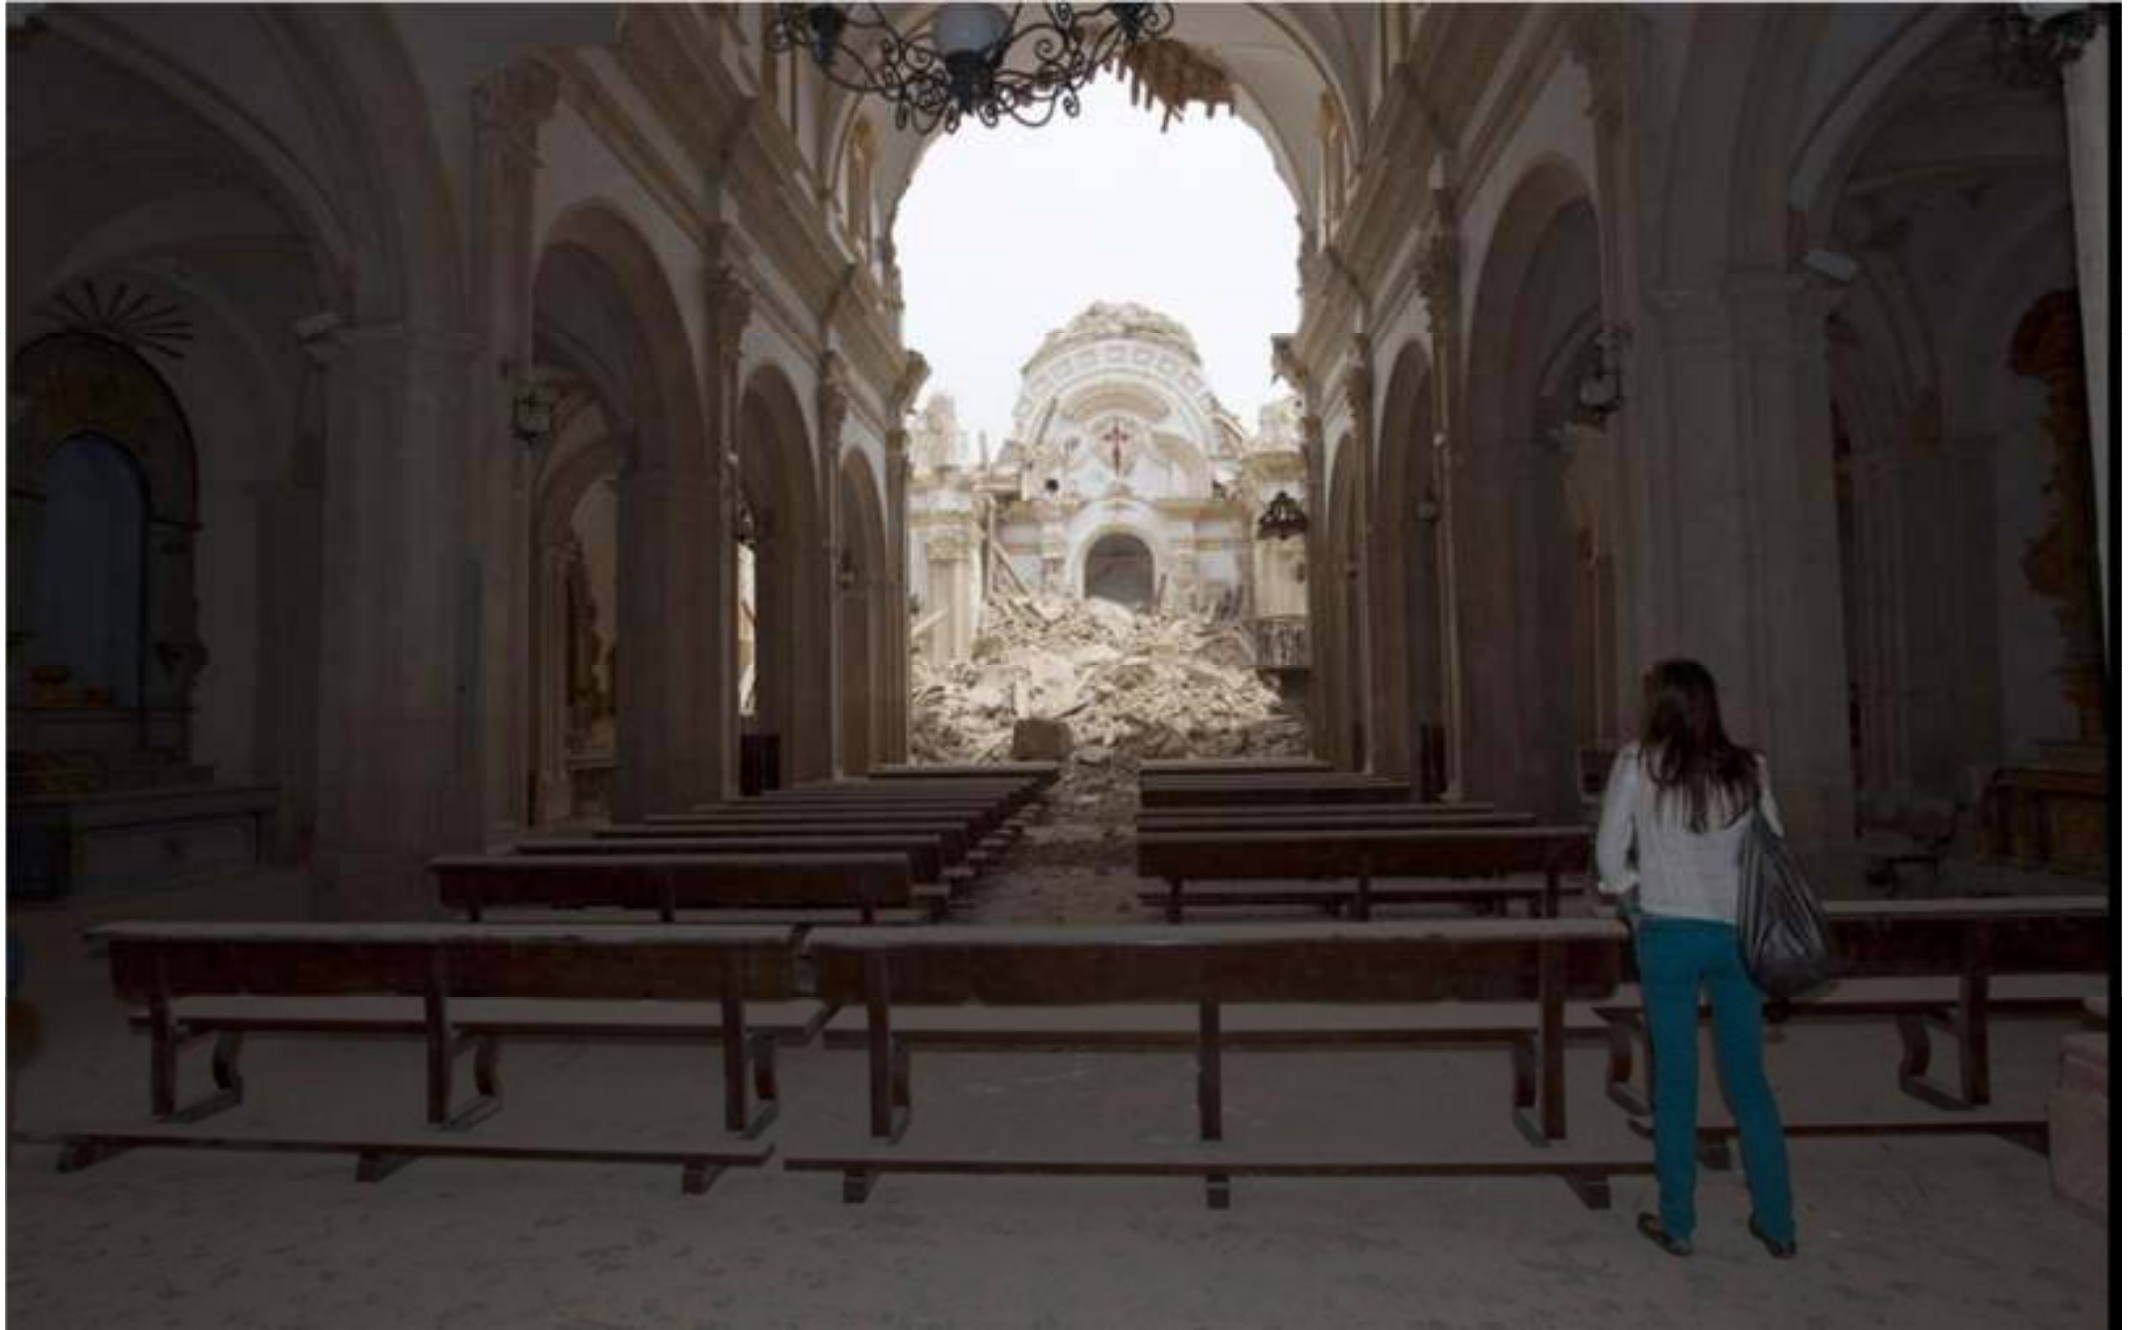
SANTIAGO CHURCH NAVE COLLAPSE
