Quick field report

Lorca earthquake 11th May 2011

Patrick Murphy Corella

Broadway Malyan

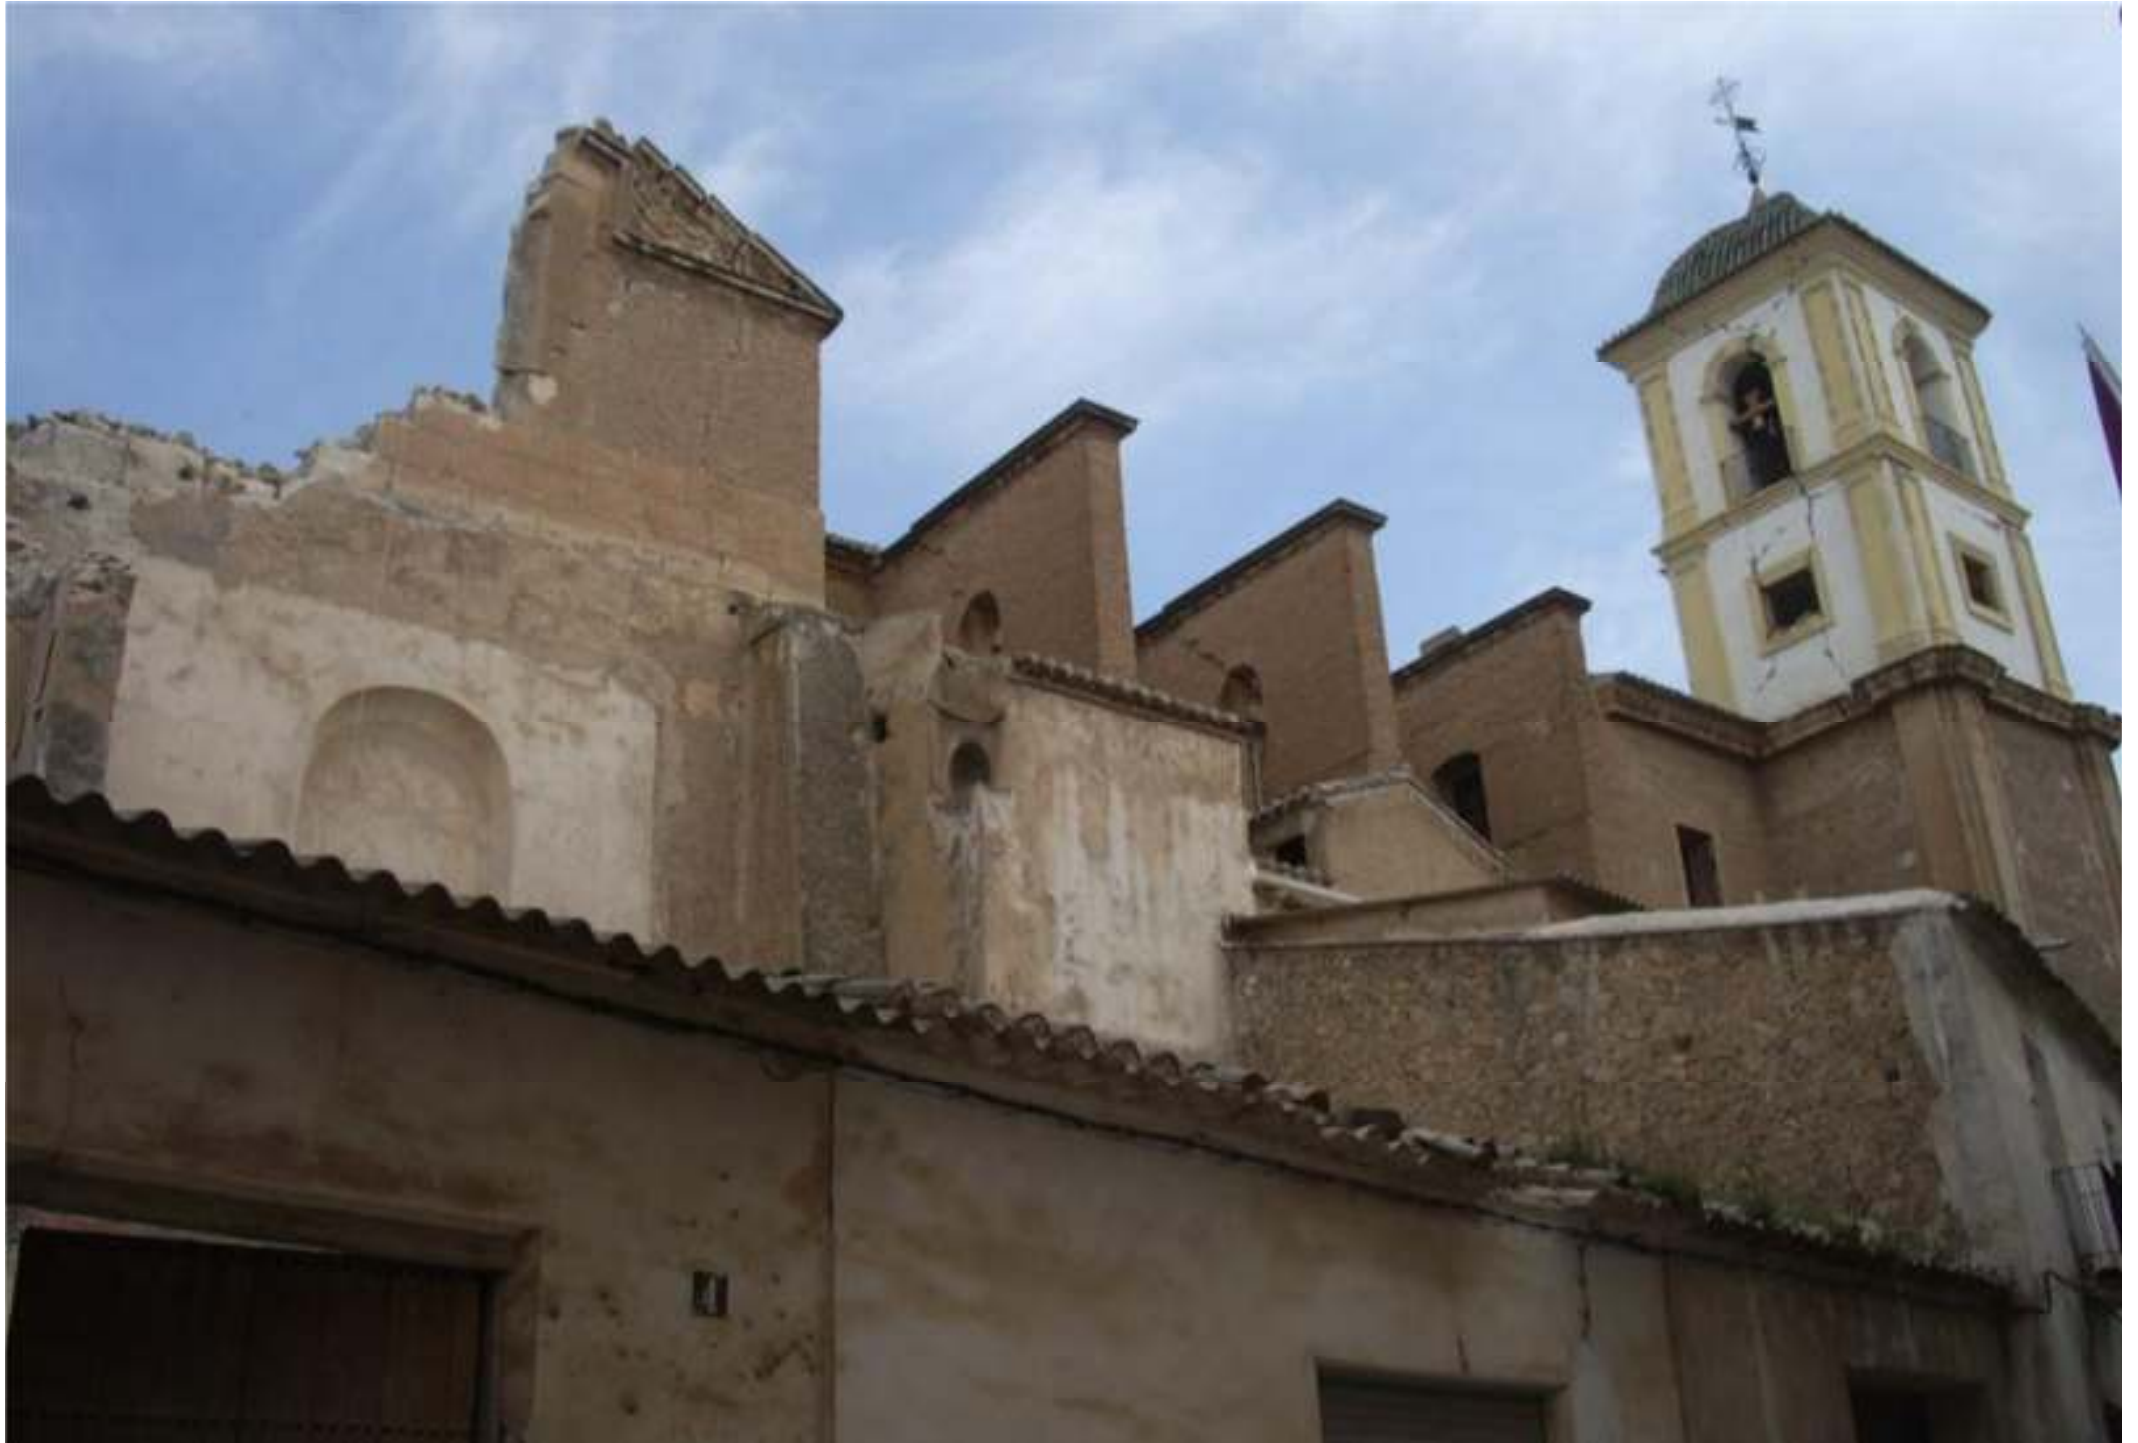
SANTIAGO CHURCH BUTRESS DAMAGE

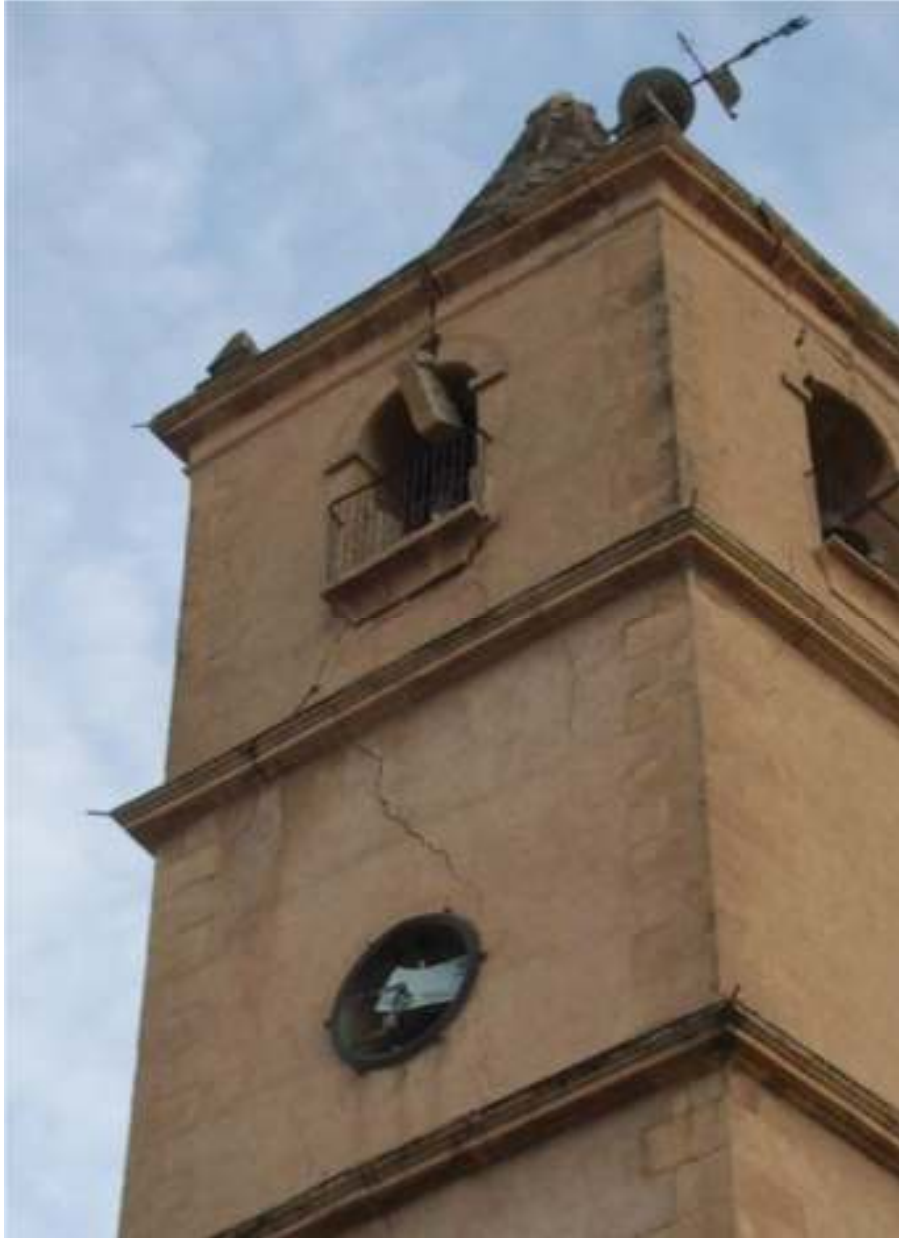
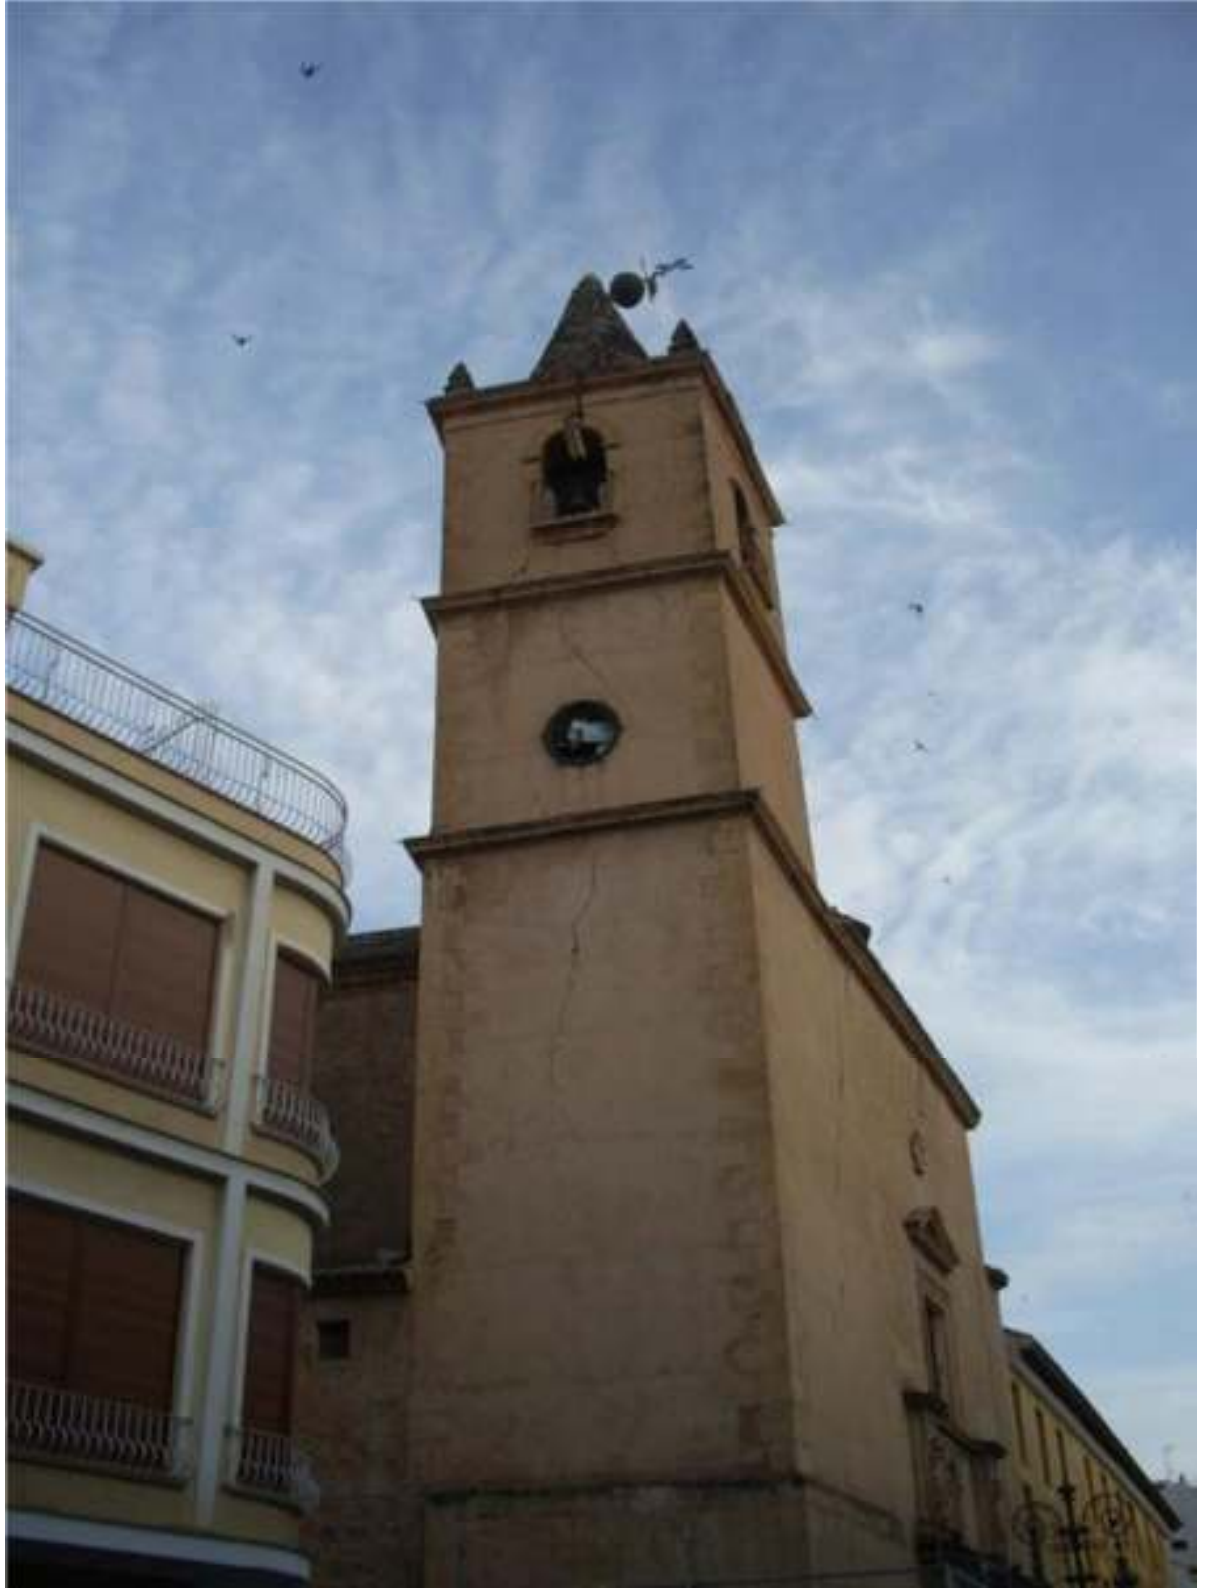
PASO AZUL CHURCH HANGING KEYSTONE

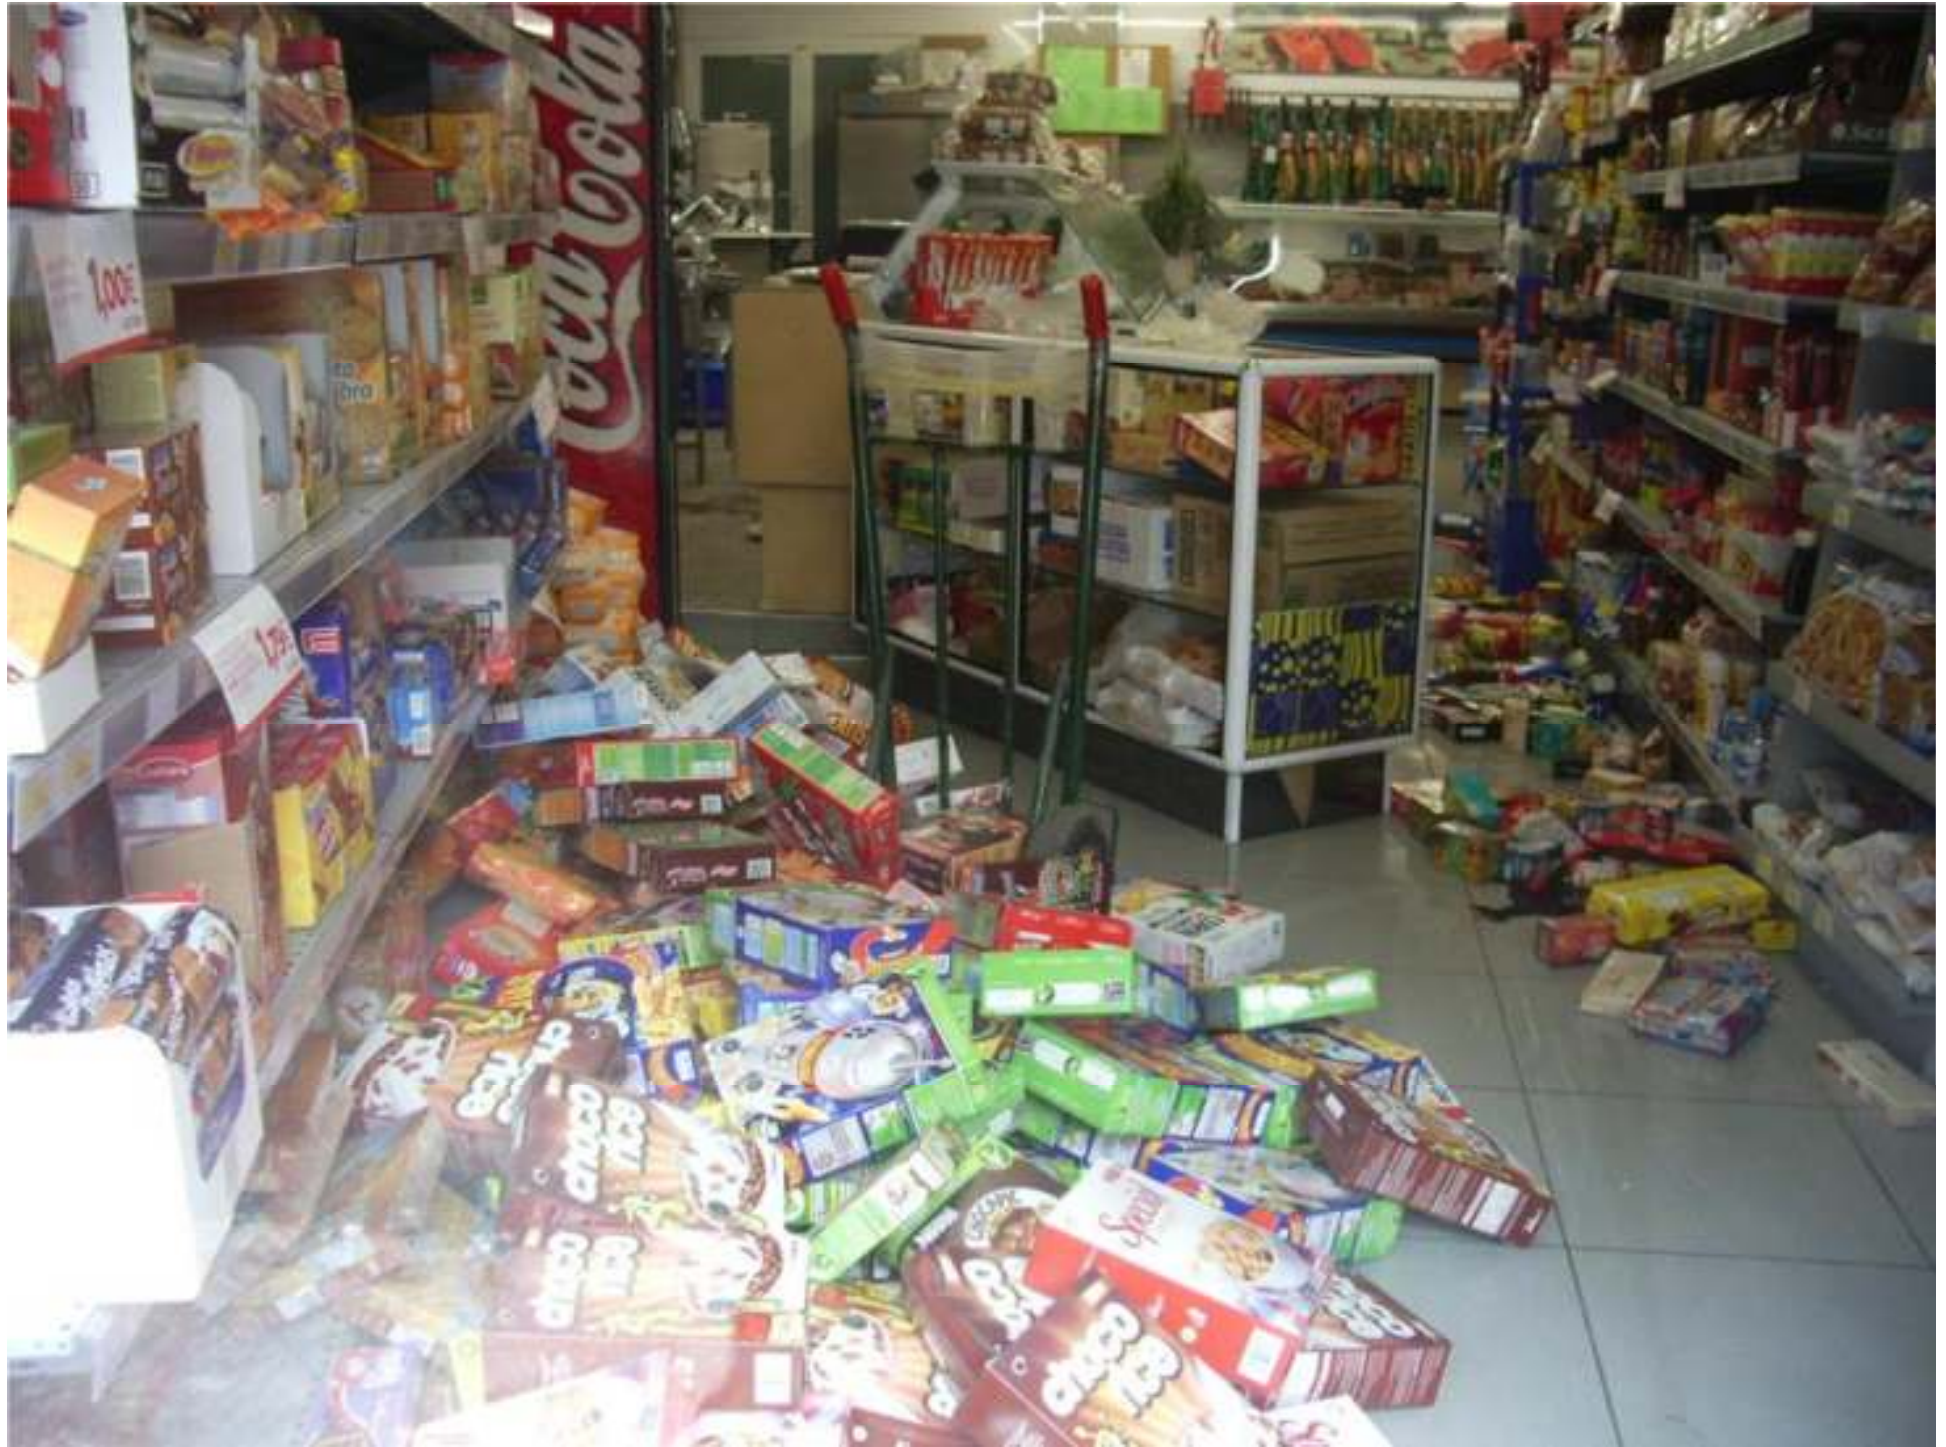
HEAVY DAMAGE TO PERISHABLE GOODS

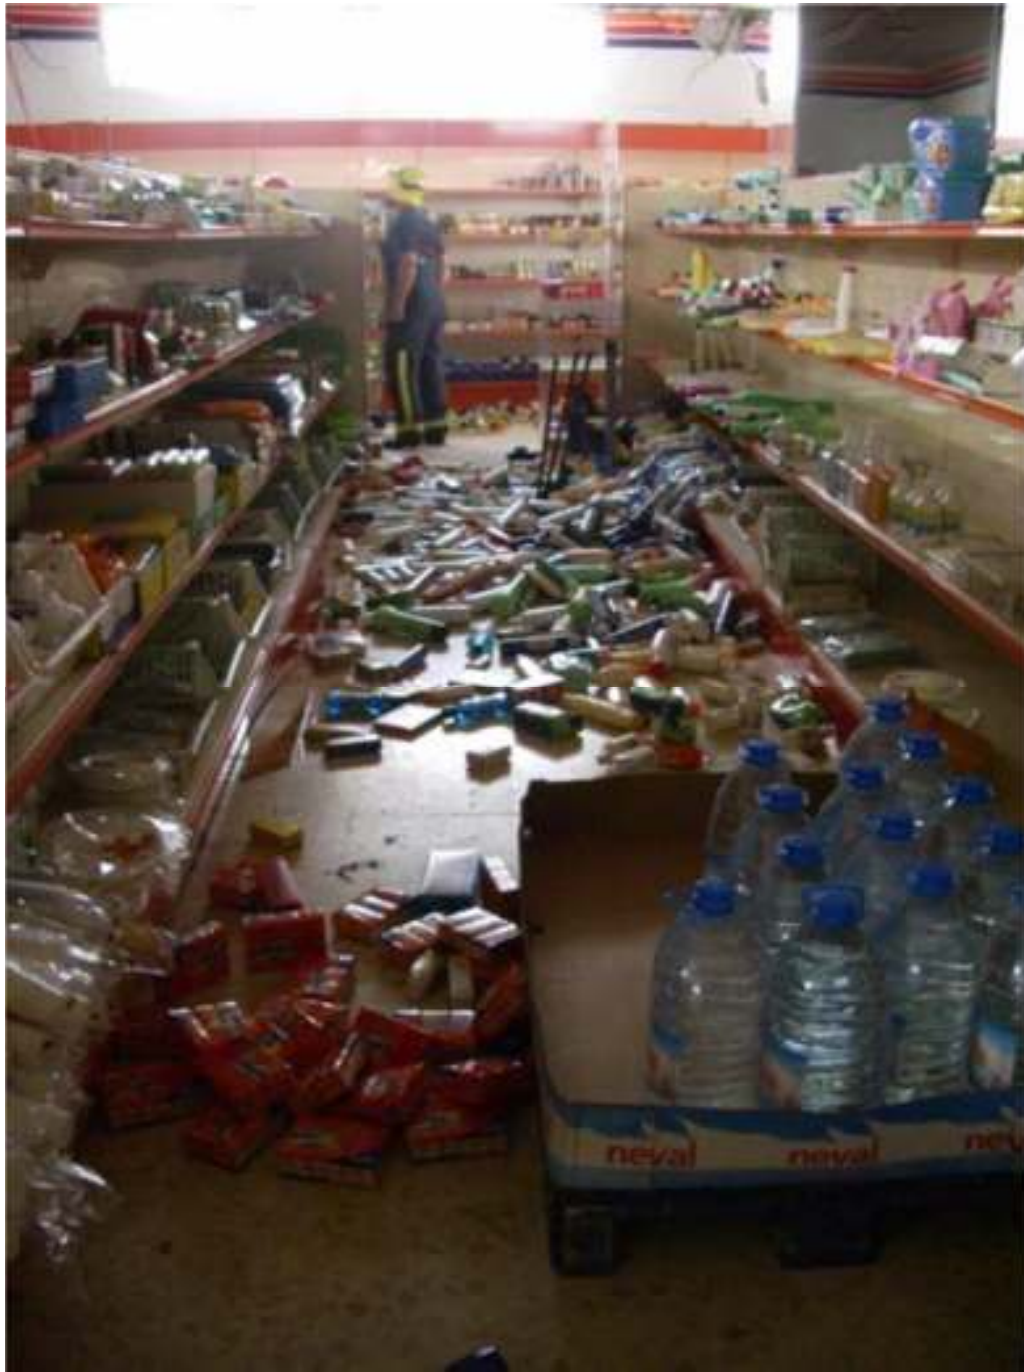
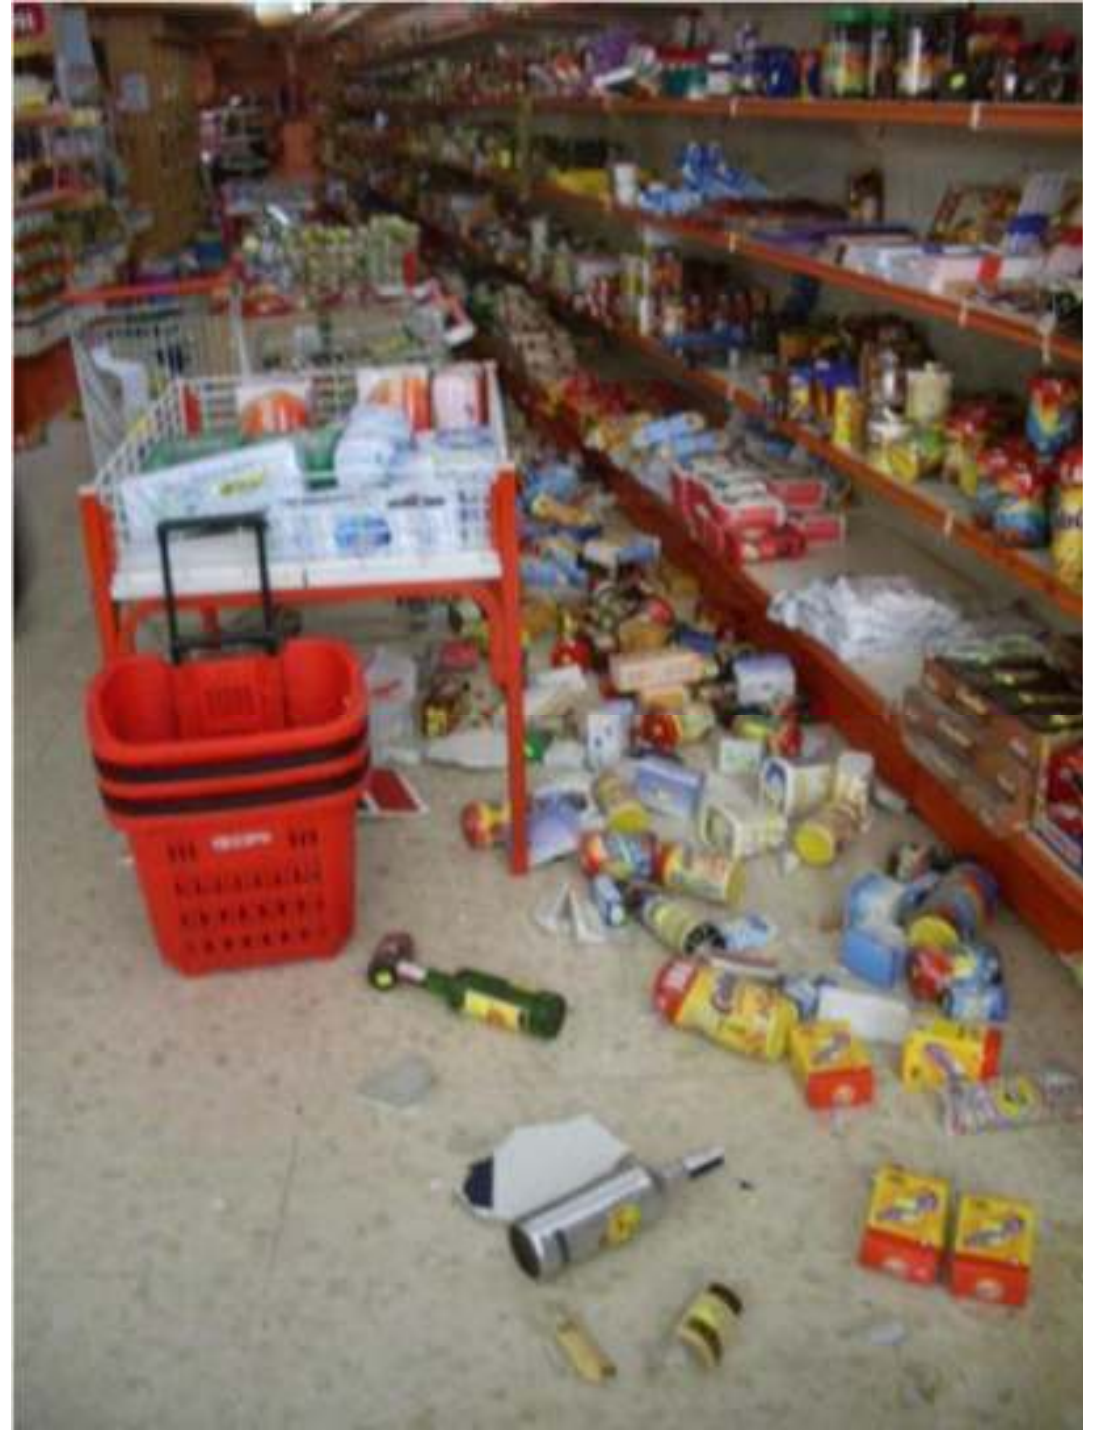
OBJECTS THROWN TO THE FLOOR IN LARGE NUMBERS (EMS 7)

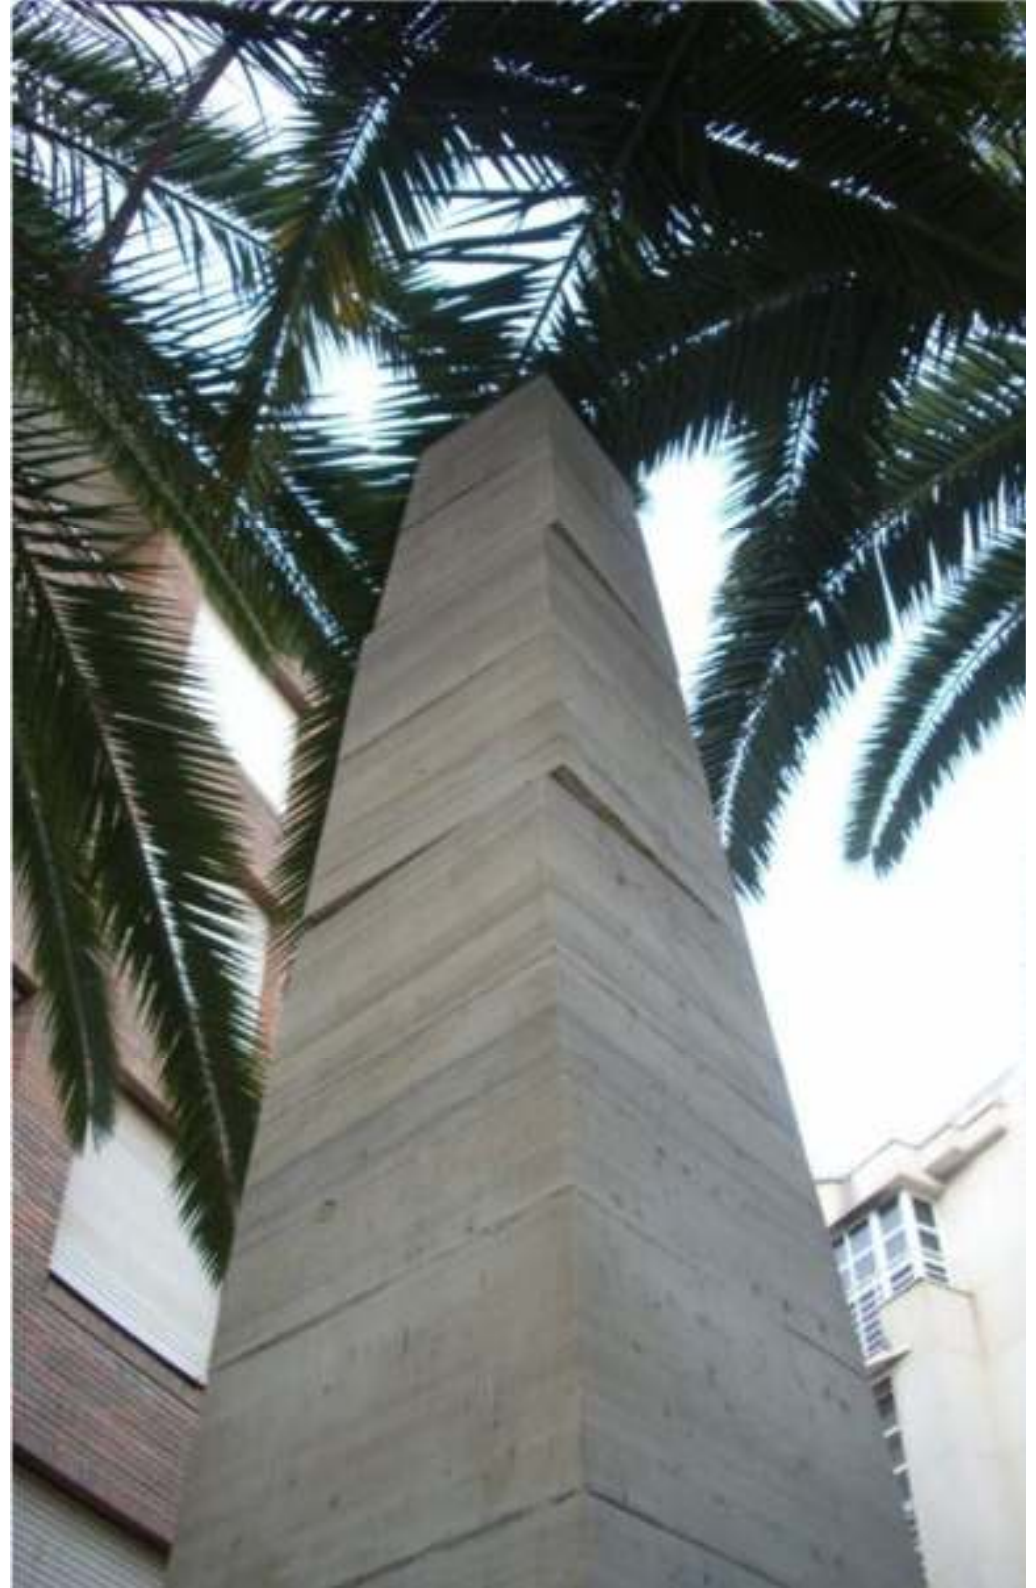
MONUMENT ROTATION

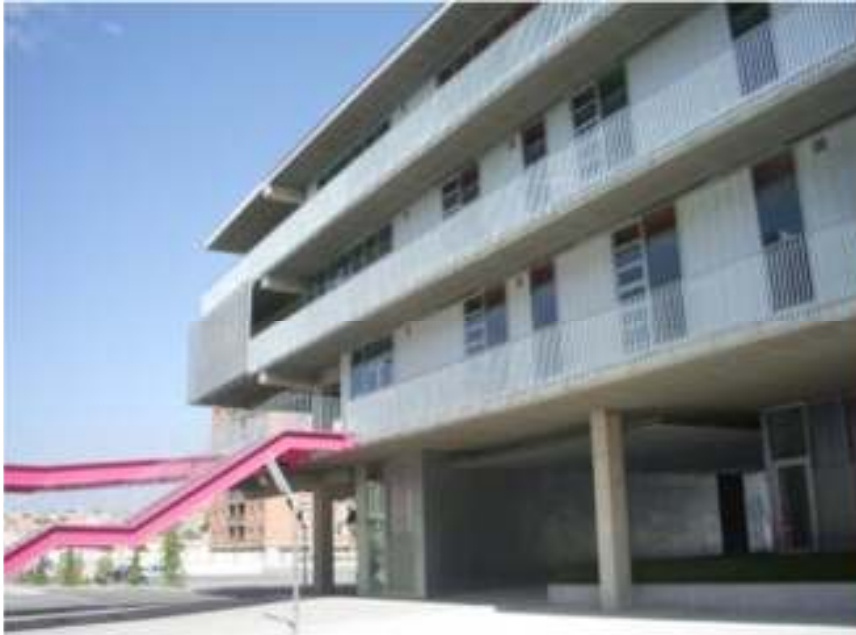
LIGHT METAL CLADDING – NO DAMAGE

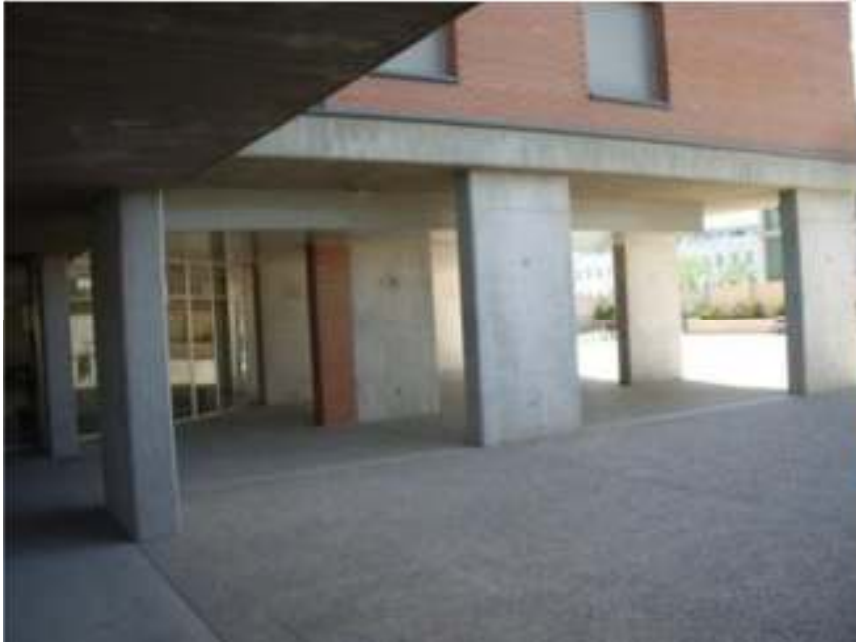
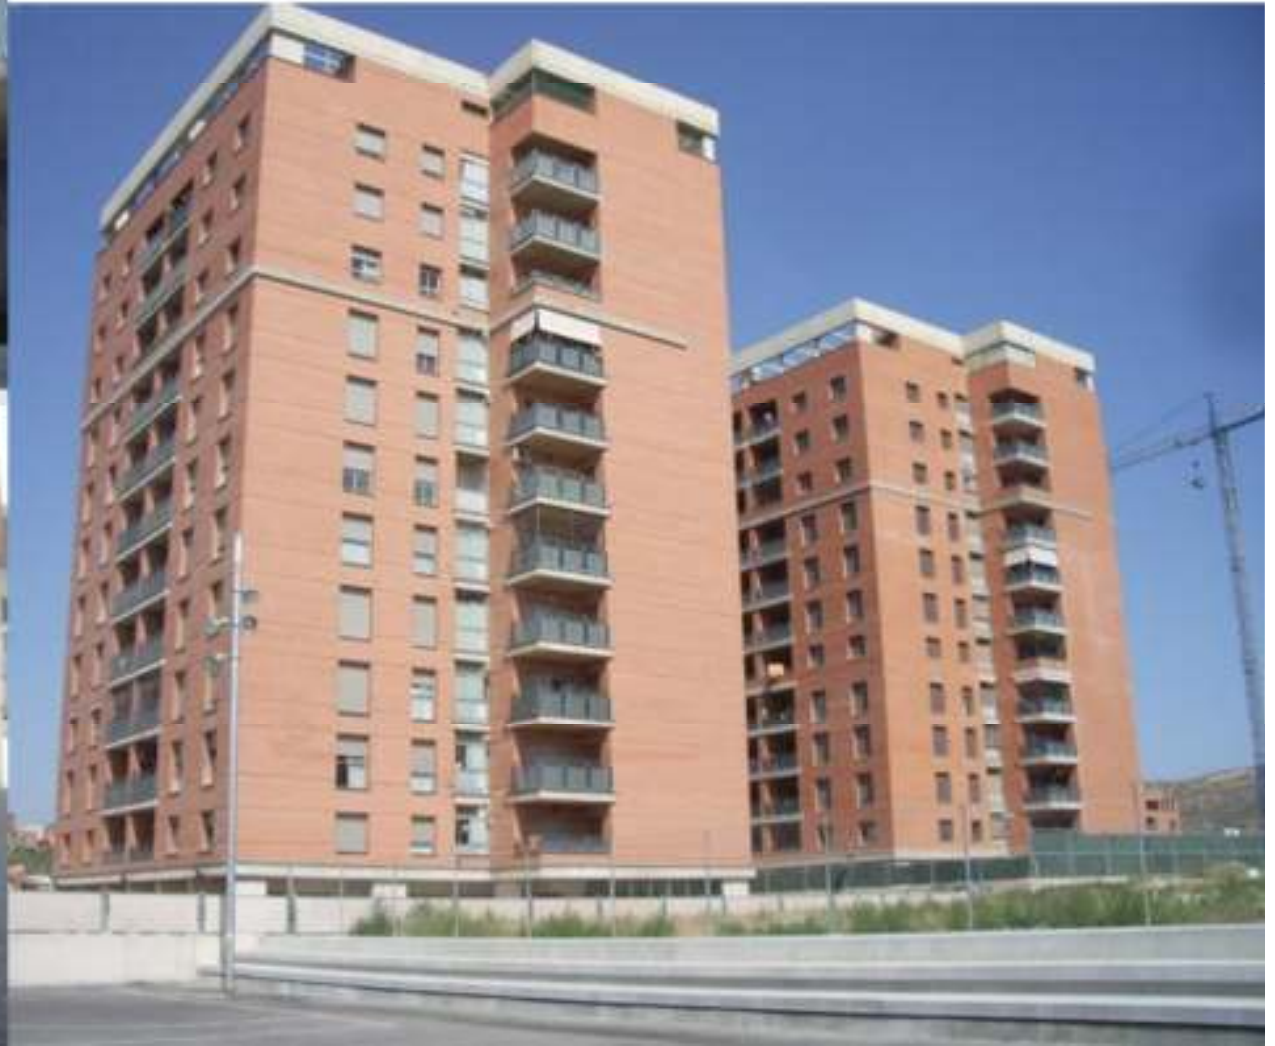
HIGH RISE WITH CONCRETE PARAPETS
AND SHEAR RESISTANT COLUMNS – NO
DAMAGE
