May 1, 2003 Bingöl (Turkey) Earthquake

Kıvanç KEKOVALI, Doğan KALAFAT, Yavuz GÜNEŞ, Mehmet YILMAZER

Kandilli Observatory and Earthquake Research Institute - Seismology Division,
Boğaziçi University, Istanbul, Turkey

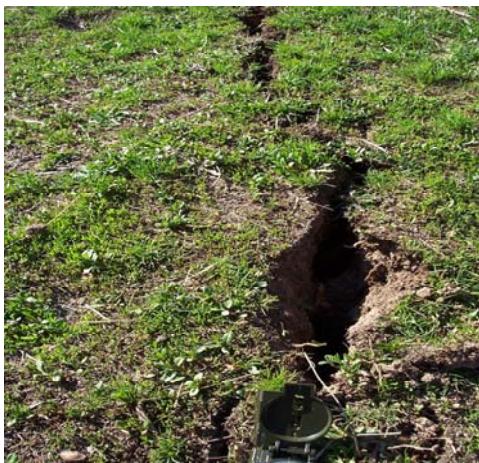
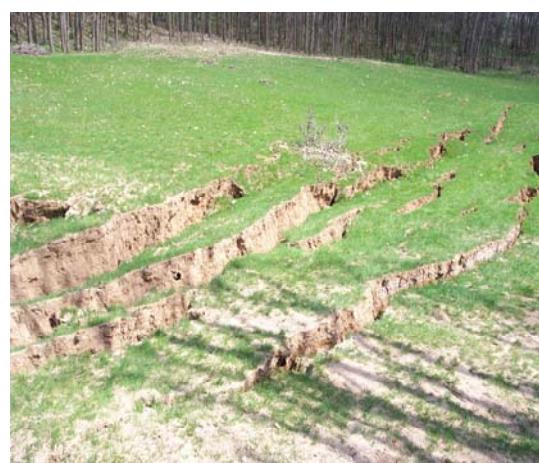
The preliminary field observations undertaken by the Dr Doğan Kalafat and Seismology Team. The epicentral location of the 2003 Bingöl earthquake is generally located in the Balıkçay-Hanoçayırlı-Kurtuluş-Südüğünü region (Kalafat et al., 2003). That agrees well with the NW-SE trending fault in the East Anatolian system and the intensity of this earthquake in the epicenter nearby is VIII (MSK). Numerous seismically induced ground deformations, fault traces, fault breaks in the surface, settlements and toppled rocks have been observed in the region (Figure 2). According to these observations, a few surface ruptures were located between Hanoçayırlı and Südüğünü villages at NW and SE that have a strike of N20°-30°W. However, a vertical drop of 40-65 cm in the western direction was observed in the field. Our preliminary observations support the idea that for the building stock in Bingöl this was a near-field experience.

Figure 2. Surface break and ground deformation in the epicentral area.

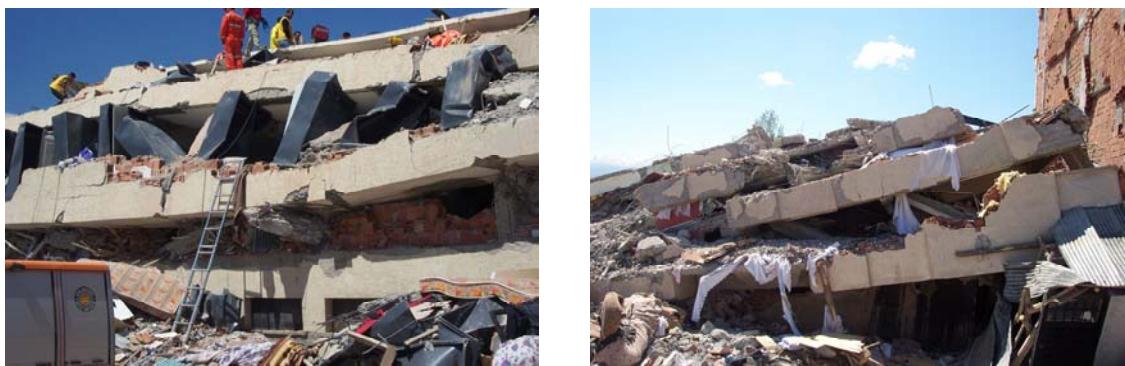
The Bingöl earthquake was strongly felt in Bingöl and its vicinity, causing panic among the people. The earthquake seriously damaged or destroyed a host of other buildings in Bingöl as well as public buildings (Figure 7). The differences in damage to buildings from place to place in Bingöl were a result of characteristics of the structures, not of foundation conditions or gross ground deformation of any kind. The damage was mainly due to poor quality of concrete, lack detailing of reinforcement steel and inappropriate construction practices. So, it should be aimed to promote the notion of seismic structural stability of buildings and infrastructure and thus better protect vulnerable people in the event of future disasters in Turkey.

Figure 7. Building damages in Bingöl city.
