# Macroseismic field survey after the 6 April 2009 L'Aquila, Italy earthquake – a brief report

In the period between 17 and 20 April 2009 I had an opportunity, together with a colleague (Matjaž Godec, civil engineer) from my institute, to join the Italian QUEST team (<http://www.mi.ingv.it/eq/090406/quest.html>) in doing the EMS macroseismic survey in epicentral region.

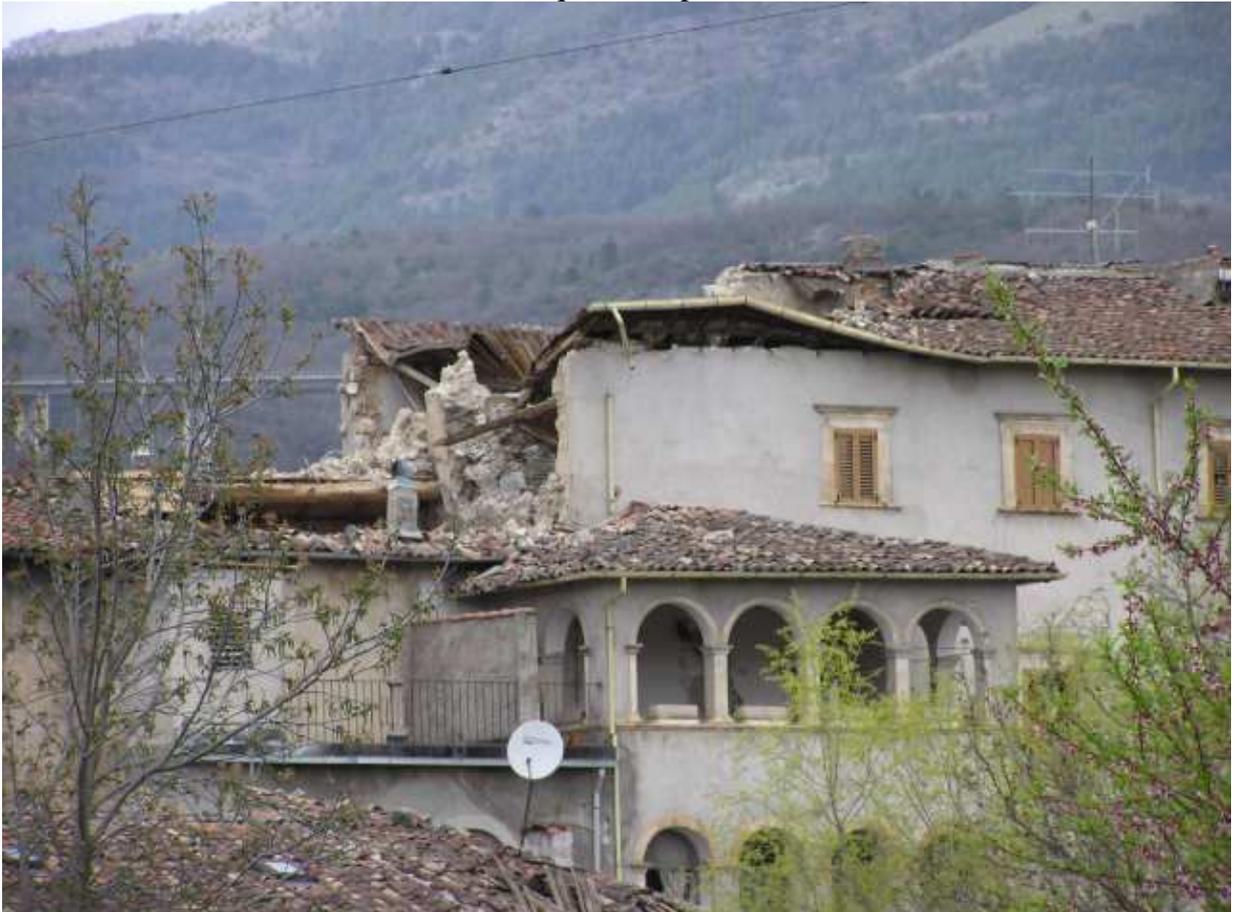
L'Aquila Tempora

Beside the damage on buildings, which was of course most prominent of the earthquake effects, some other interesting effects were noted. On the banks of the lake Sinizzo the earthquake caused the slip of the terrain into the lake, and some cracks opened in the wet ground. Cracks were noticed in some roads in the epicentral region. In Tempera a deep hole opened in the river bank.

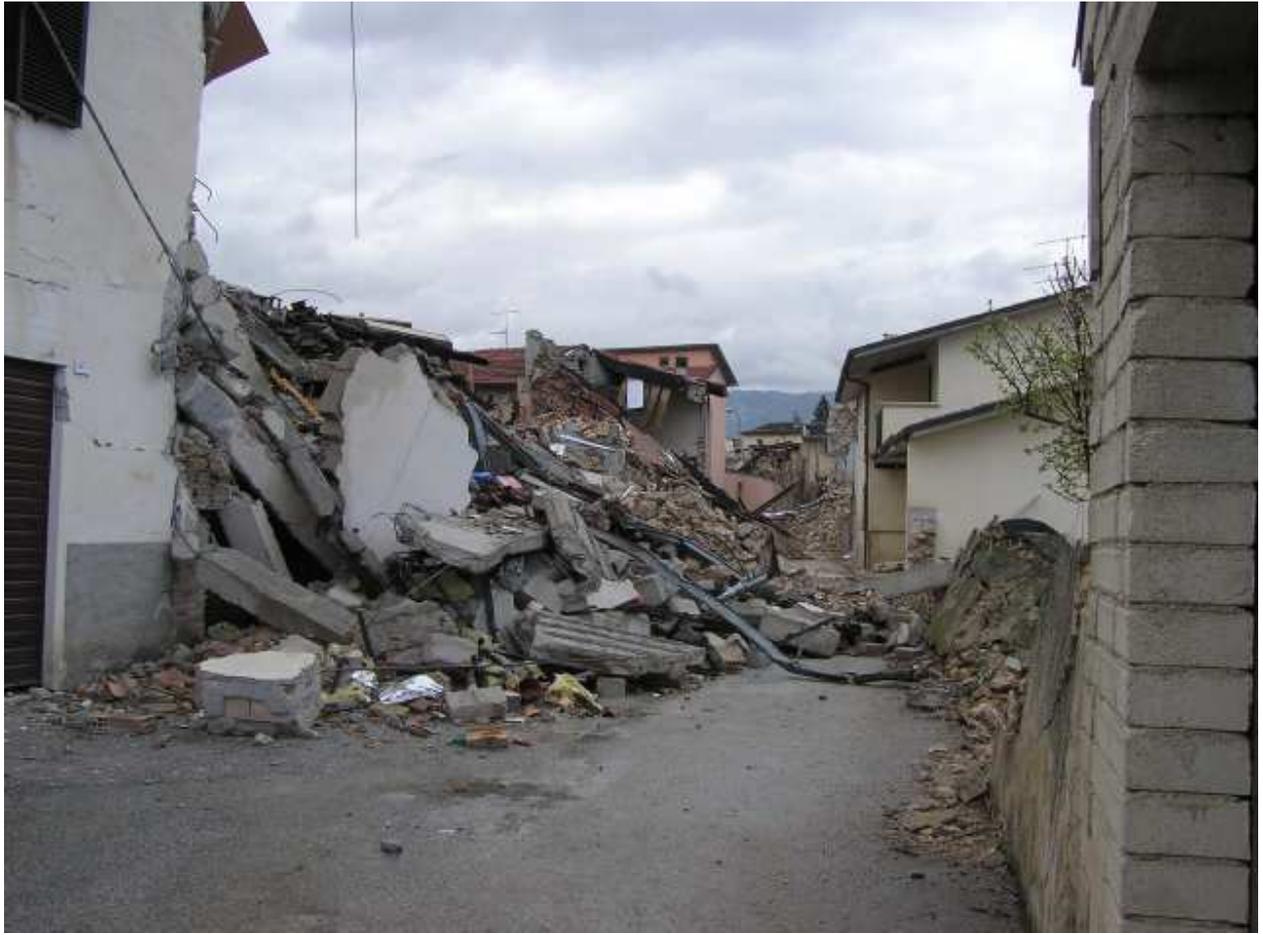
In my experience, every damaging earthquake has a different signature, and this one was going well along this thought. The majority of serious damage was visible on the masonry buildings, and in several localities partial and even total collapses of buildings can be found. The contrast between multitude of devastated older houses and here and there a new, engineered one standing untouched was striking in almost every village we visited. Moreover, the differences in damage grade on the buildings belonging the same typology only a kilometer or so apart due to the local ground conditions was very large; following the logs of the teams before us, we went to check upon a certain village, visited previously by three teams, only to confirm that the damage was negligible; but, this particular village, Monticchio, lies just next to Onna and L'Aquila, two among most damaged localities, in fact only a kilometer to the West from Onna.
