## Field observations of geological effects triggered by the January–February 2014 Cephalonia (Ionian Sea, Greece) earthquakes

Sotirios Valkaniotis <sup>a</sup>, Athanassios Ganas <sup>b,\*</sup>, George Papathanassiou <sup>c</sup>, Marios Papanikolaou <sup>b</sup>

On Jan. 26 and Feb 3, 2014 Cephalonia Island, Ionian Sea, Greece, was struck by two strong, shallow earthquakes (NOA local magnitudes  $M_L$  5.8 and  $M_L$  5.7, respectively). The earthquakes ruptured two sub-parallel, strike-slip faults, with right-lateral kinematics. During both earthquakes, ground-shaking phenomena such as liquefaction, road failures, rock falls, small/medium size landslides and stonewall failures were widespread all over the western part of the island. No primary fault surface ruptures were observed, however one patch of the rupture of the second event may have nearly reached the surface, because of the abundance of surface cracks with cm-size offsets mapped in the field in north Paliki Peninsula. Liquefaction phenomena were mainly triggered in reclaimed lands in the waterfront areas of Argostoli and Lixouri inducing structural damages to quays, sidewalks and piers. We also present evidence for l

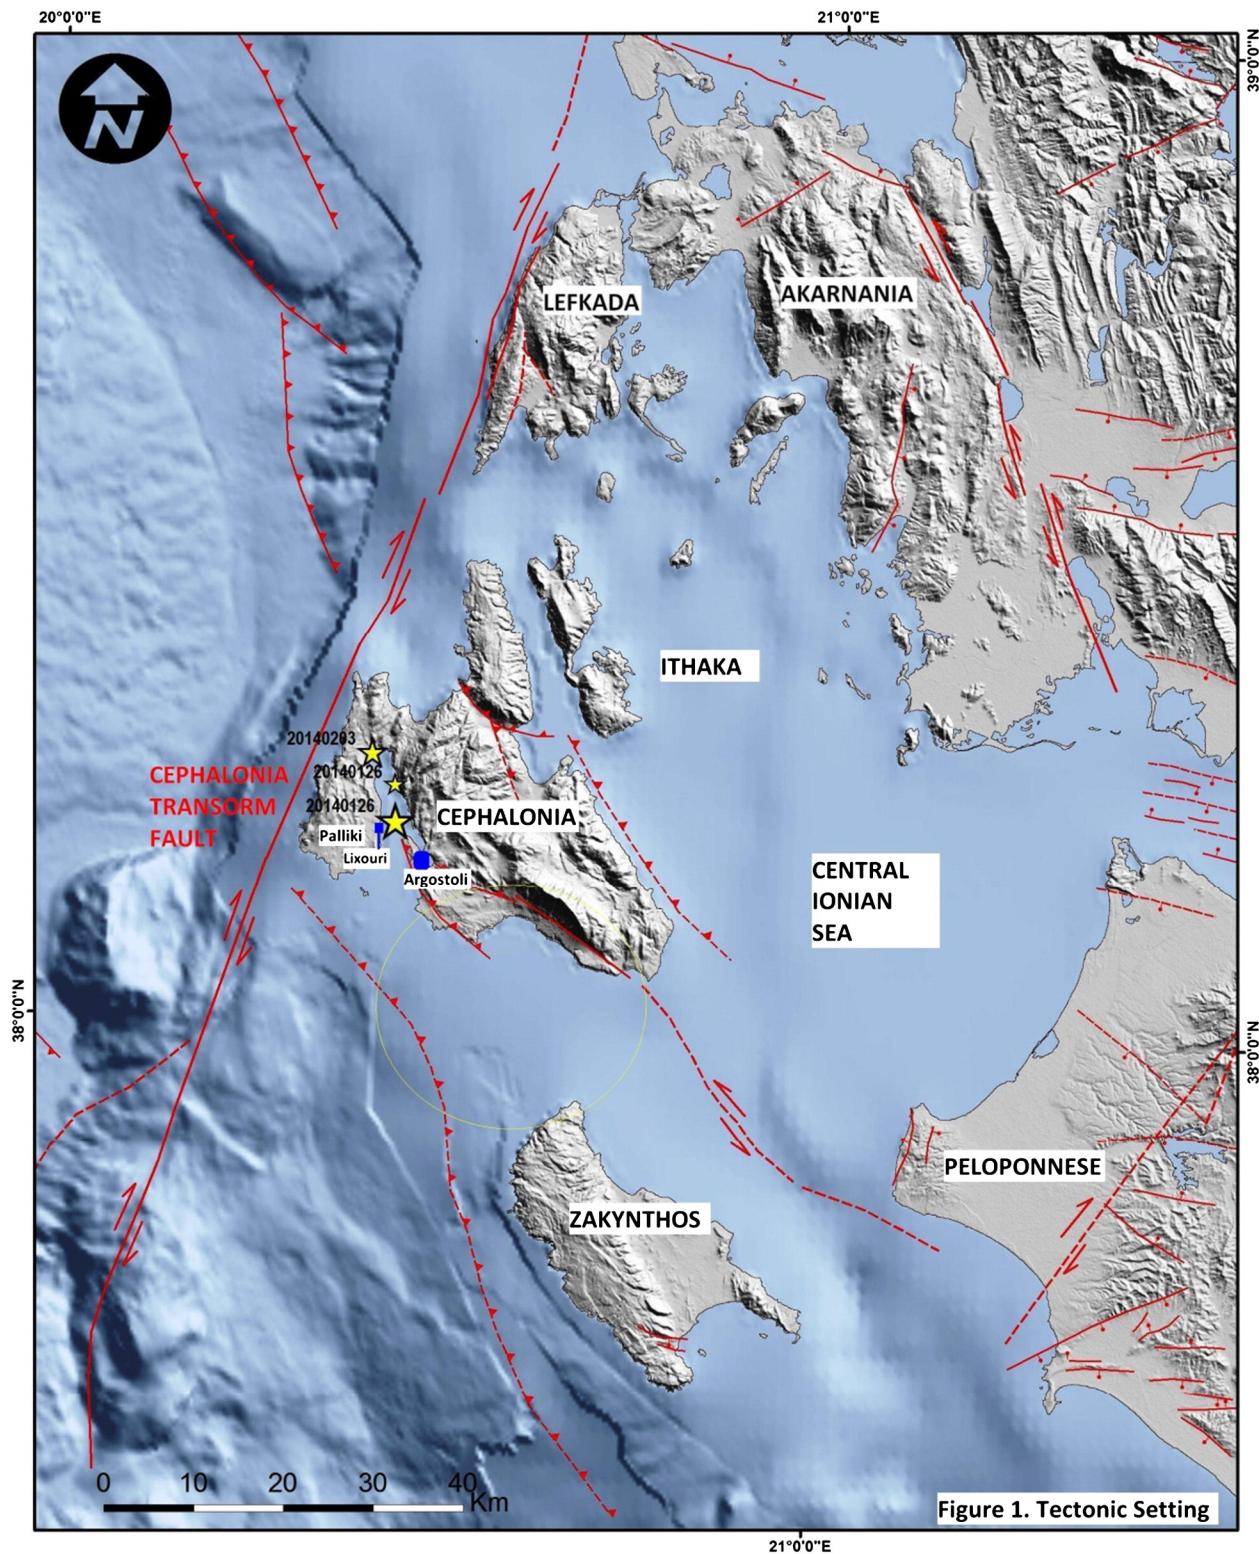
**Fig. 1.** Location map showing the epicentres (yellow stars) of the two mainshocks and one aftershock of Jan. 26, 2014 at 18:45 UTC. Red lines are active faults (dashed are inferred; from Ganias et al., 2013b), arrows indicate sense of motion. (For interpretation of the references to colour in this figure legend, the reader is referred to the web version of this article.)

Ionian Sea (western Greece) is a plate-boundary region of high seismicity and complex tectonics, dominated by frequent earthquake activity along the right-lateral Cephalonia Transform Fault (CTF). Cephalonia has been repeatedly subjected to strong ground shaking due to the proximity of the island to CTF (Fig. 1; Louvari et al., 1999; Sachpazi et al., 2000; Scordilis et al., 1985). The 100-km long fault zone accommodates the relative motion of the Apulia (Africa) and Aegean (Eurasia) lithospheric plates, and has a GPS slip-rate bracketed between 10 and 25 mm/yr (e.g., Pérouse et al., 2012). The most recent large CTF events include the Jan. 17, 1983 ( $M = 6.8$  global CMT catalogue; Scordilis et al., 1985) and the Aug. 14, 2003 ( $M = 6.2$  global CMT catalogue; Papathanassiou et al., 2005). Two strong earthquake events, with  $M_L$ (NOA) 5.8 and  $M_L$ (NOA) 5.7, occurred on Jan. 26, 2014 13:55 UTC and Feb. 3, 2014 03:08 UTC, respectively, onshore the island of Cephalonia (Fig. 1; Ganas et al., 2014; Karastathis et al., 2014) inducing extensive structural damages and environmental effects, mainly in the western and central parts. According to the National Observatory of Athens, Institute of Geodynamics (NOA; <http://www.gein.noa.gr>) the epicentre of the first event (Fig. 1; NOA web report, 2014) was located

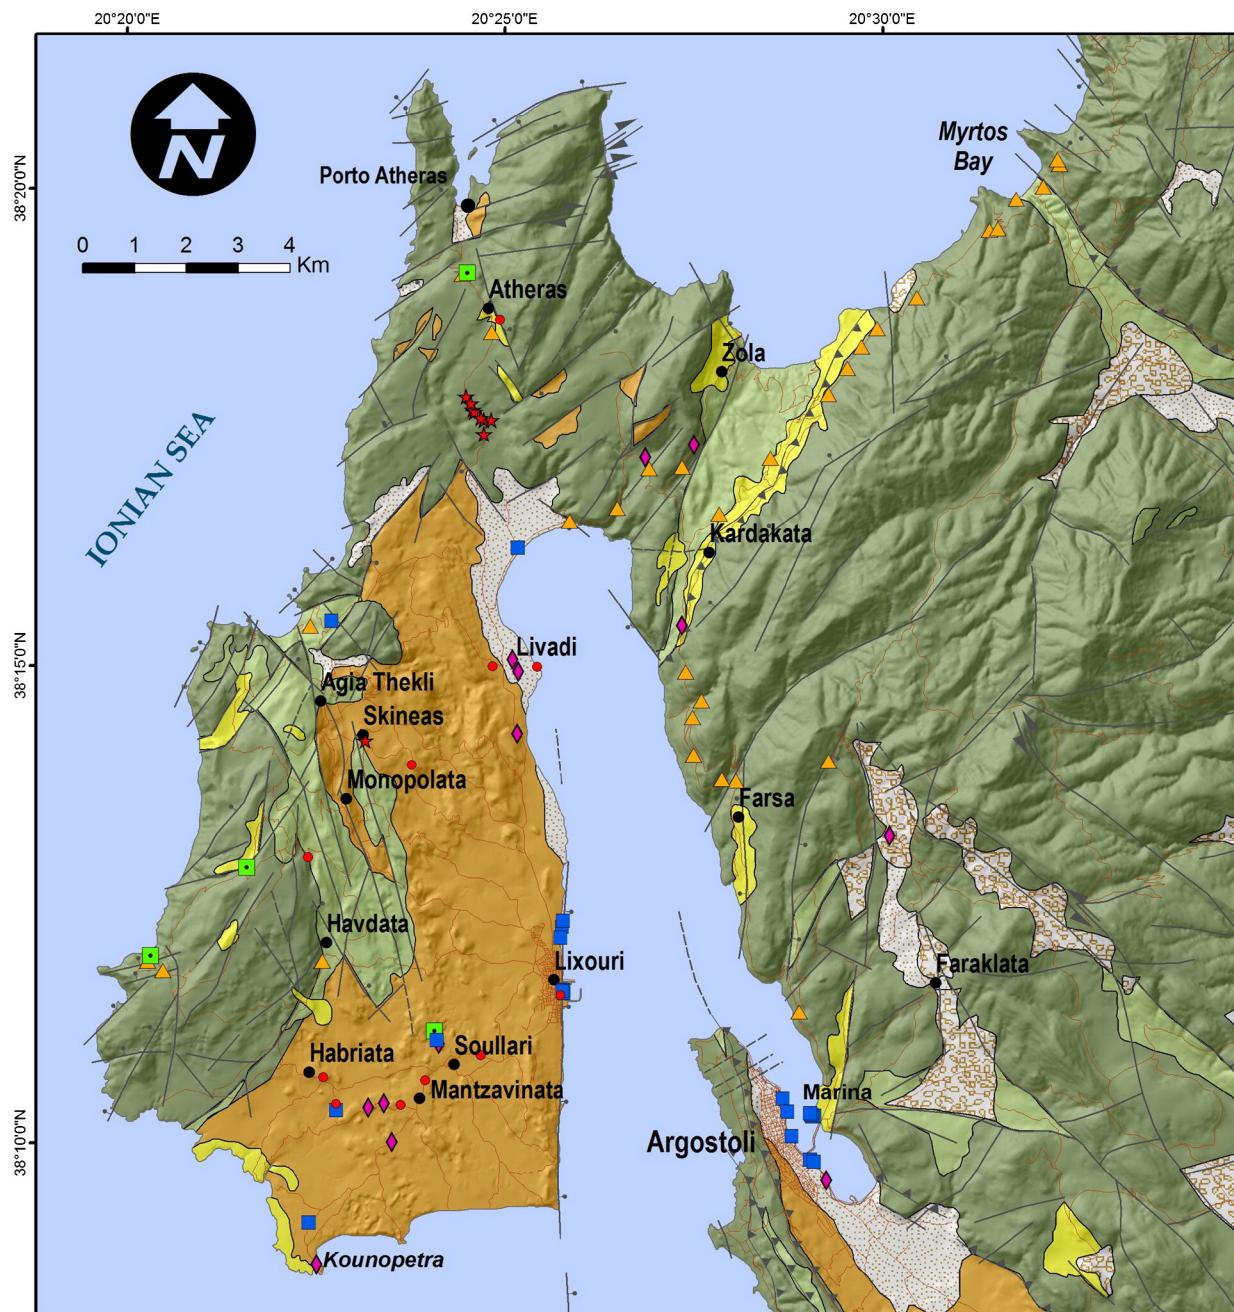
**Fig. 2.** Geological map of western Cephalonia showing the distribution of earthquake-induced geological effects. Geological formations and faults are modified from Lekkas et al. (2001).

During both events, the majority of earthquake-related phenomena were liquefaction, road failures, rock falls and small landslides. These phenomena were widespread in the Paliki peninsula and the area around Argostoli Bay (Fig. 2). In the northern and eastern parts of the island only few isolated rock falls and landslides in loose materials were observed. It must be noted that most environmental effects were created after the first event in Jan. 26 and were reactivated one week later in the second (Feb. 3) event.

The earthquake-induced slope instabilities caused road failures along the road network in the island of Cephalonia. These failures were observed in an area with radius of ~10 km around the epicentre of Jan. 26, 2014 (Fig. 2). The failures were especially severe in the south/central part of Paliki peninsula and in the east coast of Argostoli

In particular, landslides of small/medium size were widespread in soft Neogene and Quaternary sediments (Fig. 2), but also locally observed in clastic formations of Miocene flysch deposits. One of the most impressive mass-movement phenomena was the Soullari large landslide (Fig. 5), situated NE from the Soullari village in Paliki peninsula. The landslide was activated during the first earthquake (Jan. 26) on homogenous silt/clay Pliocene–Pleistocene sediments, in a small field on top of a hill. Measuring 20 m length and 30 m width, the landslide's initial rupture on the crown was along the pre-existing set of joints (NE–SW direction) and was re-activated after the second event (Feb. 3, 2014; Fig. 5 right). The re-activation was most probably assisted by the presence of rain water in the week following the first earthquake, and caused further movement of the block down-hill, along with a break of the block piece in two smaller ones and collapse of the surrounding scar-walls.

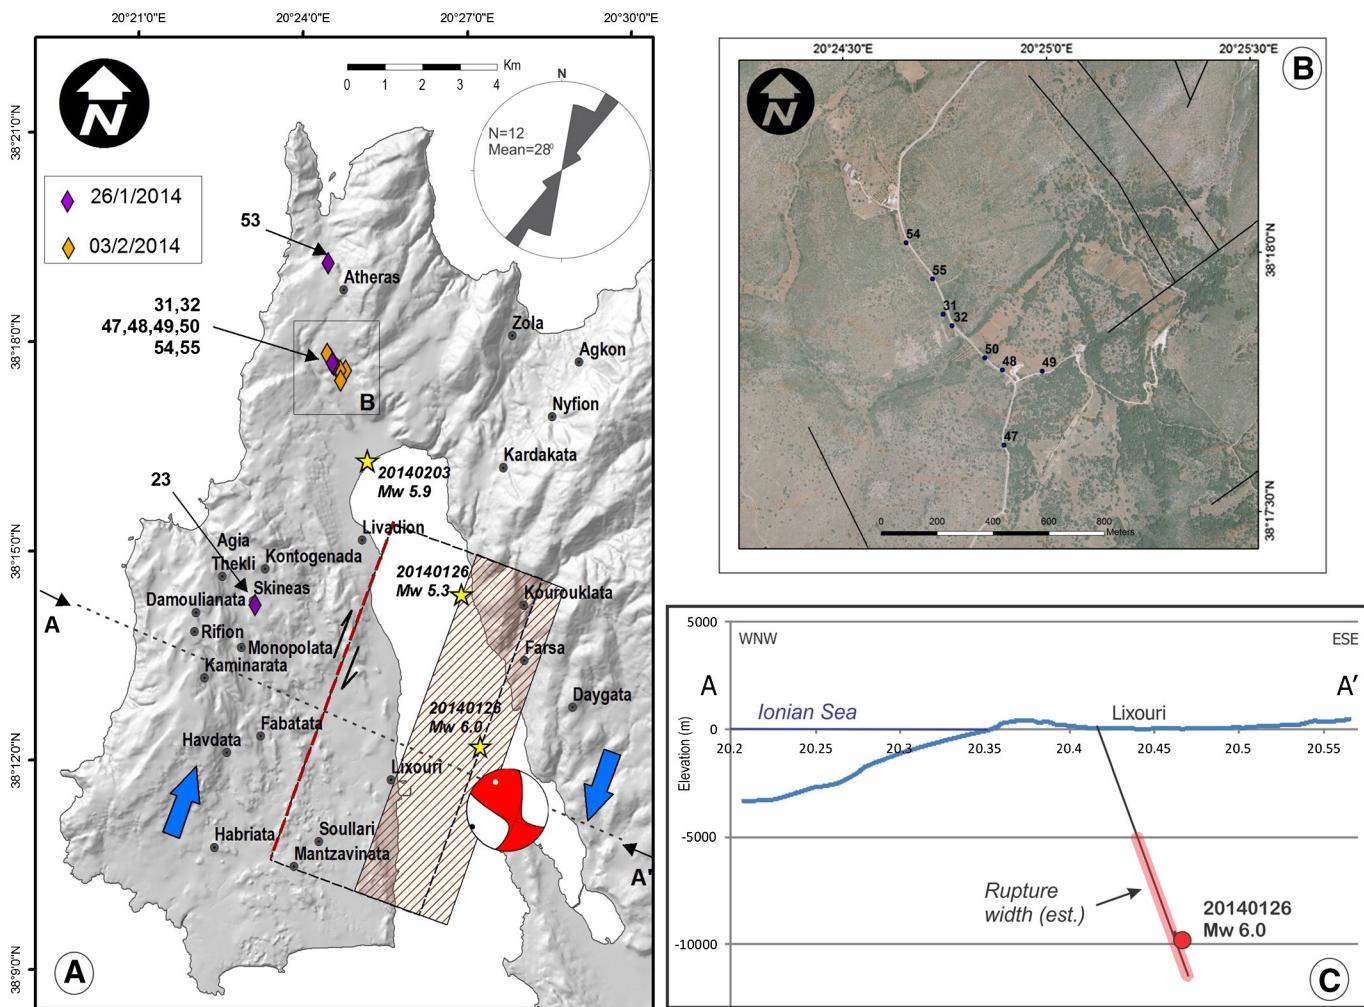
**Fig. 3.** A) Relief map of Paliki Peninsula with surface projection of Jan. 26, 2014 seismic fault (straight red line; fault attitude  $18^\circ/67^\circ/164^\circ$  strike/dip/rake, from NOA MT solution). Yellow star symbols indicate epicentre location of the two main events and the largest aftershock. Rhomb symbol indicate locality with structural measurements. Rose diagram displays azimuth of ground cracks mapped on the field (Paliki peninsula) which is roughly parallel to the strike of CTF and the NNE nodal plane of the MT solutions. B) Air-photo of the area with observed ground cracks between Atheros and Livadi. C) WNW–ESE cross-section with inferred positions of the Jan. 26, 2014 high-angle fault and estimated rupture width. Letters A and A' on the map indicate end points of section. Numbers refer to localities in Table 1. (For interpretation of the references to colour in this figure legend, the reader is referred to the web version of this article.)

Field observations of ground cracks were made at the central/north part of Paliki peninsula (Figs. 3 and 4). The southernmost locality of their observation was the church in the centre of Skineas village (Fig. 3) where a continuous crack with minor (<1 cm) dextral

displacement was mapped for a length of 10 m. Measurement of the crack's strike shows a N20°–30°E orientation. On the road leading from Atheras village to Porto Atheras beach (Fig. 2), we observed two localities with cracks: first a fracture near a Quaternary (?) fault plane (with attributes N137°E/70°; dip direction, dip angle; see NE-striking fault to the east of the crack number 53 in Figs. 2 & 3) with a dextral

A locality of several ground displacement observations was about halfway the road leading from Aheras to Livadi (Figs. 2 and 3). In two localities along this road three cracks ruptured the road after the Jan.

26, 2014 earthquake with azimuth (strike) of  $N30^\circ E$ – $N50^\circ E$  (Fig. 4A). The road is constructed directly on a karstified limestone, with a thin red soil cover locally reaching 5–10 cm depth. After the Feb. 3, 2014 earthquake, the same cracks showed signs of further displacement and newer fractures were found in five (5) places along a ~600 m stretch of the road. Measurement of the fractures shows a similar orientation ( $N15^\circ E$ – $N41^\circ E$ ). Additional cracks were mapped across a dirt road to the east (number 49 on Fig. 3, possible extension of number 47 crack; see air-photo detail in Fig. 3B). This locality shows a clear and fresh rupture of the bedrock with a dextral horizontal displacement of 2–4 cm (Fig. 4B). These limestone breaks didn't exist in the pre-Feb. 3rd field investigation, so they are attributed to the Feb. 3, 2014 earthquake. A rose diagram shows that ground cracks mapped on the field (Paliki peninsula) have a mean azimuth of  $N28^\circ E$  (Fig. 3A), roughly parallel to CTF strike and to NNE–SSW nodal plane of MT solutions.

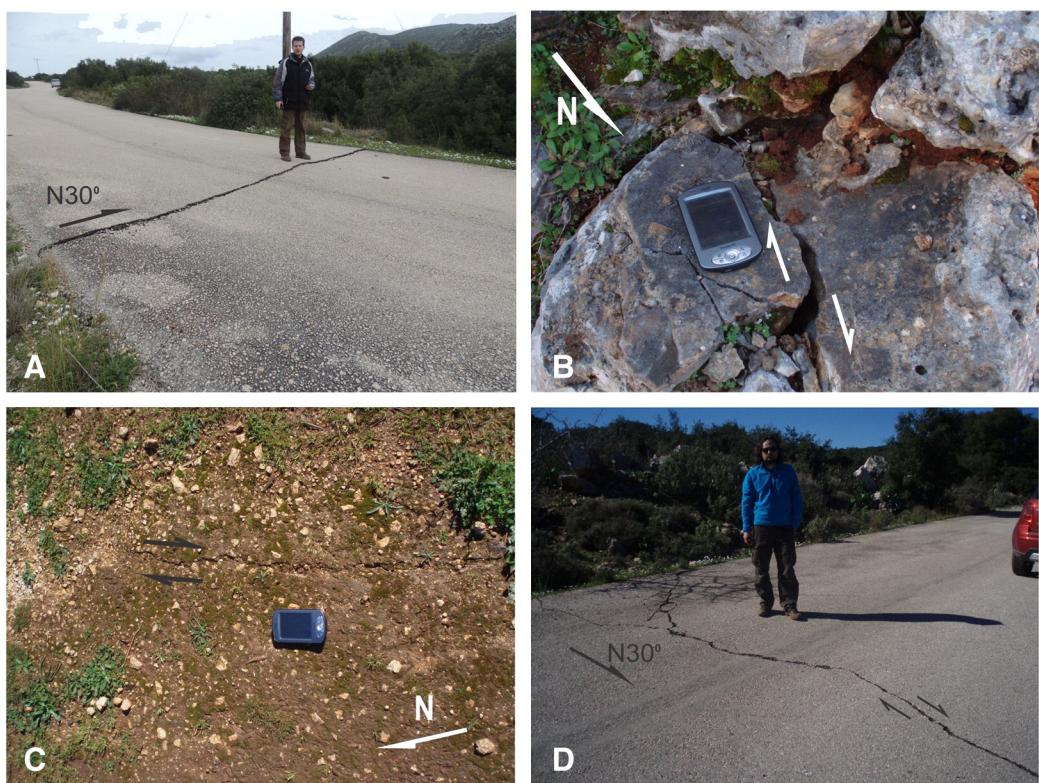
**Fig. 4.** Field photographs of geological effects: A) Road crack near Atheras village (photo taken Feb. 7, 2014, see point 32 in Fig. 3). B) Post-Feb. 3, 2014 earthquake photo of a crack in bedrock near Atheras (see point 32 on Fig. 3). C) Ground crack (see point 49 in Fig. 3B). D) Road crack (see point 50 in Fig. 3B).

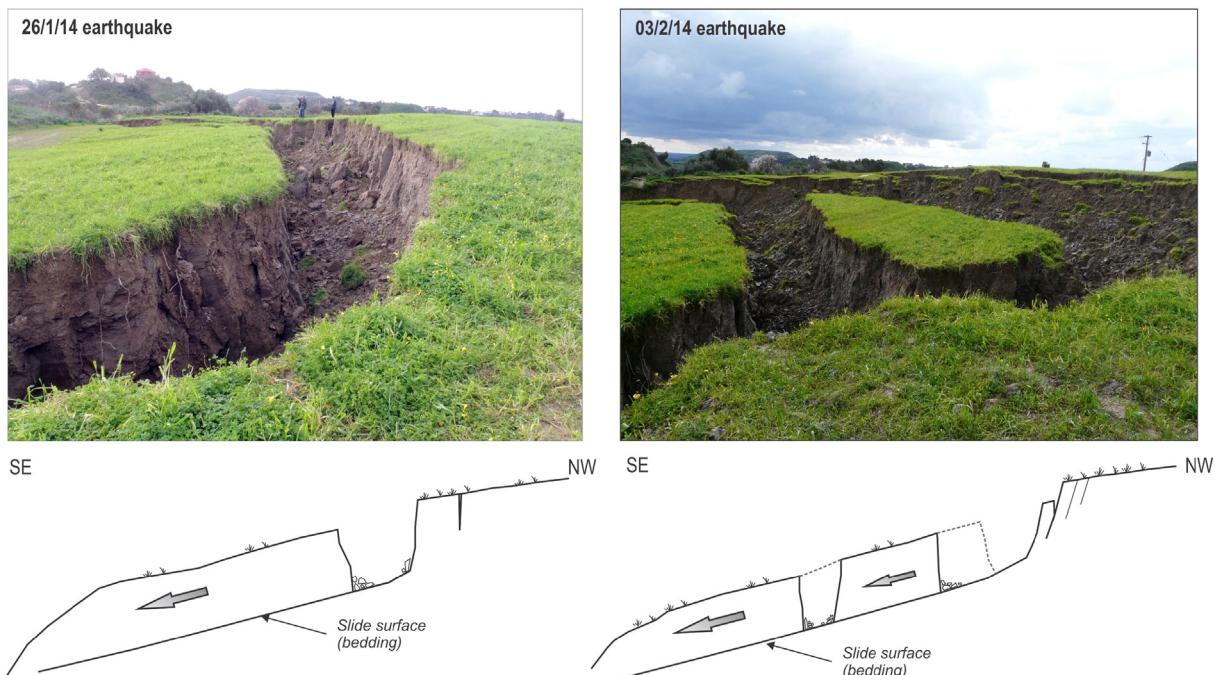
**Fig. 5.** Field photographs of the large landslide in Soullari village, Paliki Peninsula, Cephalonia. View to the southwest. Sketches below each photograph show a geological interpretation.

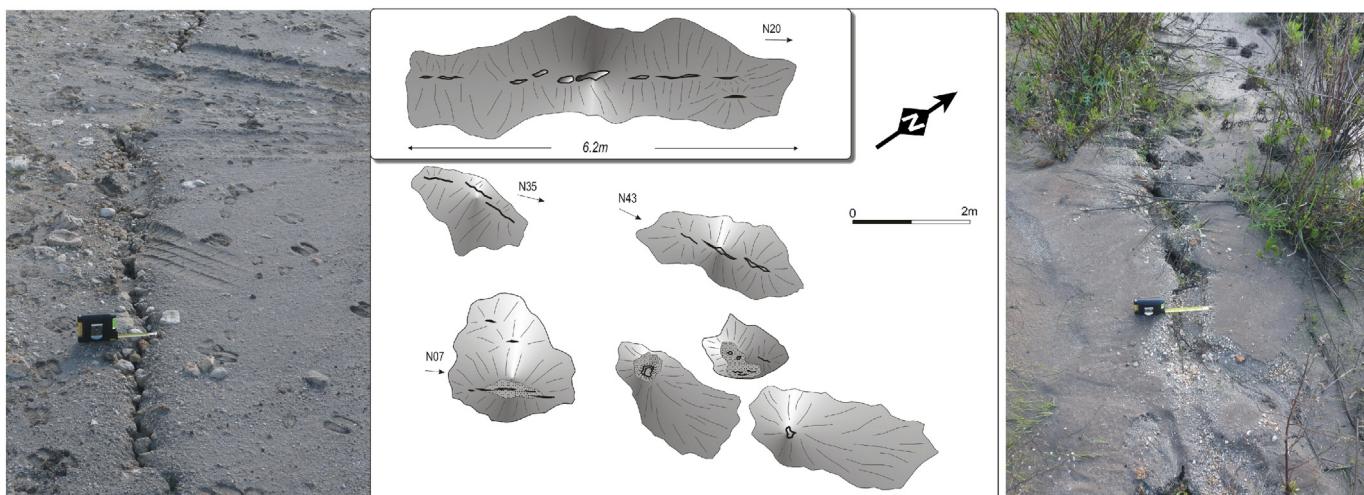
**Fig. 6.** Field photographs (taken on Feb. 8, 2014) of liquefaction phenomena, triggered in the area of Argostoli marina (see map in Fig. 2). A characteristic sketch of liquefaction surface evidence (arrows indicate fissure azimuth; in general NE–SW) is showing in the middle (notice scale bar in metres).

In particular, in the town of Argostoli (Fig. 2), clear evidence of liquefaction occurrence, like sand boils and ground fissures (of variable azimuth) with ejection of silty sand–water mixture, have been triggered by the first and second events according to eyewitnesses and mapped by our team during the post-earthquake field surveys. Settlement of 5–6 cm of the buildings of customs and port authorities was documented and coarse sandy material was ejected from cracks. Similar phenomena were reported at the area of municipality market, in the second quay called “agora”, where sandy material spewed out through existing cracks on the sidewalk and on the pavement along the perimeter of buildings, inducing a vertical displacement of 3–4 cm. Furthermore, typical liquefaction phenomena were documented at the sidewalk area located to the south of the De Bosset bridge, where sandy material ejected through ground cracks. Liquefaction phenomena were also documented in the marina of Argostoli (Fig. 6), an area located at the eastern shore of the bay, and was constructed in 2002 in order to accommodate yachts and boats. In this zone, a large area was covered by grey fine sandy material ejected through ground cracks. The length of the fissures was up to 6 m and their width up to 8 cm. In the same zone, a vertical displacement of the artificial fill that is placed between two piers, from 15 cm to 40 cm, was reported without surface evidence of liquefaction. A characteristic sketch of the liquefied area in marina is shown in Fig. 6, where

the information regarding the orientation, dimensions and spatial distribution of the liquefaction-induced ground disruption is provided.

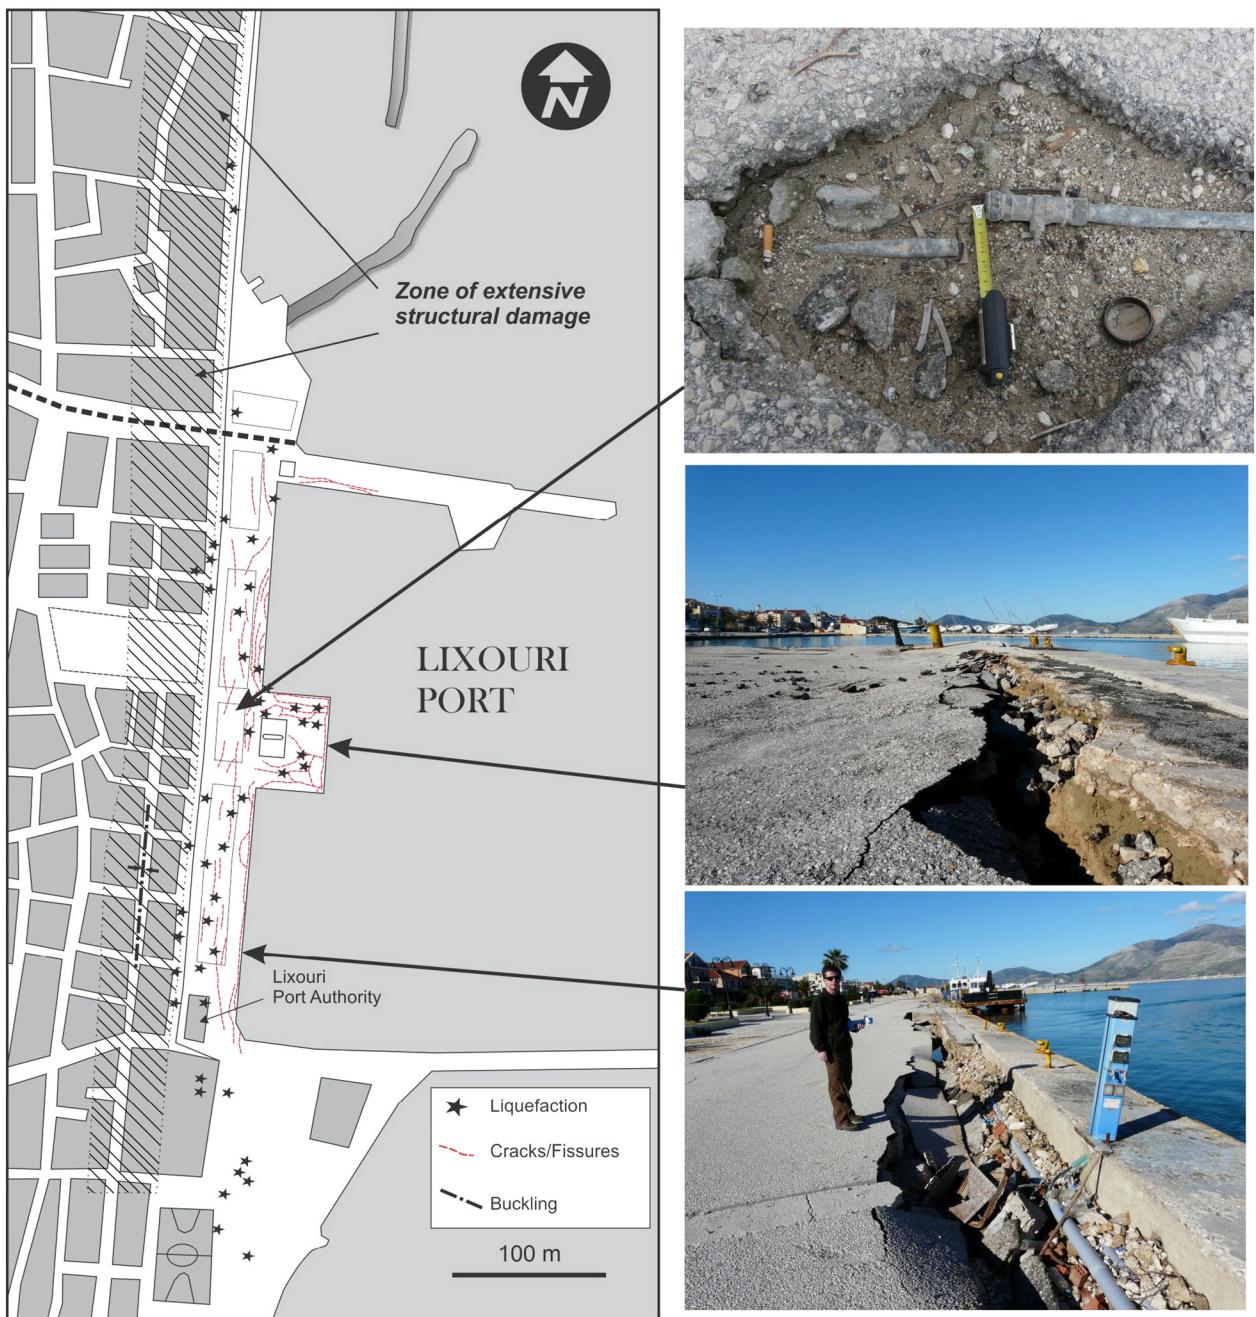
**Fig. 7.** Map showing the liquefaction manifestation (black star), the cracks/fissures along the waterfront area and the location of buckling phenomena in the town of Lixouri. In addition, characteristic liquefaction-induced structural damages are shown in post-Feb 3, 2014 field photographs (photos taken on Feb. 7, 2014) on the right and particularly a broken water pipeline due to the sloshing of the ground (top), a "graben" formation behind quay wall (middle) and movement of the quay wall towards the sea (bottom).

In the waterfront area of Lixouri (Fig. 7), the liquefaction of the sub-soil layers induced severe damages to port facilities and caused the complete loss of functionality for 24 h. In particular, at the area of the building of port authorities, cracks on the sidewalk were opened and brown sandy material was ejected and covered the area of the sidewalk and the park situated behind. Few metres to the south, more than 10 sand craters with diameter up to 50 cm were generated by the second earthquake. At the main quay of Lixouri, at the central part of the waterfront area, sandy material and gravels were ejected indicating the high value of acceleration generated by the second event. These cracks were initially opened during the first earthquake but their width and the amount of ejected material were not so large as those generated during the second earthquake. In the same area, behind the quay walls, large vertical and horizontal displacements were documented, however without any evidence of ejecta.

An important result of our work comprises that most of the coastal areas severely affected were those that had been artificially filled after the devastating 1953 earthquakes. The material used to reclaim devastated areas due to the 1953 earthquakes was not appropriate. This must be taken into account by geotechnical experts, engineering geologists and civil engineers in future works.
