THE 20th JULY 2017 (22:31 UTC) BODRUM/KOS EARTHQUAKE AND TSUNAMI; POST TSUNAMI FIELD SURVEY REPORT

August 17, 2017 (new version)

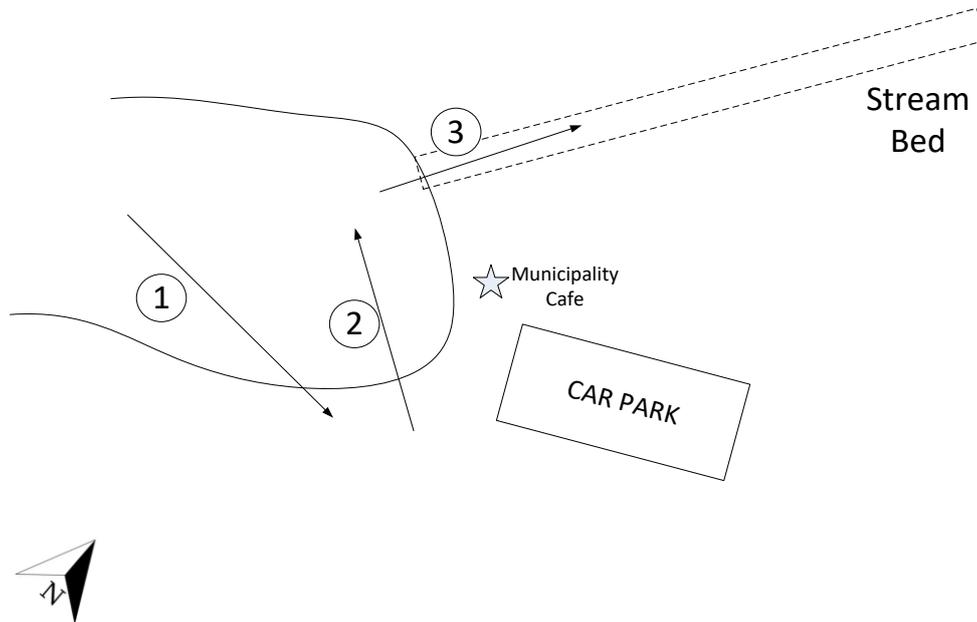
Figure 4.1: The motion of tsunami at eastern end of Gumbet Bay (Municipality café is at 27.408503E 37.029732N).

It is stated by the workers that approximately 20m of inundation is observed near the municipality café. The flow depth in front of the municipality café is measured as 0.56m in the second survey. Waves dragged the parked cars near the shoreline on the concrete bed of dry stream. Totally 12 cars have been dragged and all were collected in the same location (37.031137N 27.406882E) away from the shore at the stream and concrete planters in front of these car parking area. Eyewitnesses from the sea front restaurant staff reported successive waves (sea withdrawal and advancing) until the sun rise (about three hours after the earthquake). In the next morning after the earthquake, water level was decreased about 2m in vertical (Figure 4.2). People have found dead fish mostly near and around the stream bed, and all along the coastline of the bay. Besides, they observed remarkable increase in the number of rare insects in last couple of days on the ground.

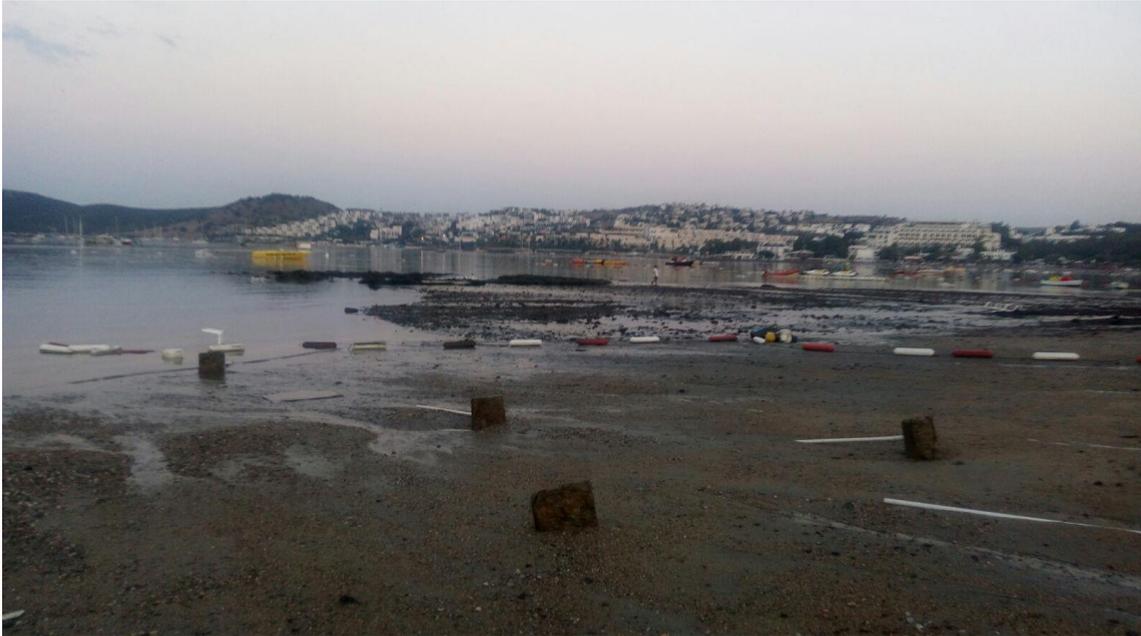
Figure 4.2: View of sea withdrawal in Gumbet Bay about three hours after the earthquake

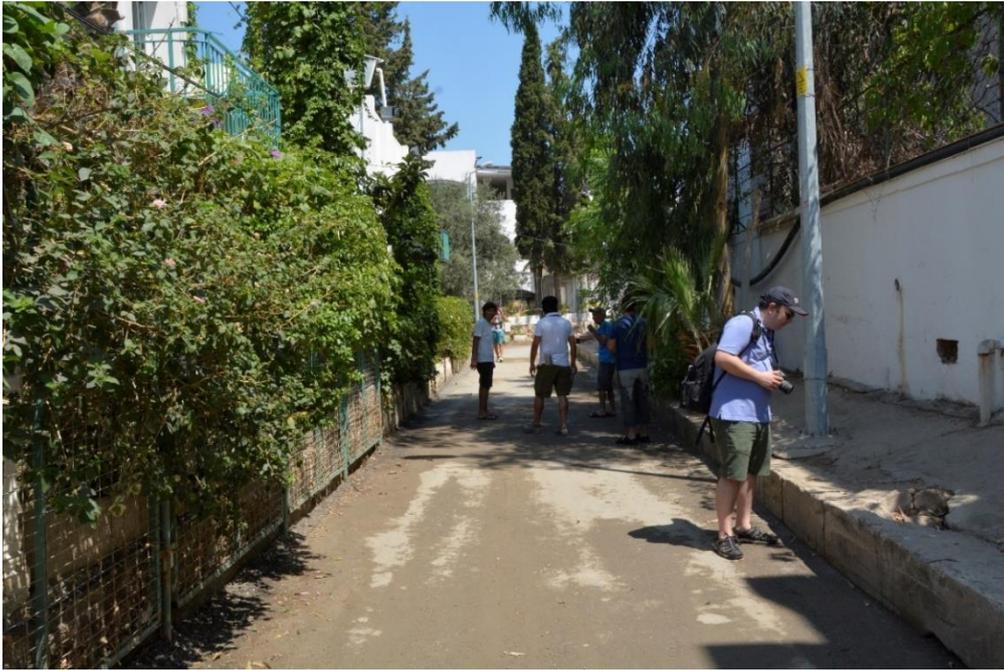
The waves mostly penetrated through the dried stream bed (used as a road and parking place) near Ayaz Hotel (Figure 4.3). The width of the road is 3.3 meters (5.7 meters with side walls). The waves penetrated through this stream bed, accelerated as flowing in a channel and reached up to 100m away from the shoreline. The maximum flow depth in the stream bed was around 0.85 m (Figure 4.4). According to the security camera records of a hotel, waves reached to the entrance door of hotel about 13min after the earthquake. The tsunami inundation distance is about 60 meters and flow depth reached up to 0.5-0.6m. Waves flew in strong current in hotel front.

Figure 4.3: Penetration of the waves through the dried stream bed near Ayaz Hotel

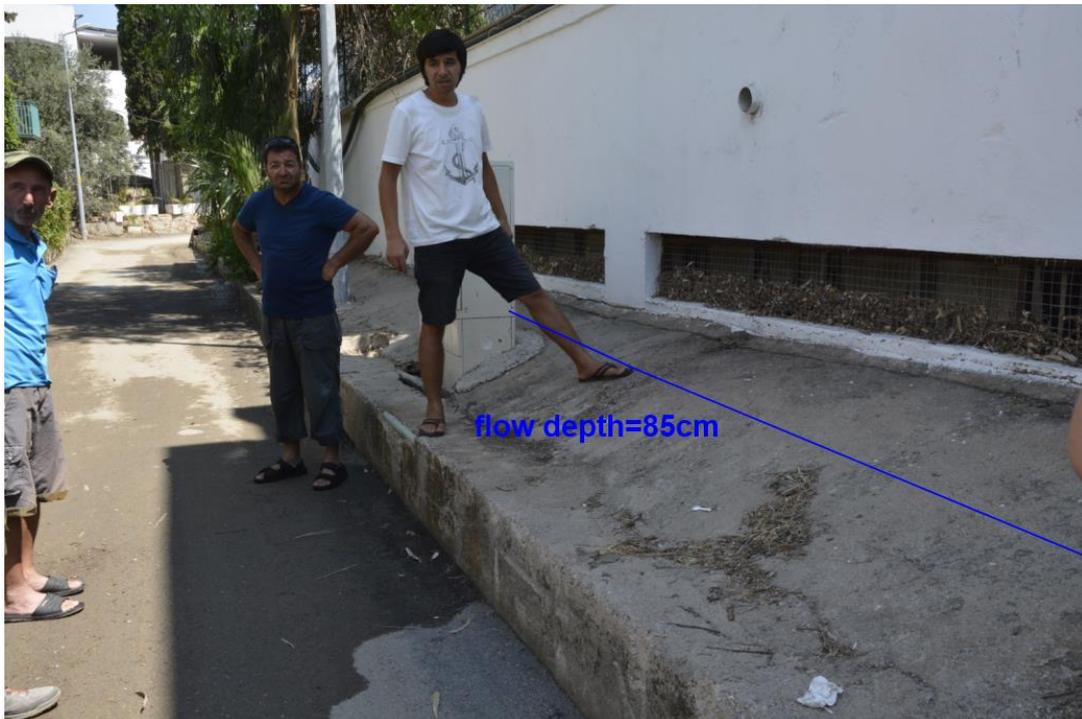
Figure 4.4: Observer showing the flow depth by his foot (37.031412N 27.406703E)

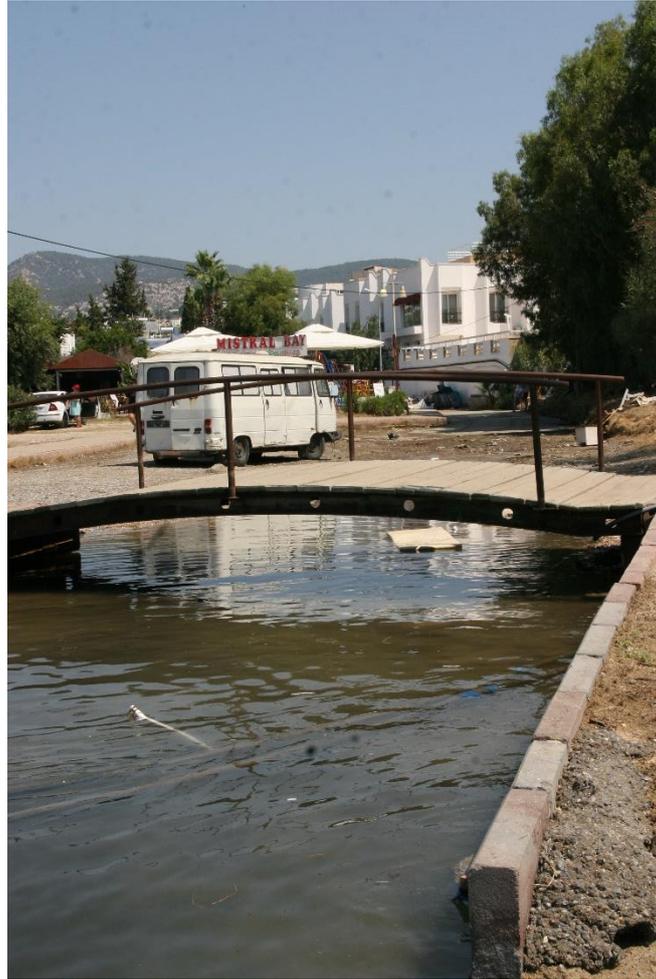
Figure 4.5: View of the stream bed that the tsunami inundated (27.407821E 37.029761N)

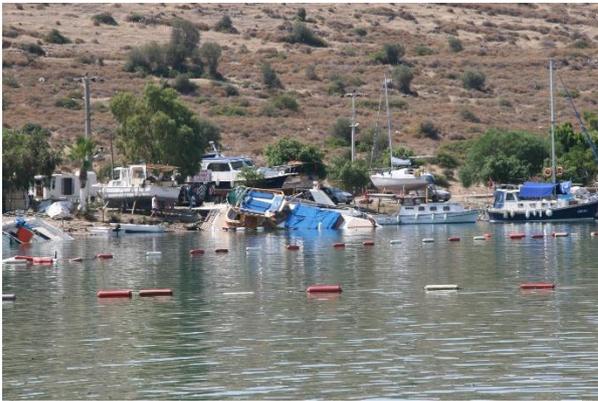
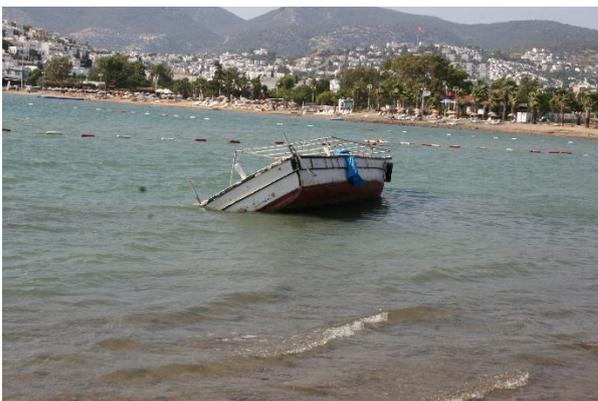
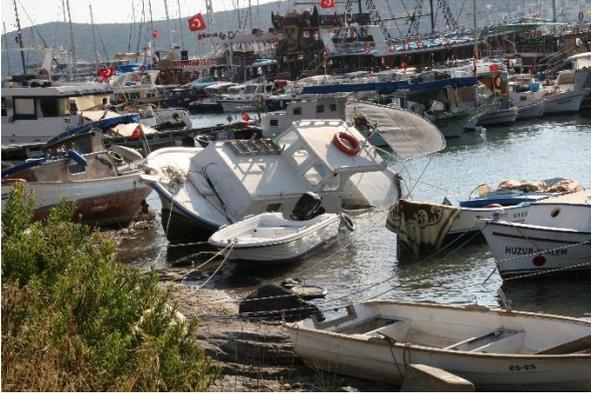
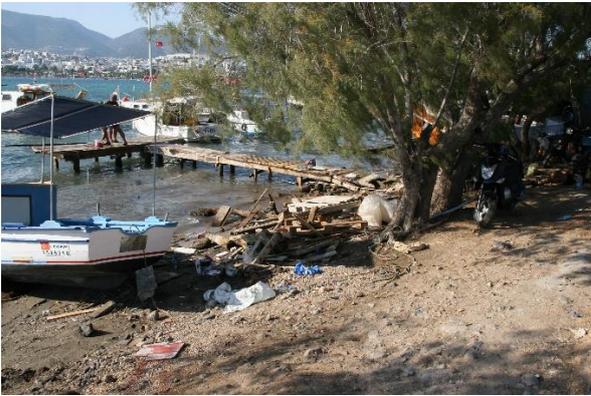
At the most eastern part of Gumbet bay (27.407621E, 37.037478N), the small boats berthed at shallow region. Tsunami dragged all boats together and moved them away from the shore to the location (27.405029E, 37.0281.33N) in the bay. More than 30 boats were damaged and more than 10 boats sunk in this location. The boat captains reported that there was very strong swirling water motion at three locations in the bay. Approximate locations are i) 27.405029E, 37.0281.33N, ii) 27.400399E, 32.029001N, iii) 27.403934E, 37.030043N. In the second survey, the run-up height is measured as 1.72m in this berthing region.

Figure 4.6: View of damaged boats and coastline of Gumbet Bay

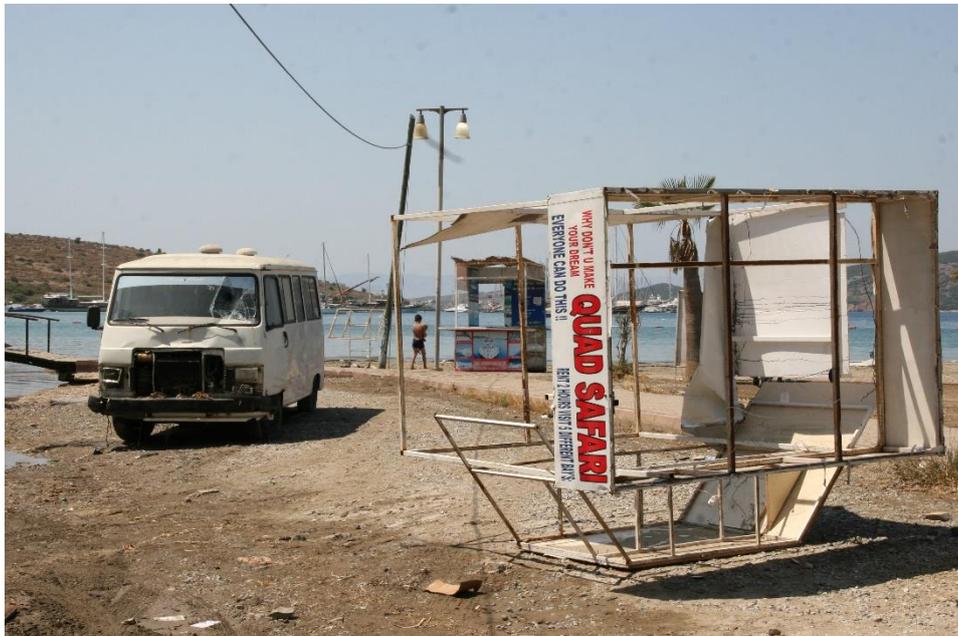
Figure 4.7: Damaged minibus and advertisement board

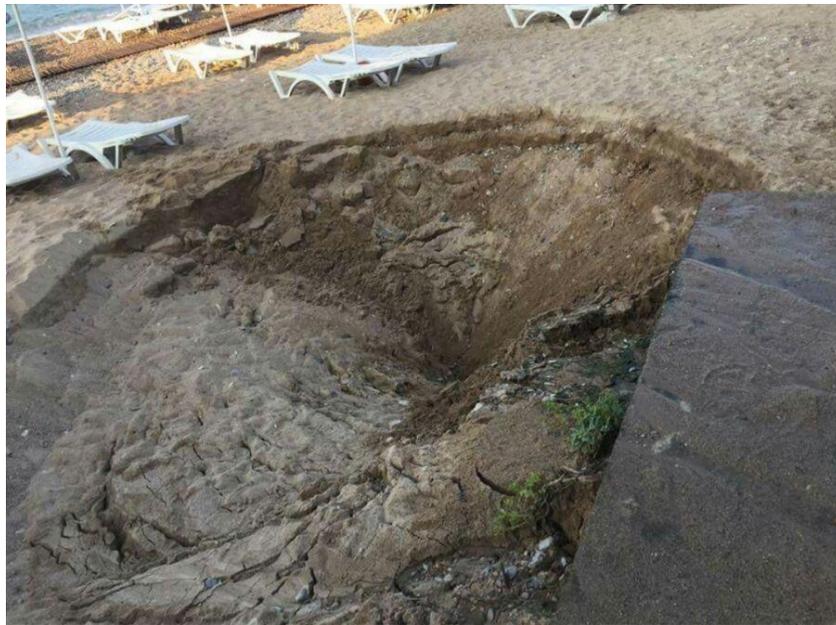
Figure 4.8: Big hole appeared at Yaliciftlik Bay after the earthquake (27.527908E 36.992786N)

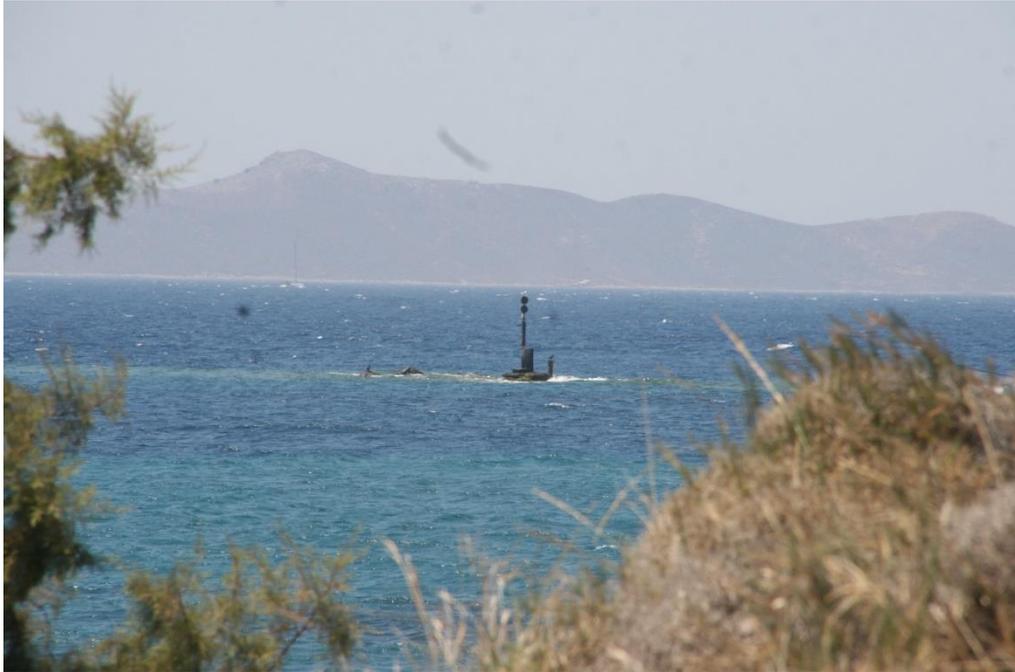
Figure 4.9: Boundary of the tsunami observation at the western end of the Southern Coastline of Bodrum Peninsula according to eyewitnesses (27.264562E 36.964772N)

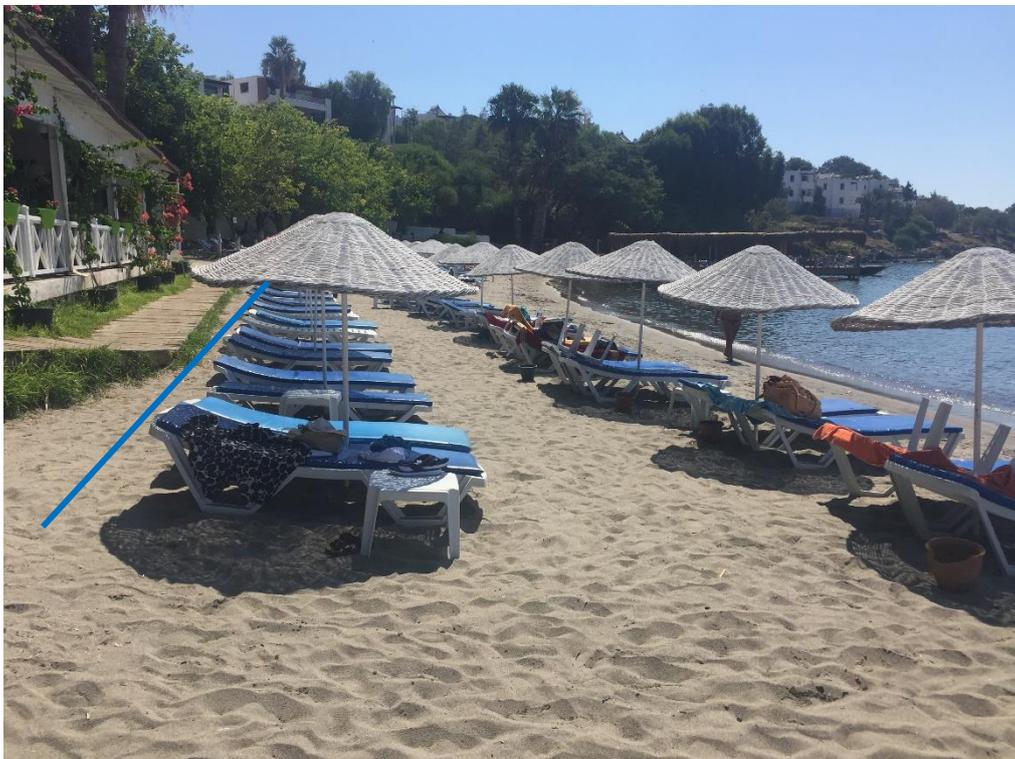
Figure 4.10: View of inundation line at Meteor Beach (27.278796E 36.966191N)

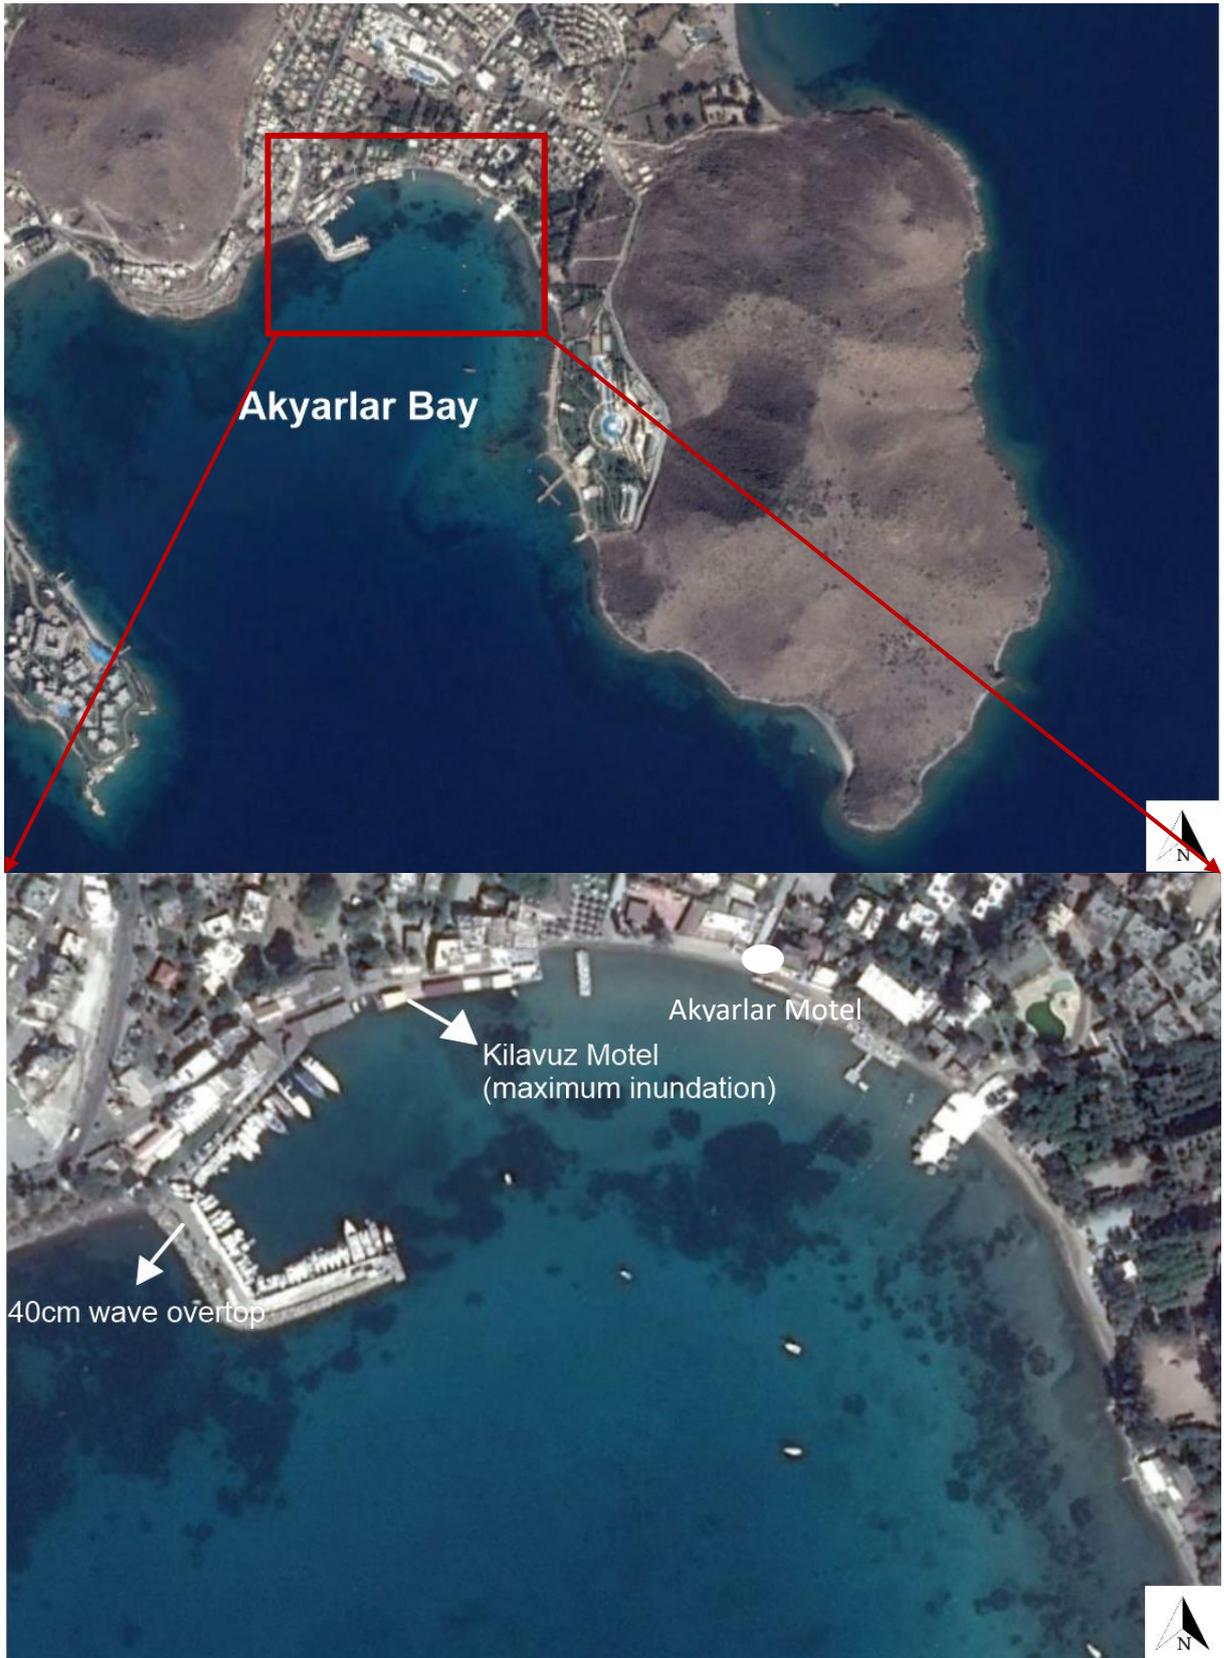
Approximately 10 meters of inundation distance is observed along the coast of Akyarlar Bay **(3)**. One of the summerhouse residents observed that the small hole at 10-15m distance from the coast was all washed up by the waves. He stated that the flow depth was about 50cm. The port in this bay is at a safe location by the natural conditions, therefore no damage observed by the waves in the port. According to the fisherman observations in the port, the sea level first decreased and then rising was observed. Also, strong currents were observed at the nose of the breakwater, one of the fishermen said *“it was flowing like stream water at the entrance of the port”*. The dock height was measured as 80cm. The water level rise at the harbor was 120 cm according to the eyewitnesses. (Figure 4.11). Waves affected the part up to Akyarlar Motel (27.294602E, 36.967830N) if one considers a perpendicular line to the coastline from the head of the breakwater. The water level increased 40cm in front of the vertical wall of this motel. The coordinate measurements and related observations along Akyarlar Bay is given in Table A.4 in Appendix A.

Figure 4.11: Schematic view of wave motion in Akyarlar Bay (27.290930E 36.967359N)

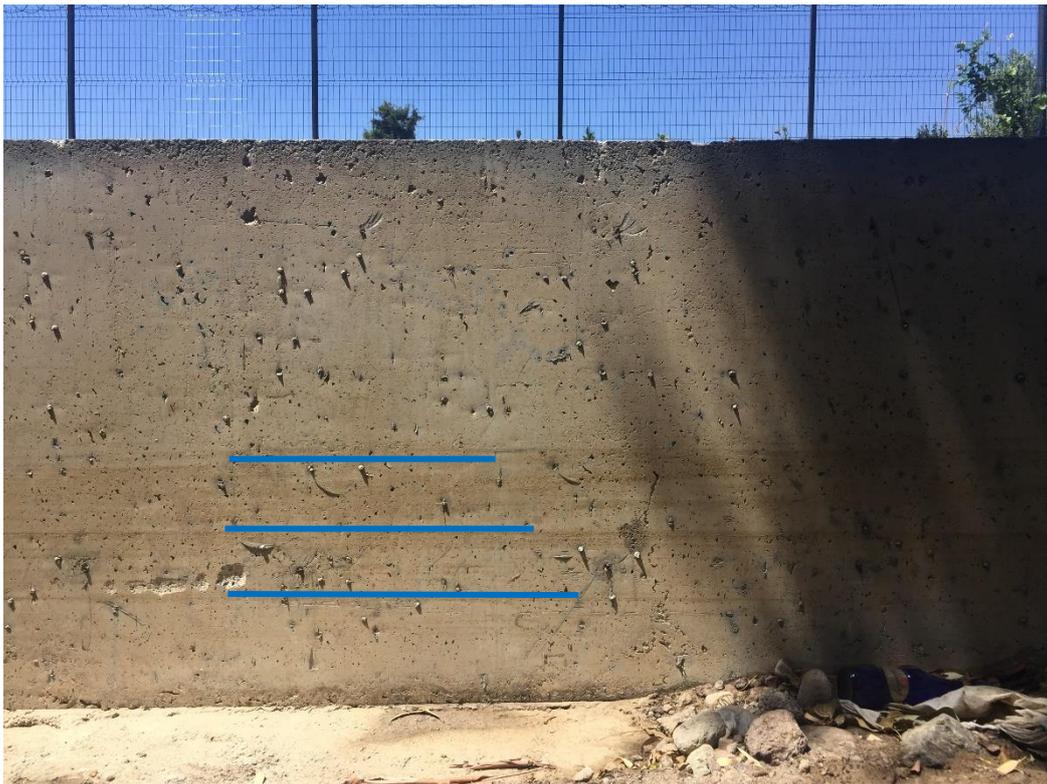
Figure 4.12: Wave traces in the stream bed, Karaincir Bay (27.300718E 36.973574N)

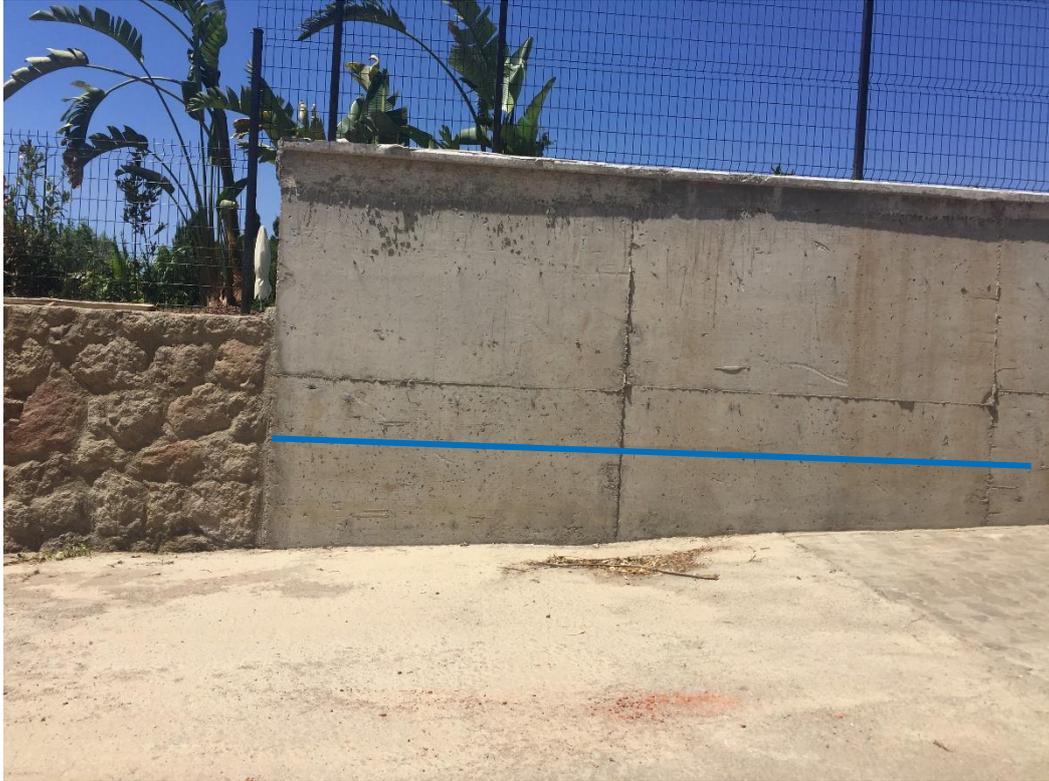
Figure 4.13: Wave trace on the sidewalls of the road, Karaincir Bay (27.300718E 36.973574N)

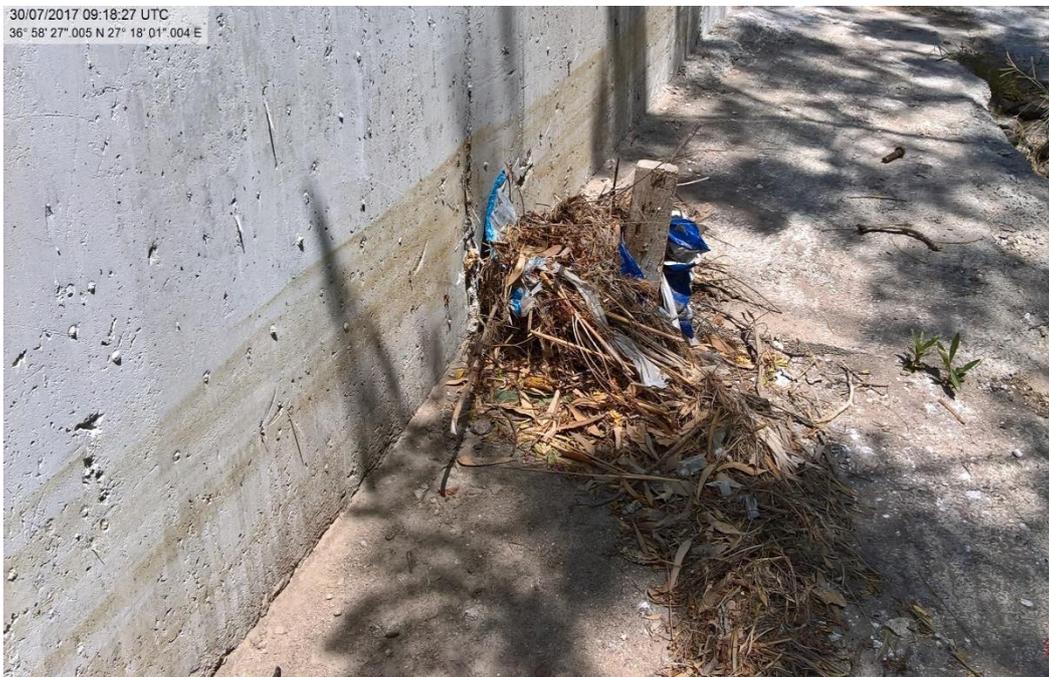
Figure 4.14: Debris material accumulated, Karaincir Bay (27.30041E, 36.97433N)

The field survey continued at Karaincir, Balmahmut's Place (4). Inundation is reported approximately 60m near Atakan Beach, water drawdown is approximately 20m and the motion was like tidal wave according to the observers. The observers state that water level was first decreased and then rised up resulting in a total wave oscillation of +1.4m -1.2m. Also, in the second survey, the maximum run-up height is observed and measured in the stream bed (width: 2.5m) as 1.4m (0.8m flow depth + 0.6m elevation) at 100m away from the shore. Then the inundation was observed up to 150m along the stream bed. Furthermore, the traces on the walls of the stream bed shows that more than one wave (at least three waves) has reached (Figure 4.12) the Karaincir locality. The run-up height is also measured as 1.5m (0.5m flow depth + 1m elevation) on the road (width: 6m) just near the stream (Figure 4.13). The incoming wave washed away cars along the road. The visualization of the inundation can be described in Figure 4.14.

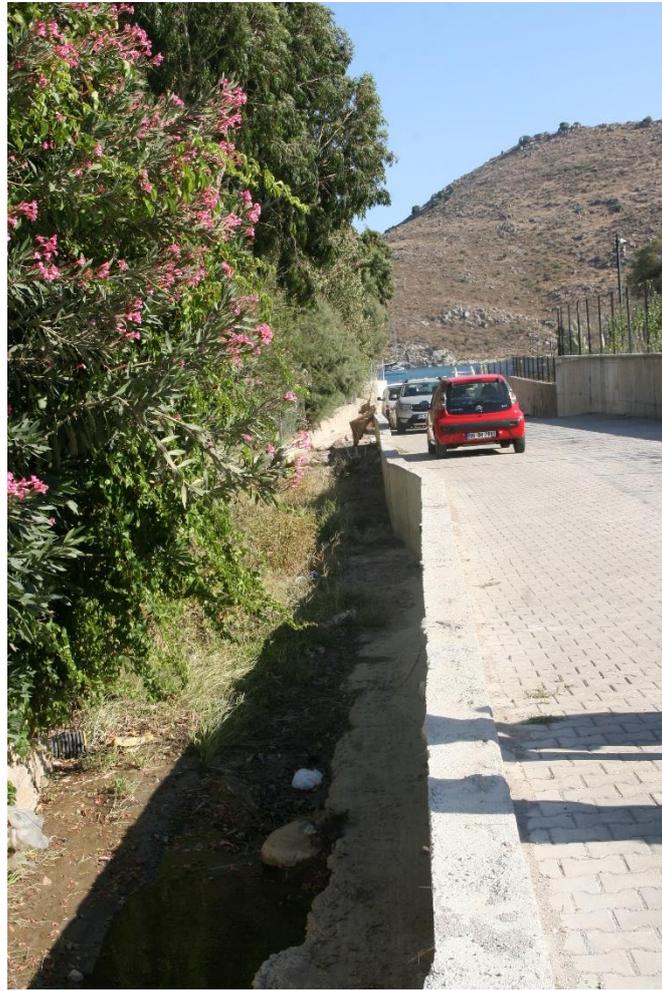
Figure 4.15: Maximum inundation distance in Karaincir Bay along the streambed

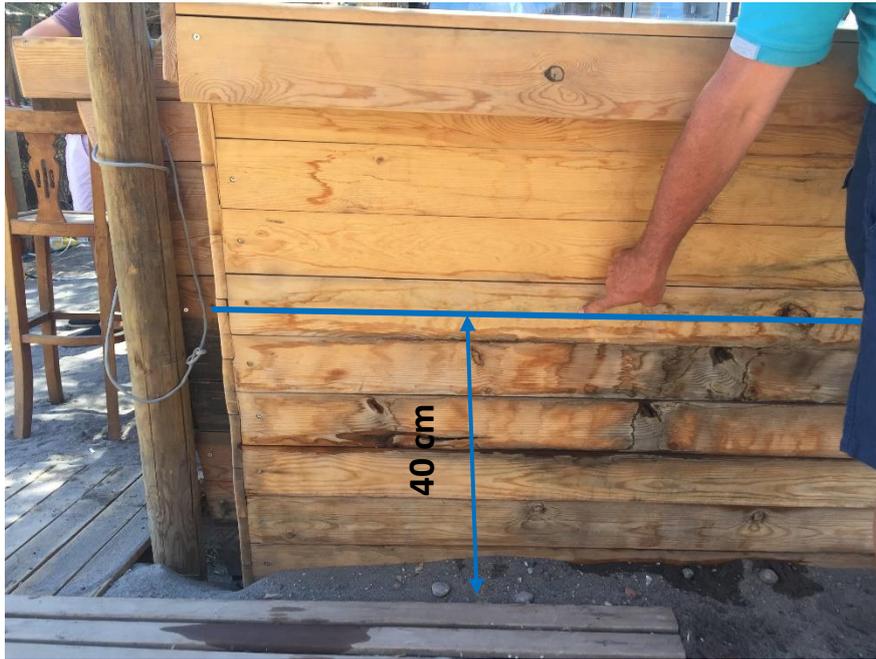
In the second survey, more points in Karaincir Bay were investigated. One of them is La Brezza Beach (15) which is located at western part of the bay. 125 m inundation distance is reported at this beach and 40cm of water level is measured at an elevation of 1.2m with respect to the sea level, for a total of 1.6 m (Figure 4.17).

Figure 4.17: Water level sign observed at La Brezza Beach, western part of Karaincir Bay
(27.300179E, 36.969923N)

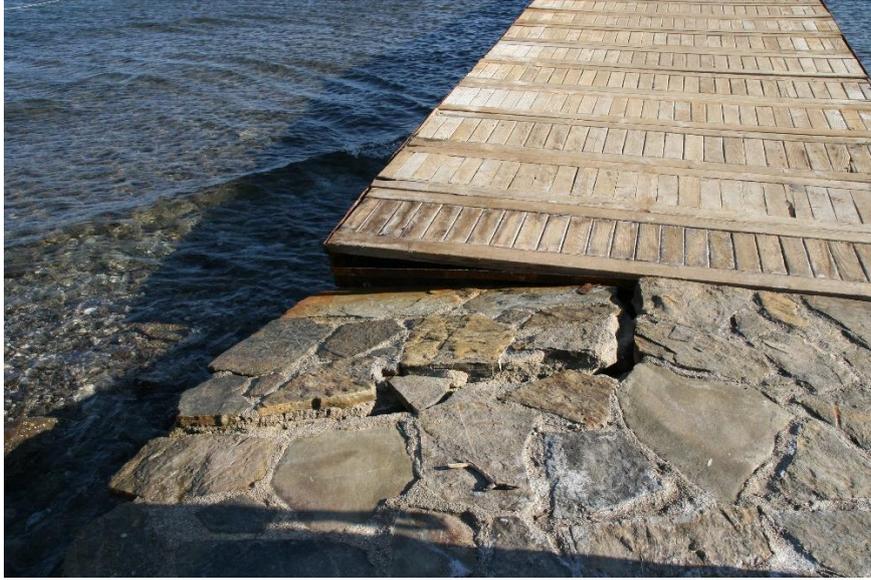
Figure 4.18: Damaged Pier in Aspat Bay (27.312356E 36.979592N)

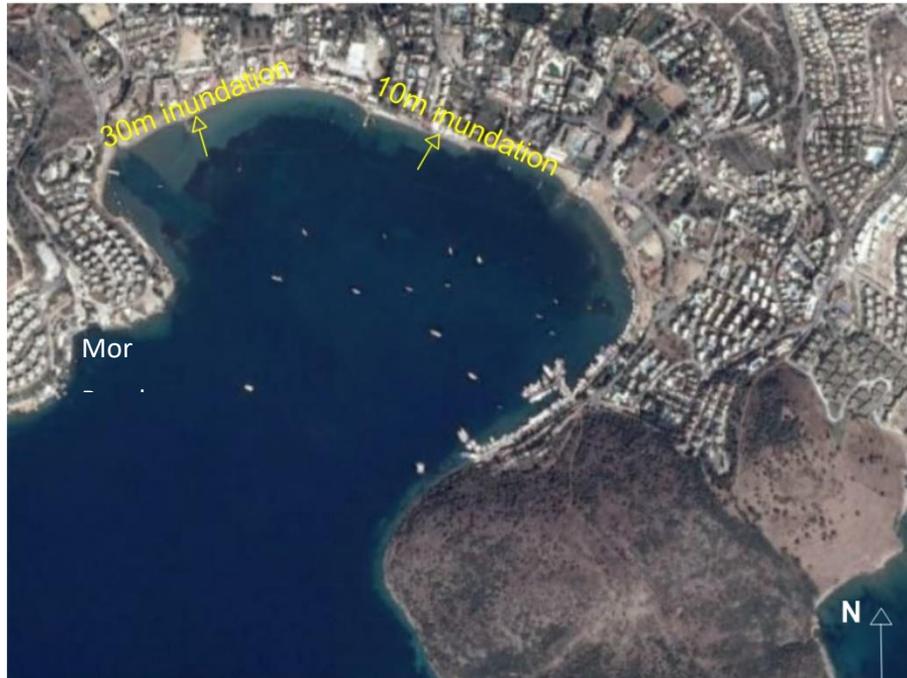
The field survey ended at Bitez Bay **(7)** of Bodrum where the first motion of the sea is reported as drawdown of 3m, 10-15 minutes after the earthquake. The inundation distance is stated as approximately 10m in the middle of the bay but the eastern part of the bay is more affected by the waves (inundation distance is approximately 30m in this part) due to the location (Figure 4.19). Flow depth is reported as nearly 50cm and no strong current was observed in the bay.

Figure 4.19: Schematic view of wave inundation at Bitez Bay (27.383582E 37.025615N)

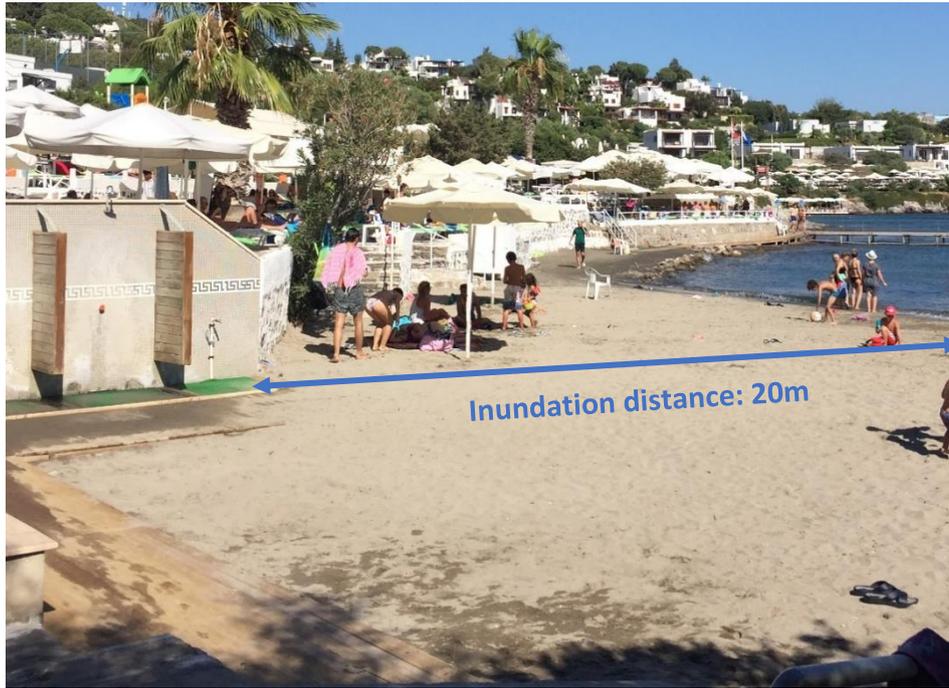
Figure 4.20: Inundation at Aktur Beach (27.366069E 37.02439N)

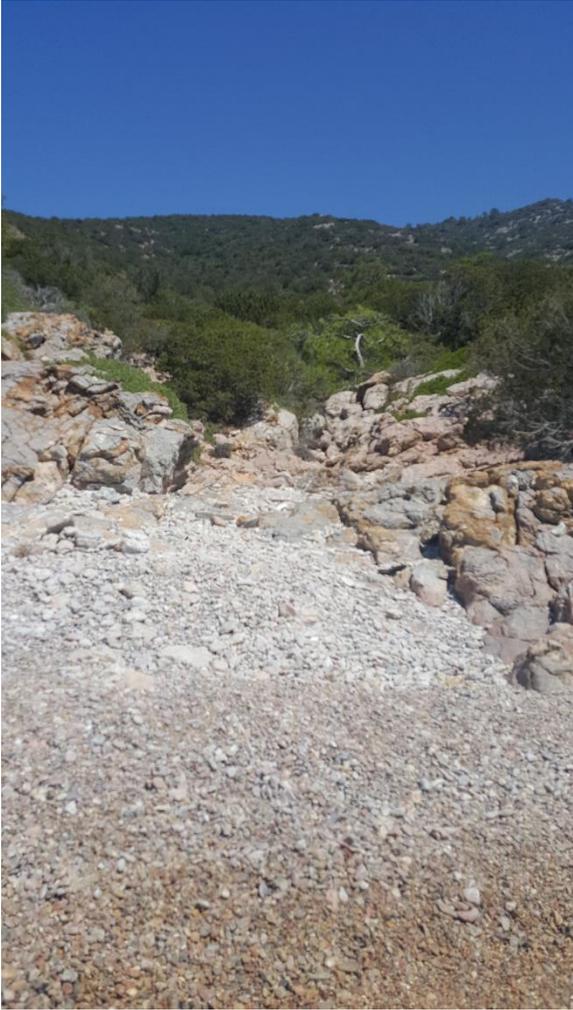
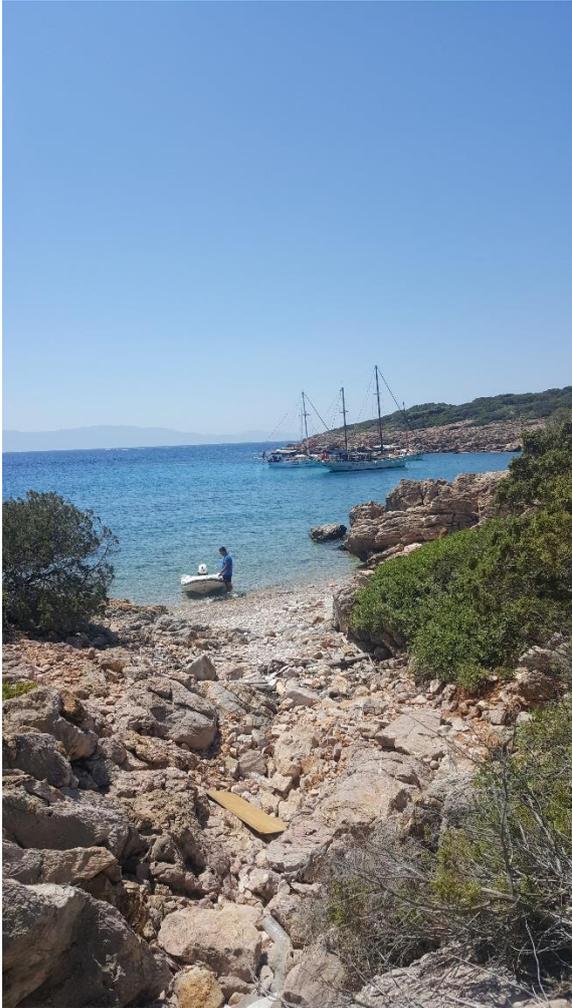
Karaada in English Black island, is located in between Bodrum town and Kos island with a size 7km along NW-SE direction and in average 1.2km along SW-NE direction. A special field survey has been performed to Karaada by boat on July 31, 2017 by Yalciner and Dogan). At south coast of island (facing to epicenter) there are two small gravel beaches. The view of small gravel beach at Kucuk Poyraz bay (27.461422E 36.966323N) is given in Figure 5.1 a and b from different perspectives.

Figure 5.1: Kucukpoyraz Gravel Beach at Karaada (Black Island) a) view from the shore b) view from the beach

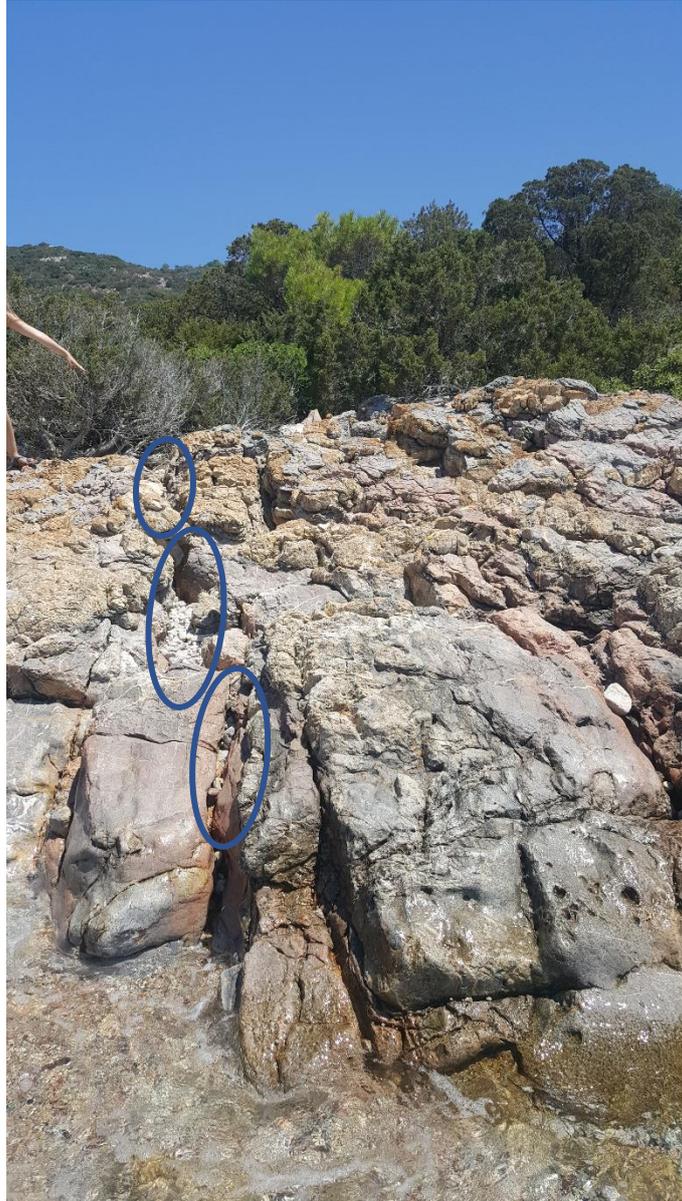
The team visited Kucuk Poyraz beach at Karaada and found small gravels in the spaces on the rocks of the beach which are thought to be washed by the tsunami waves. The elevation that the gravels reached is approximately 2m (Figure 5.2).

Figure 5.2: Small gravels found in the gaps between the rock surfaces at Kucukpoyraz Beach, Karaada (Black Island)

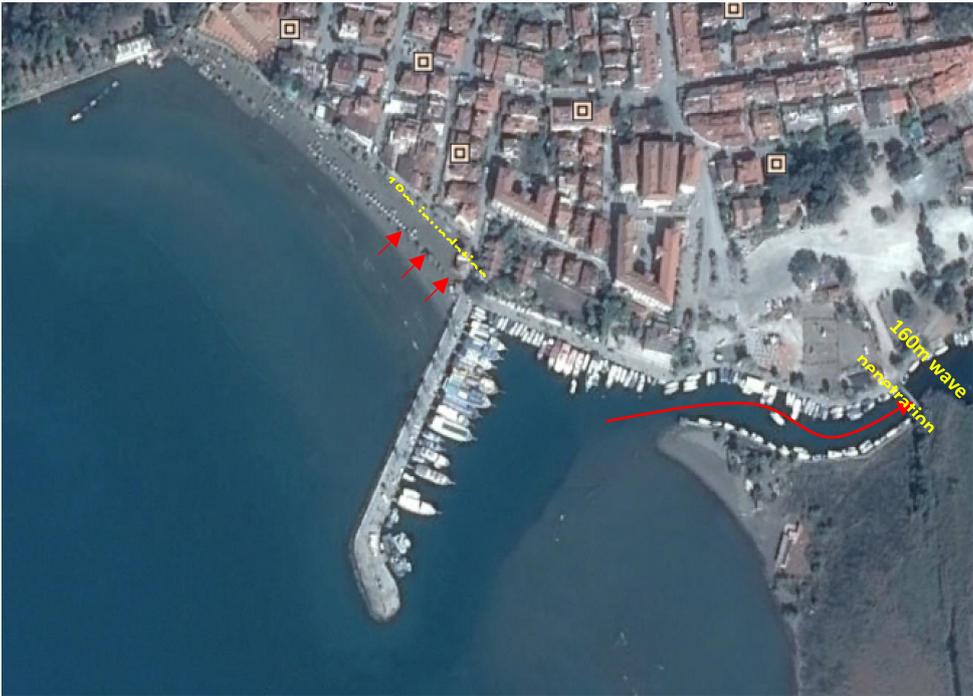
The survey team has been contacted with the workers of cafes in Akyaka beach and fisheries cooperative. The eyewitnesses informed that in Akyaka beach wave receding was first observed around 35 minutes (not confirmed yet) after the earthquake with about 50m distance. Then tsunami inundation was observed up to the first trees in the beach, which is about 18m from the shoreline.

Figure 6.2: Schematic view of wave inundation at Akyaka Beach

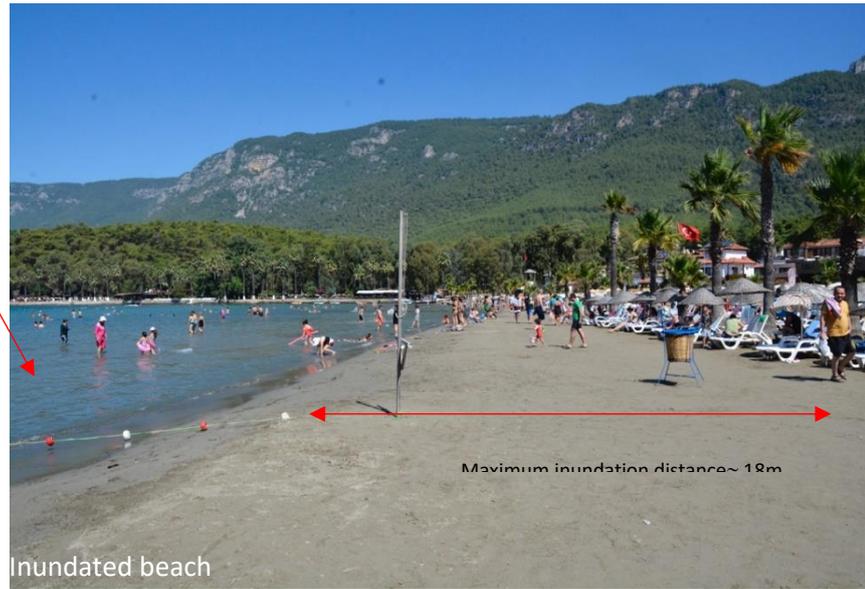
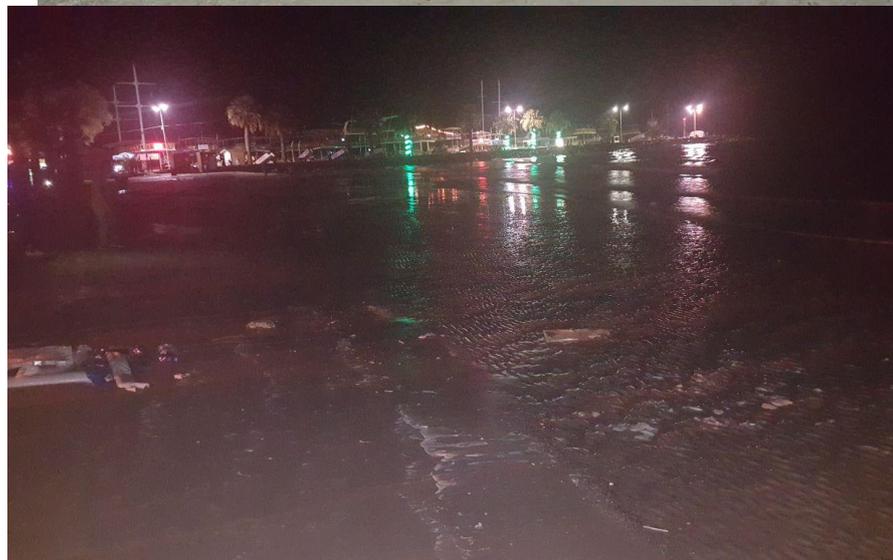
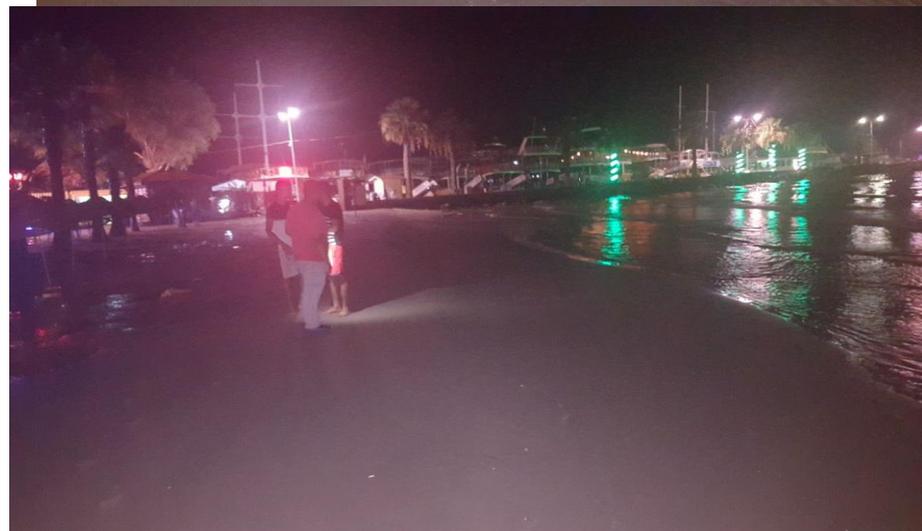
Figure 6.3: Akyaka Beach; original beach condition (above) and the picture shot by an eyewitness after wave inundation (two photos below)

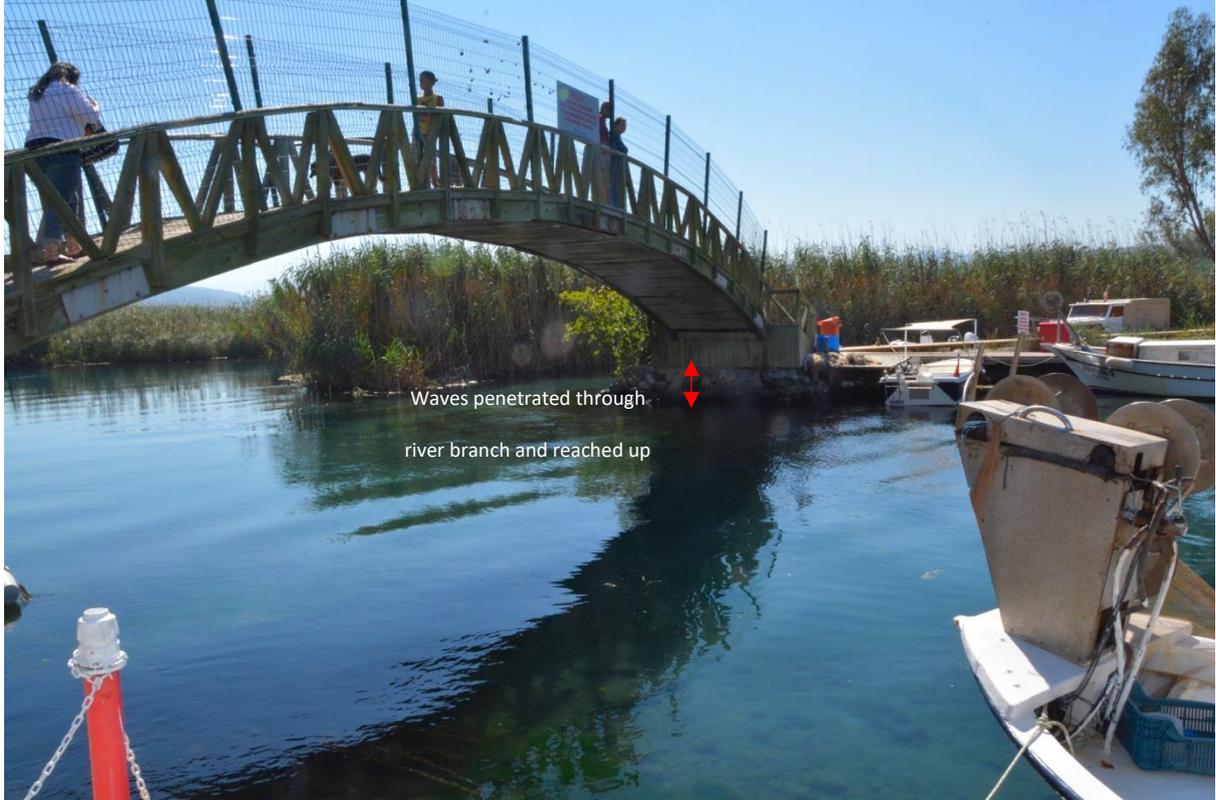
The workers of fisheries cooperative informed that wave receding was first observed in the Azmak stream and then waves penetrated through the river up to the first bridge (about 160m inundation distance) with a height of about 60cm. No flooding was observed on the banks of Azmak stream.

Figure 6.4: Akyaka Stream Branch; waves penetrated through the river up to the first bridge and sea level increased about 60cm

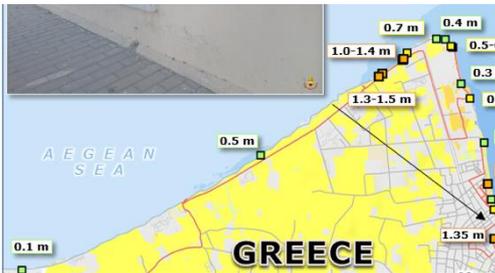
Starting from the left part of the North section of Kos island, 4 points have been identified ranging from 0.1 to 1.4 m.

The North coast of Kos shows an increasing intensity starting from the southern locations towards the top cape of the island.

The largest impact has been noticed at about 900 m from the cape with a maximum height of 1.5 m. The maximum height then decreases at the cape to about 0.4 m.

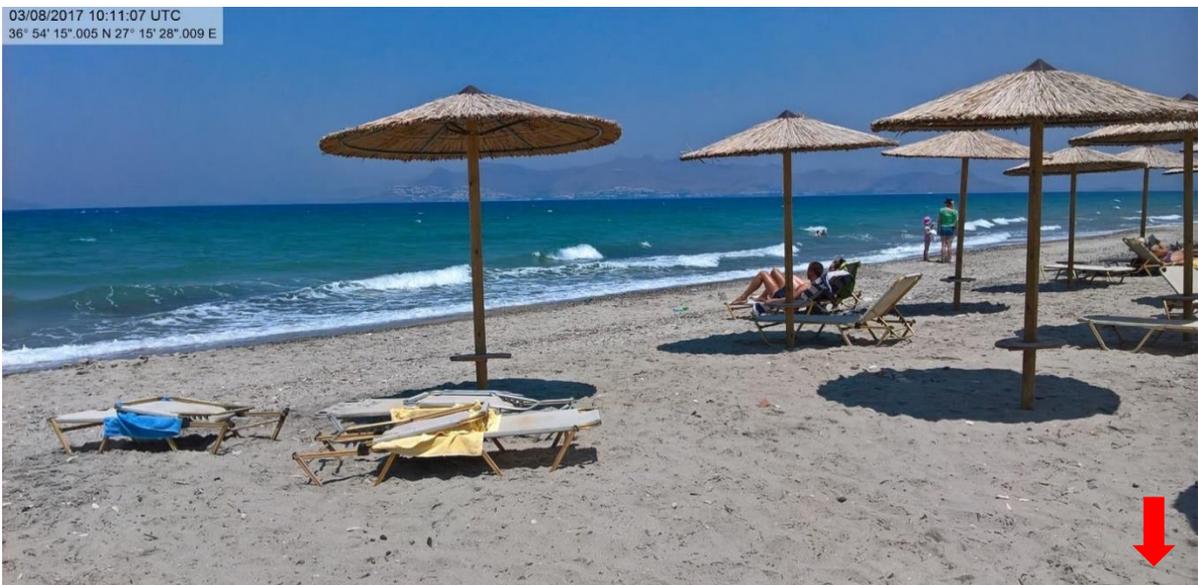
Figure 7.2: Image taken at 36.89991/27.24879, showing debris at elevation 0.1 m, point (2) in table 7.1; the sharp change is not clear if is due to the Tsunami (subsidence) or just to coastal

erosion.
