THE 20th JULY 2017 (22:31 UTC) BODRUM/KOS EARTHQUAKE AND TSUNAMI; POST TSUNAMI FIELD SURVEY REPORT

August 17, 2017 (new version)

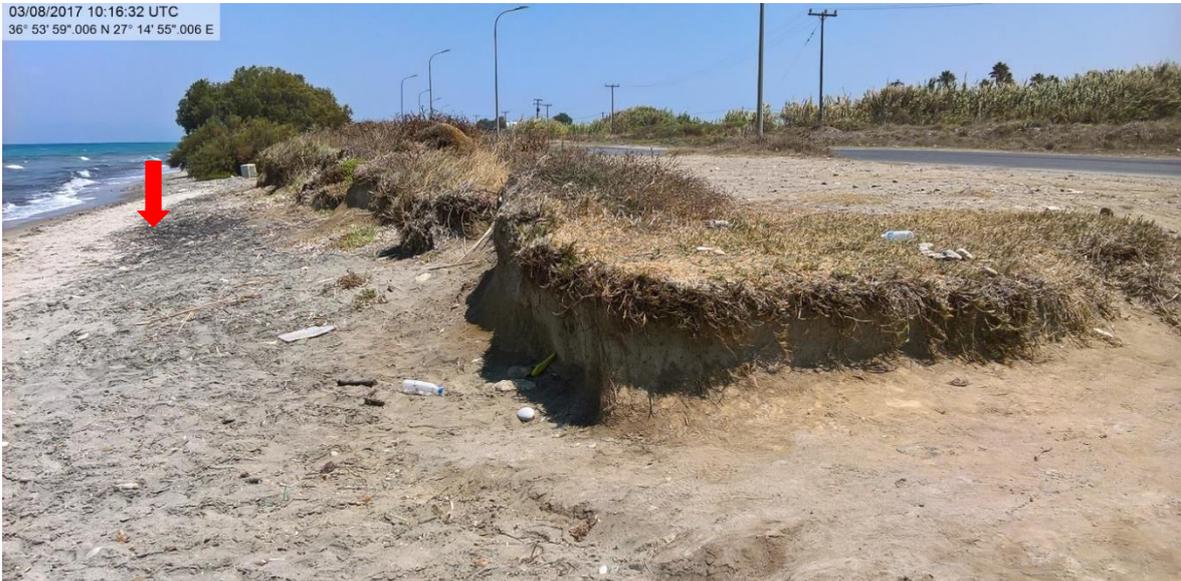
Figure 7.3: Image taken at 36.90433/27.25805. One witness, point (3), reported that the beach was inundated by 16 m and corresponding to 0.5 m water height.

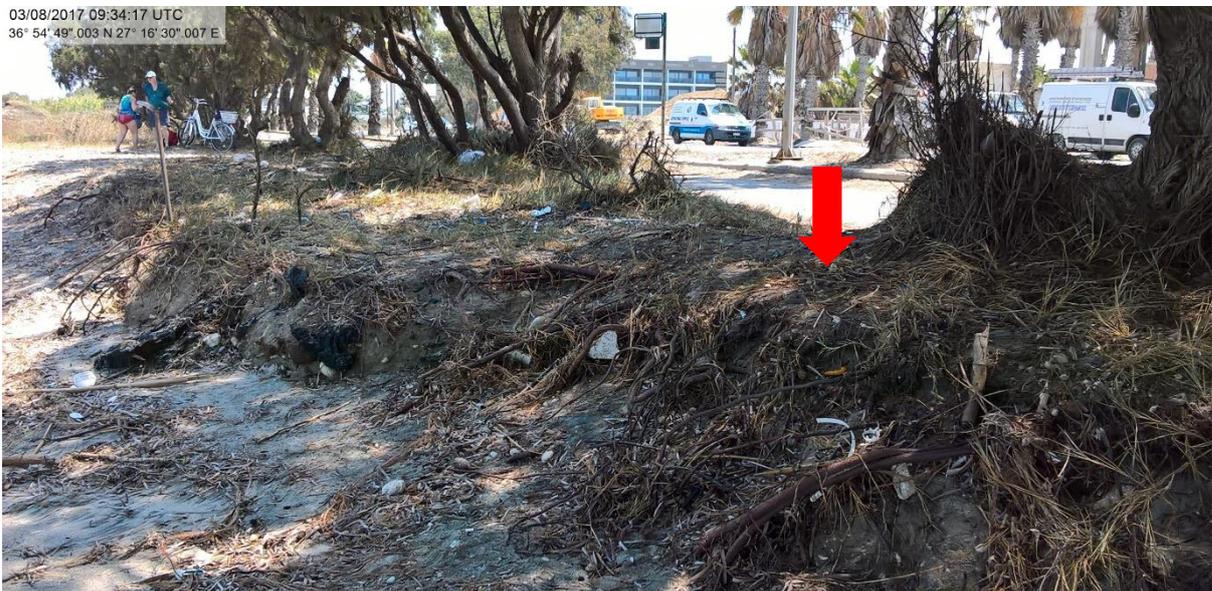
Figure 7.4: The image above was taken at 36.91370/27.27521 (5) and shows several sea deposits up to 1 m. The beach is very small, the distance from the sea is less than 5 m.

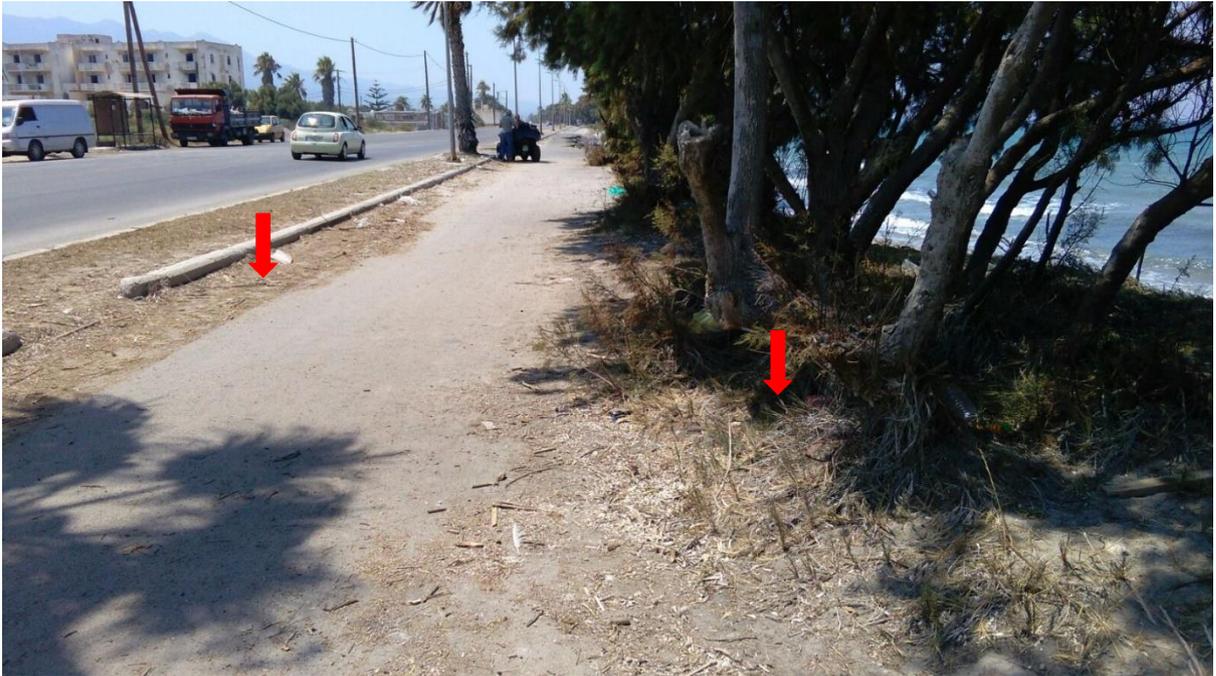
Figure 7.5: Image taken at 36.91358 / 27.27503, showing the presence of sea debris below the trees but also on the other side of the bicycle street.

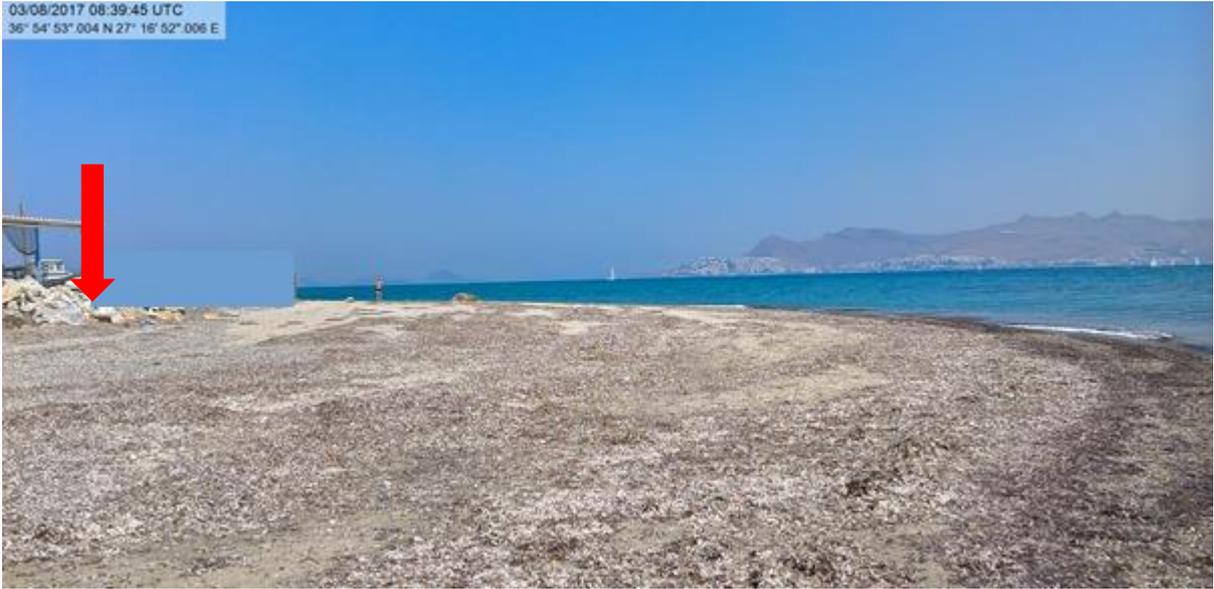
Figure 7.6: The image above, taken at 36.91564 / 27.28037, shows debris close to the shore but an eyewitness reported that the water arrived up to the stones (red arrow). The height measured was 0.6 m, point (7).

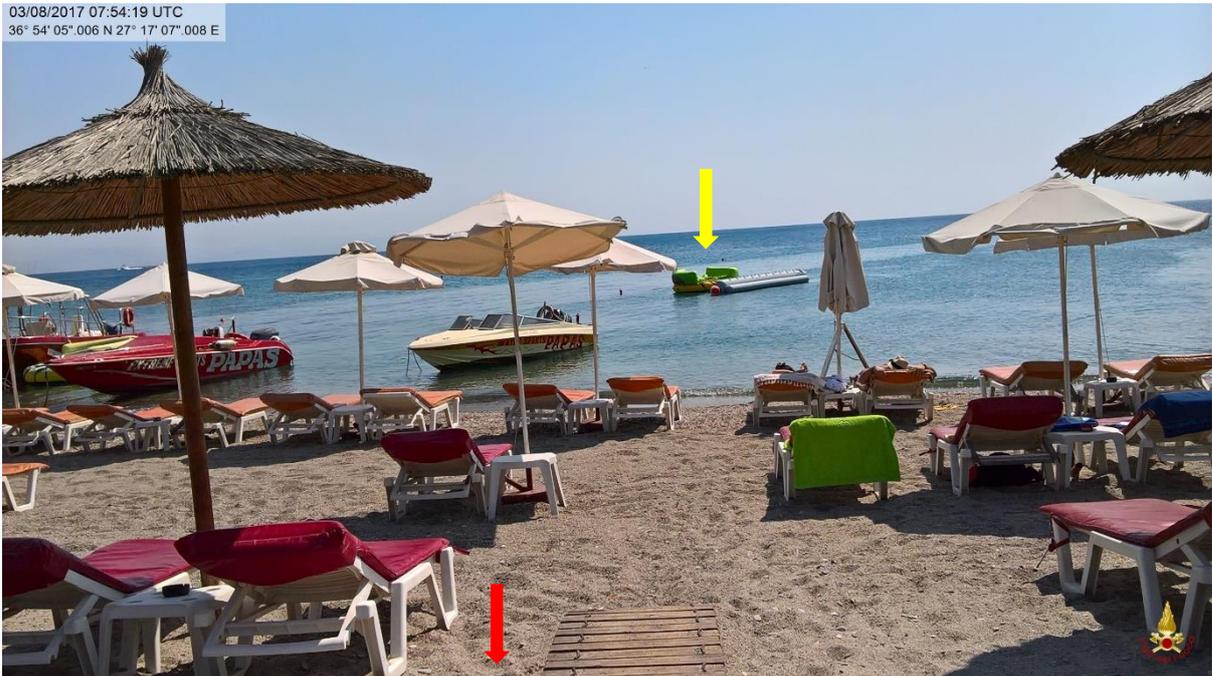
Figure 7.8: The image was done at 36.90156 / 27.28551, point (11). The height is between 0.5 and 1.2 m.

The largest height in this area before the port has been reported here by Dimitri Giagoglu, the owner of the beach, who also indicated that water receded several tenths of meters (yellow buoy indicated by the yellow arrow) before advancing. He mentioned that, according to him, the magnitude was much larger, 7.5 or 8.0 as it was very very strong, cut umbrellas. He showed movement of a large anchor fixed on a wall, left and right. He recorded about 10 min of audio.

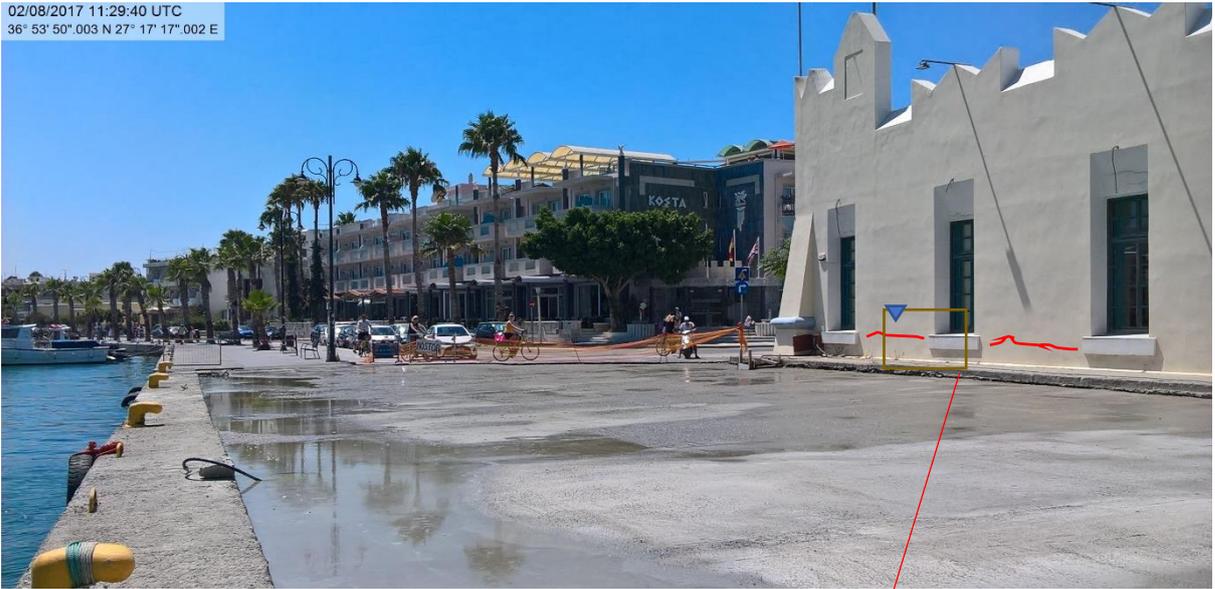
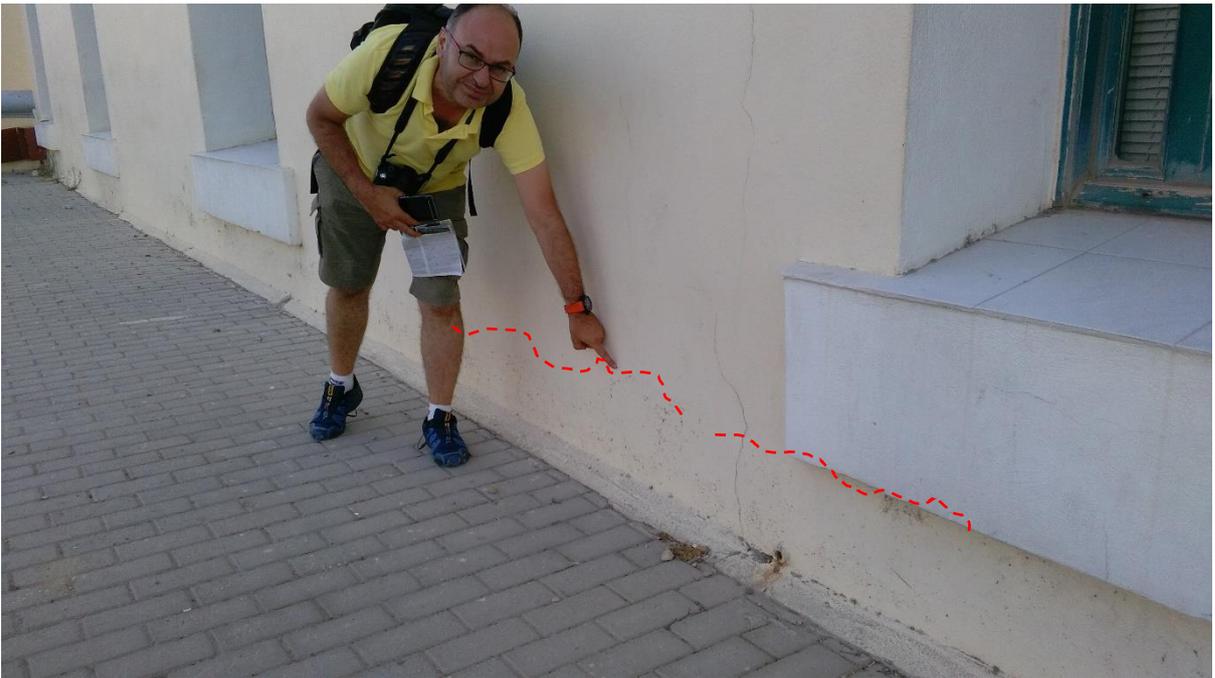
**Figure 7.9: Image above was taken at point 36.89745 / 27.28791 and the estimated height is
1.4 m.**

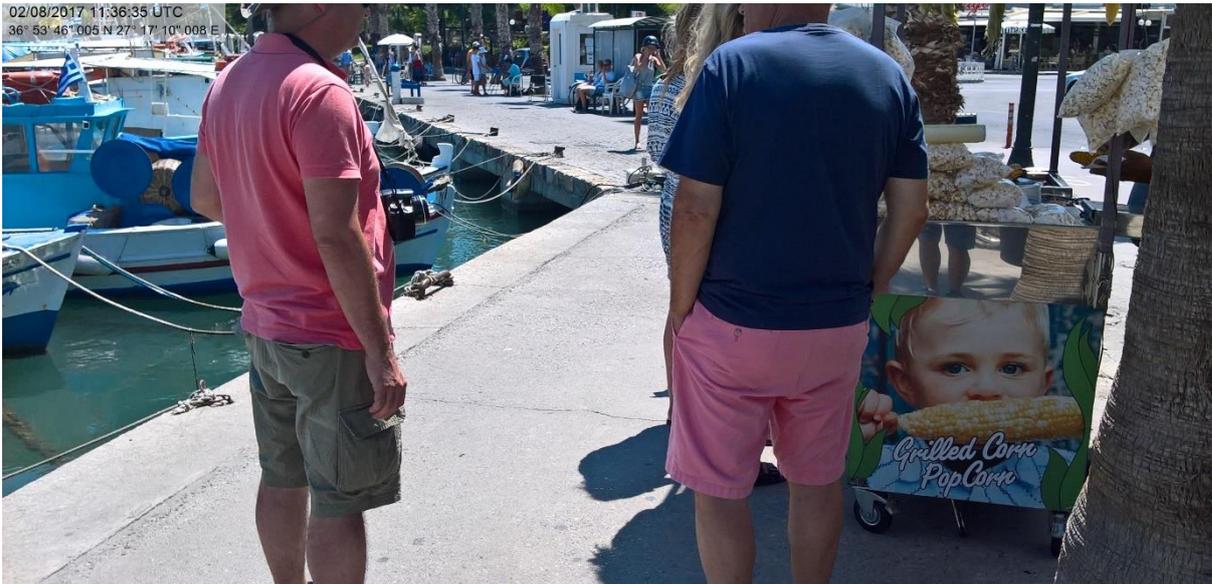
Figure 7.11: Corn panicles seller (36.89626 / 27.28635)

Figure 7.11 is done at 36.89626 / 27.28635, has been reported by the corn panicles seller, who mentioned that his chariot was flooded for about 45 cm. Considering the height of the plane on the water the resulting height was **1.35 m**.

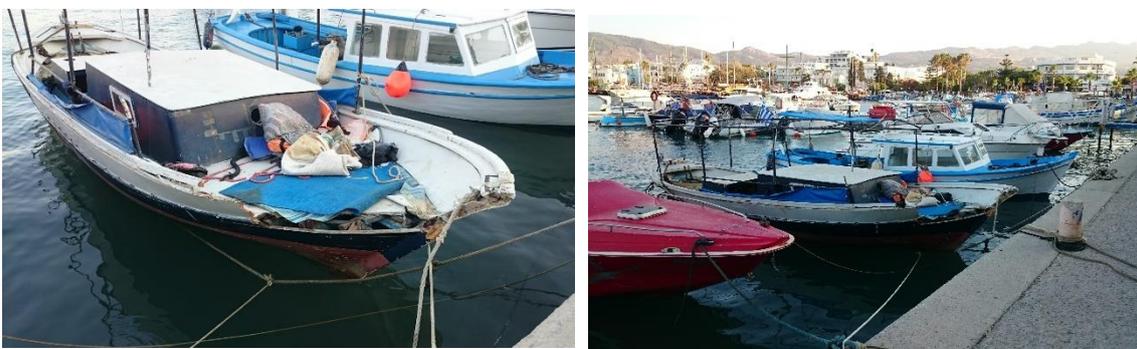
Figure 7.12: Boats damaged due to crashes among the boats, agitated by the tsunami waves or against the trees on the docks

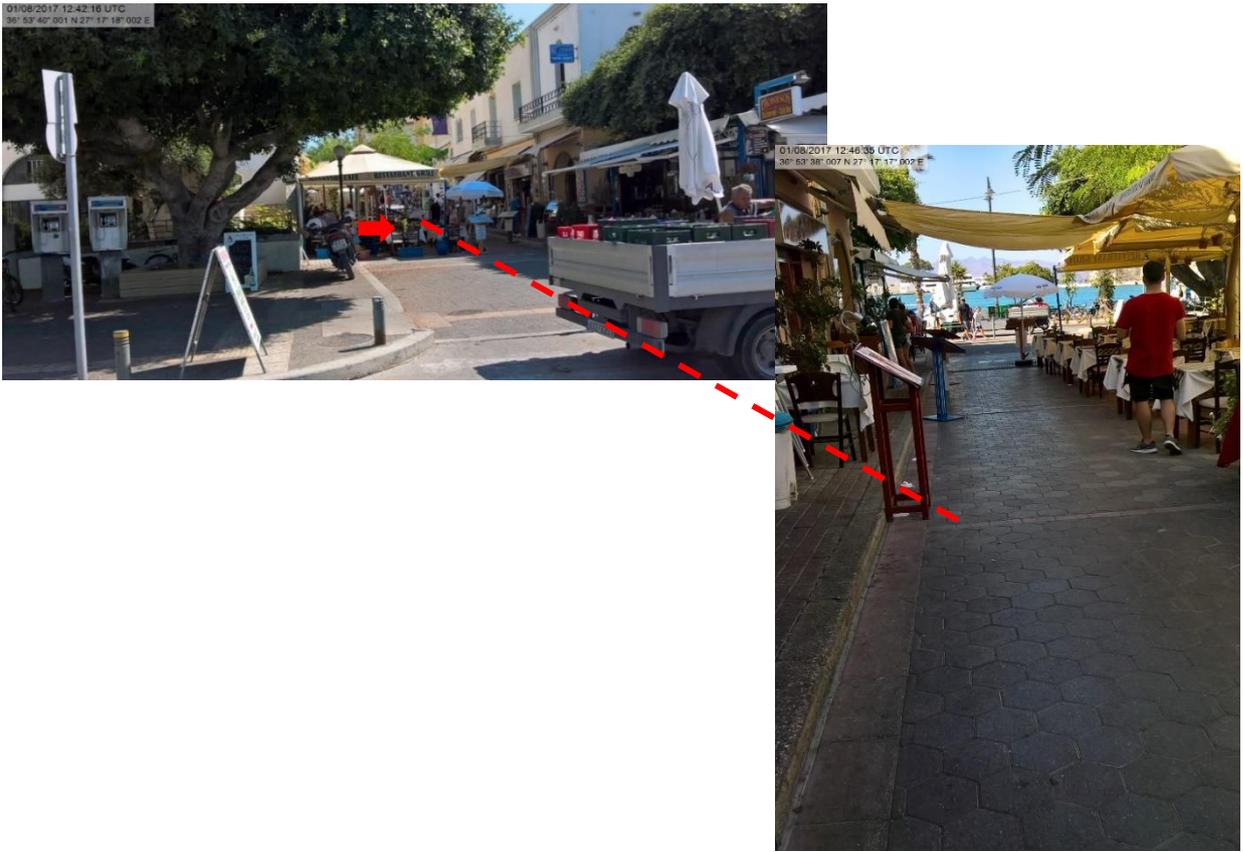
Measurements indicate about **1.5 m** from sea level. It should be noted that this road is in front of the port mouth and therefore some larger wave height should be expected.

Figure 7.13: Ioanidi road flooded with sea water up to the pharmacy sign

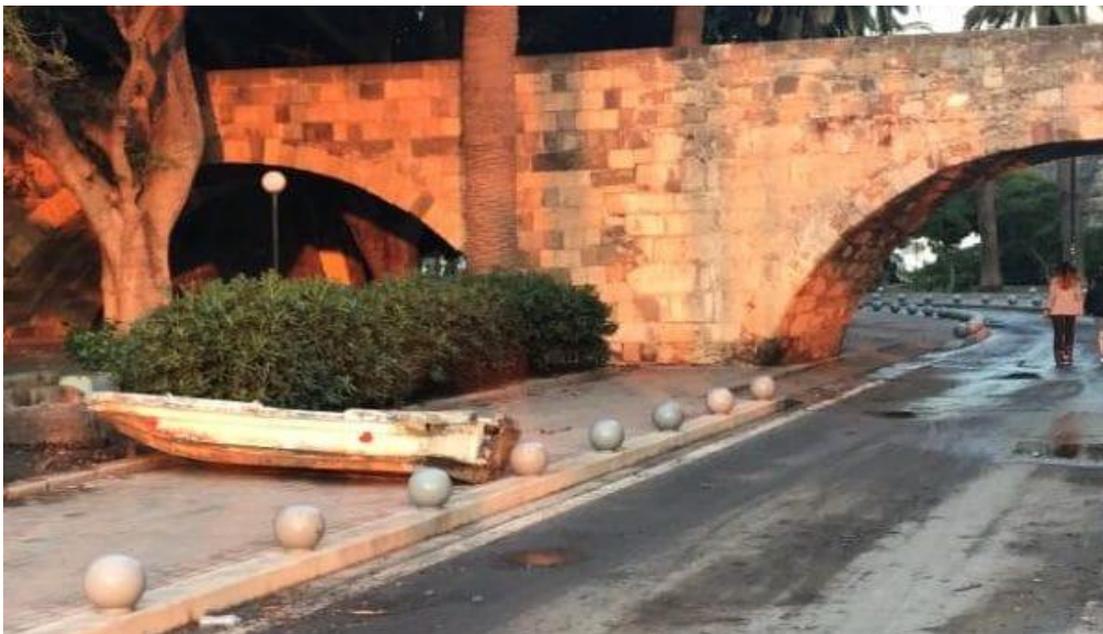
Figure 7.14: Boat resting on the pavement after its removal inland near the observation point 36.89478/ 27.28959, east side of Kos Port locally called “Bridge” (photo credit Reuters).

The Marina Officer Mr Kostas Liakovassilis arrived near the “Bridge” point ~ 1-1.5h after the earthquake. The area was wet apparently due to previous tsunami inundation. Bikes and motorbikes had fallen down and drifted. Cars crashed and drifted (see next pictures). At that time, the sea level was ~1.5-2.0 below its usual place. In about 1-2 m the sea level increased quickly by ~0.5m above the dock level, inundated by ~25-30 m and removed away motorbikes. After that the water retreat and the sea remained at its normal place. As the dock is at about 1m from the sea level the estimated height is **1.5 m**.

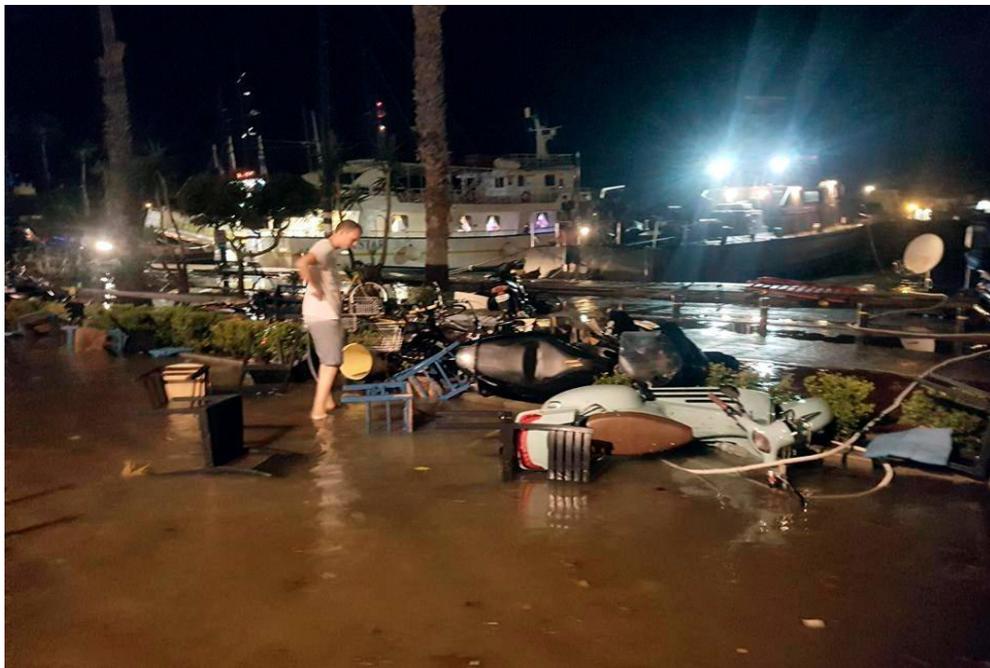
Figure 7.15: Bikes, motorbikes and other objects overturned and drifted by the tsunami in Port of Kos, near the “Bridge” point (photo credit ANA-MPE).

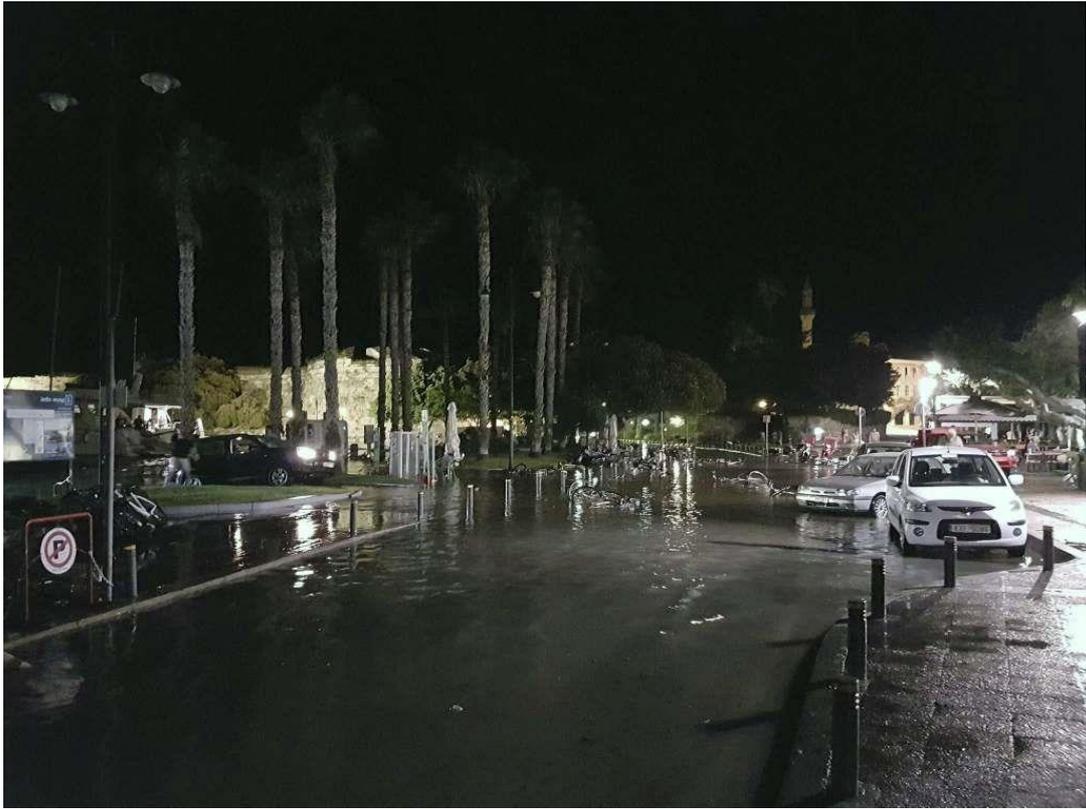
Figure 7.16: Cars drifted by the tsunami in Port of Kos, near the “Bridge” point (photo credit ANA-MPE).

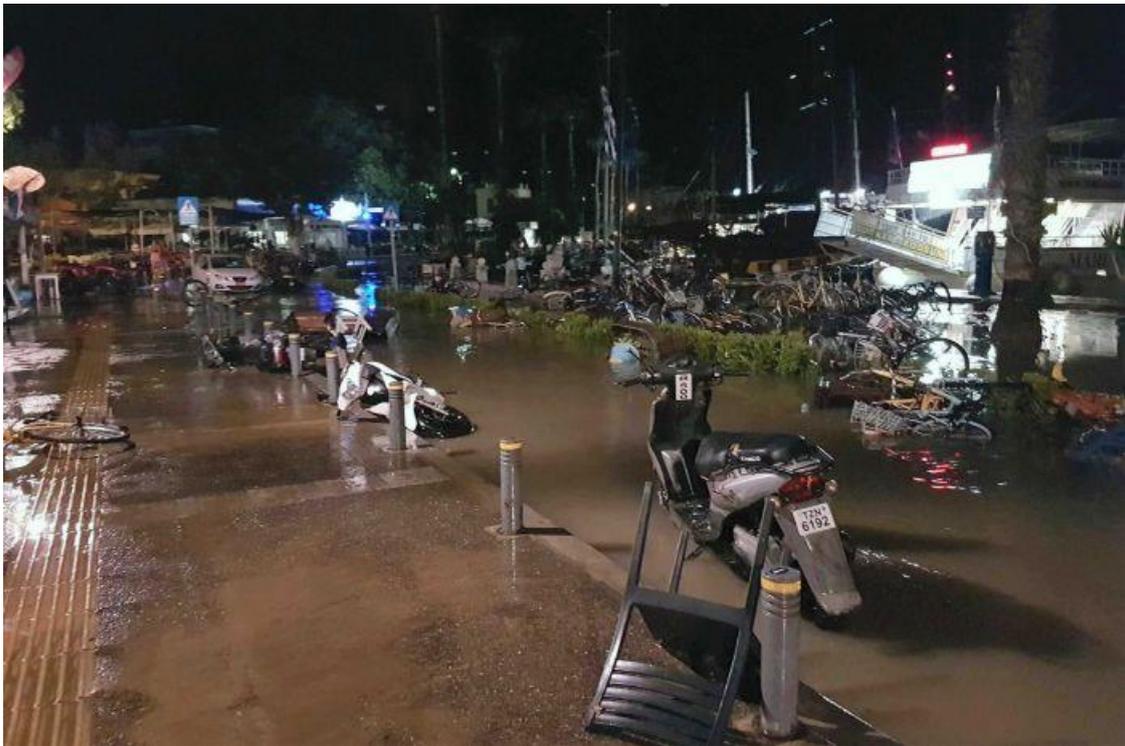
Figure 7.17: Bikes, motorbikes and other objects overthrown and drifted by the tsunami in Port of Kos, near the “Bridge” point (photo credit ANA-MPE).

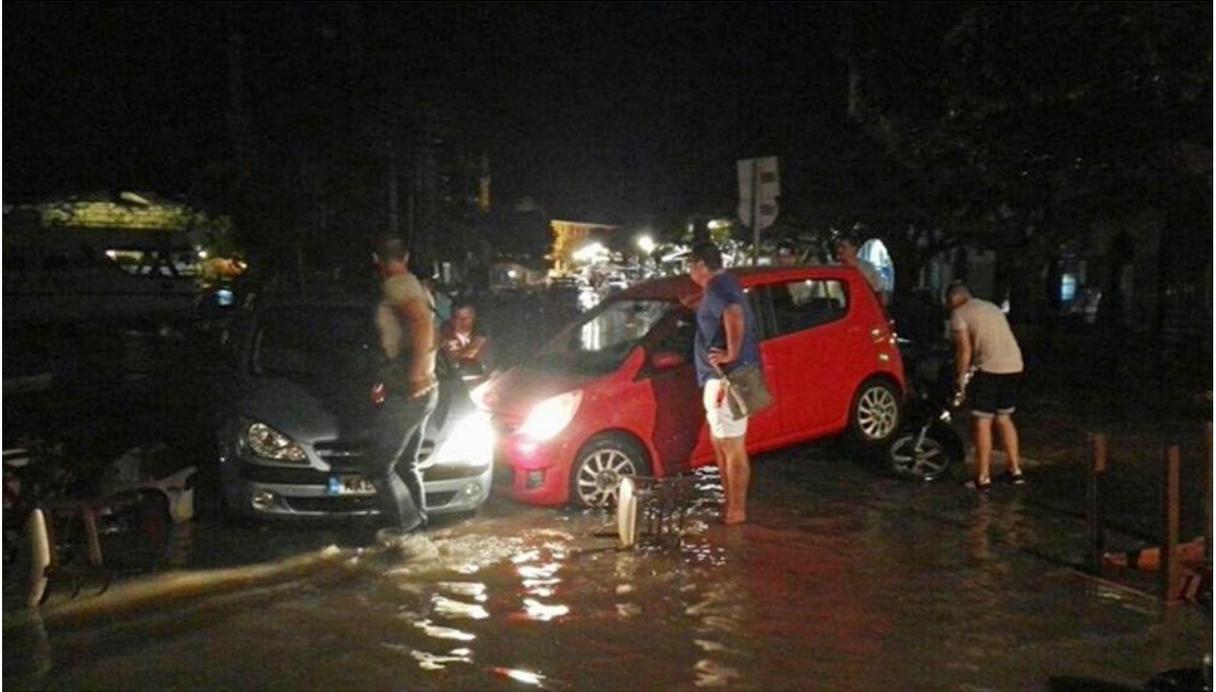
Figure 7.18: People trying to take away cars crashed due to tsunami attack in Port of Kos (photo credit ANA-MPE).

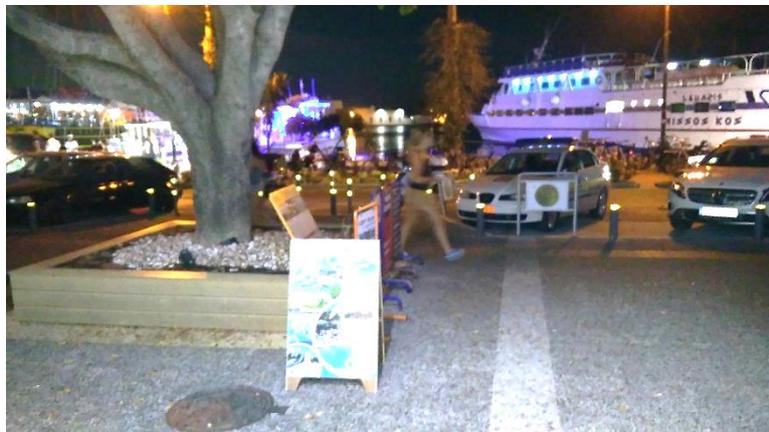
inundation of the port. From those images, it was also possible to reconstruct the timeline of the wave action at this location, after a careful measuring of the structures present in the video⁴. The dimensions of the box above, which is extremely important for the identification of the Tsunami timeline, are indicated below.

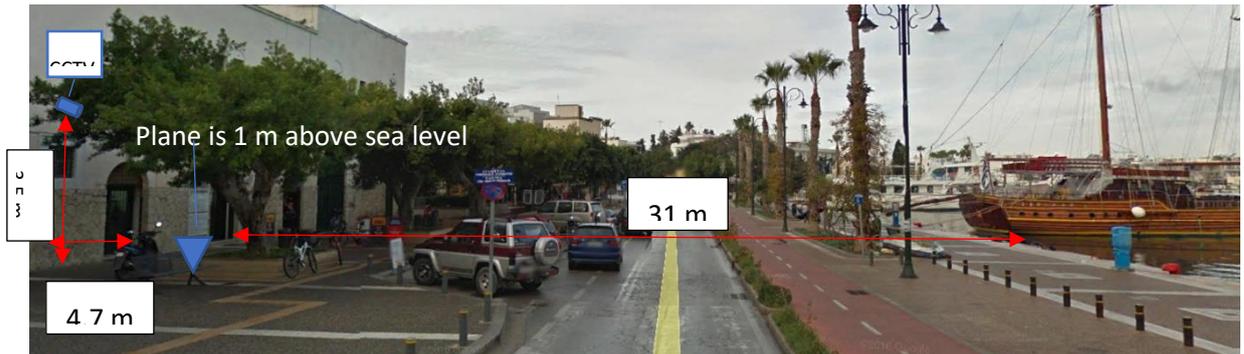
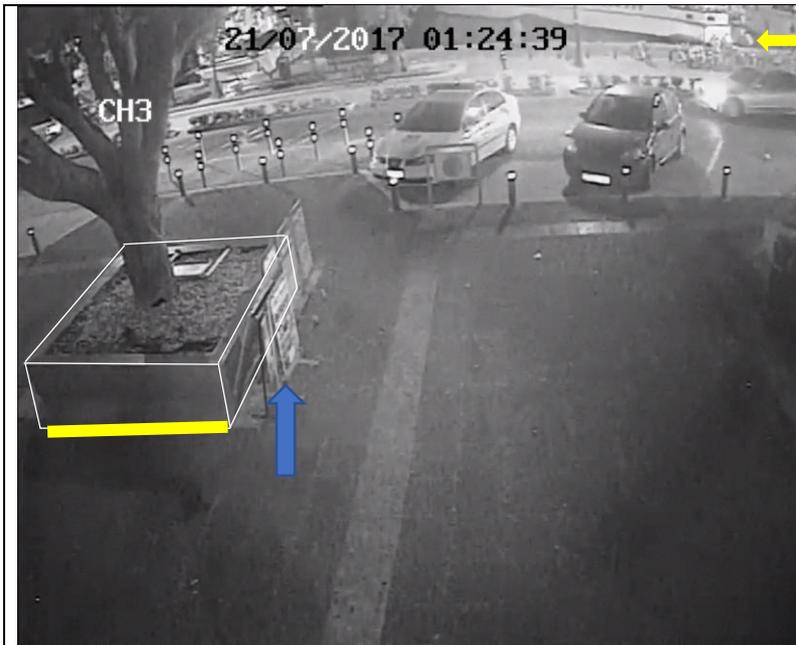
1 second before the earthquake struck. Look at the position of the fenders of the boat in yellow and the light in the city, very bright. The yellow line indicates the bottom of the plant box that is very important to establish the water height.

<p>The earthquake hits: timestamp is wrong as it should be 1:31, so it is 6 min back.</p> <p>Look at the position of the advertisement that is oscillating.</p>
	<p>People in panic runs around. Please note that now all lights are off and the area is much darker due to blackouts</p>

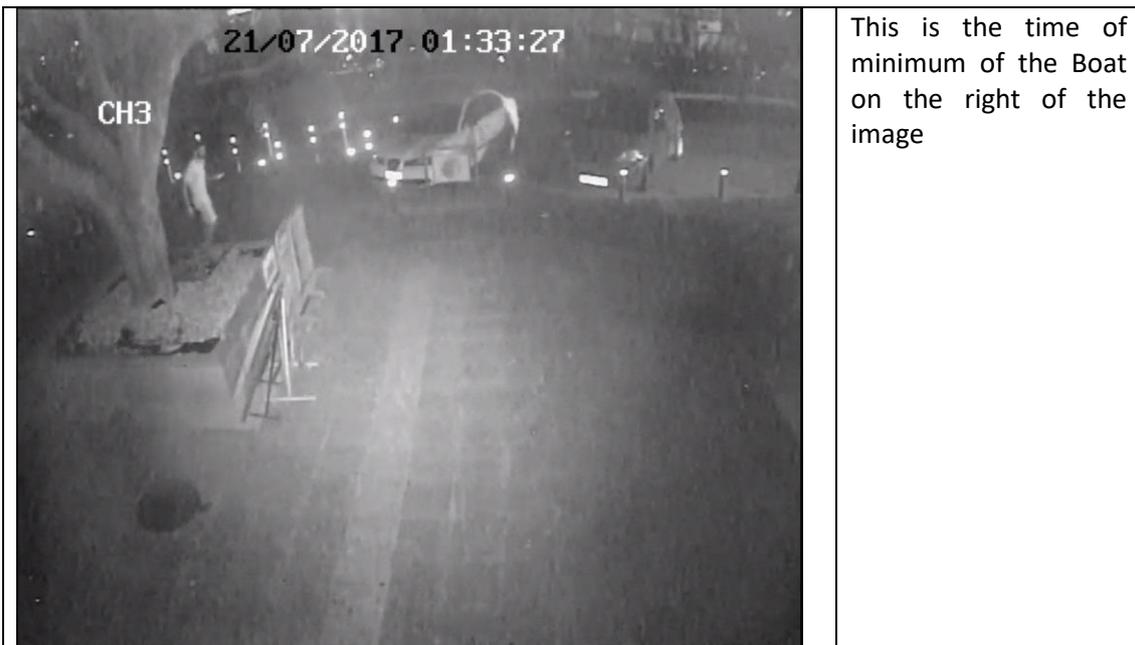
This is the time of minimum of the Boat on the right of the image

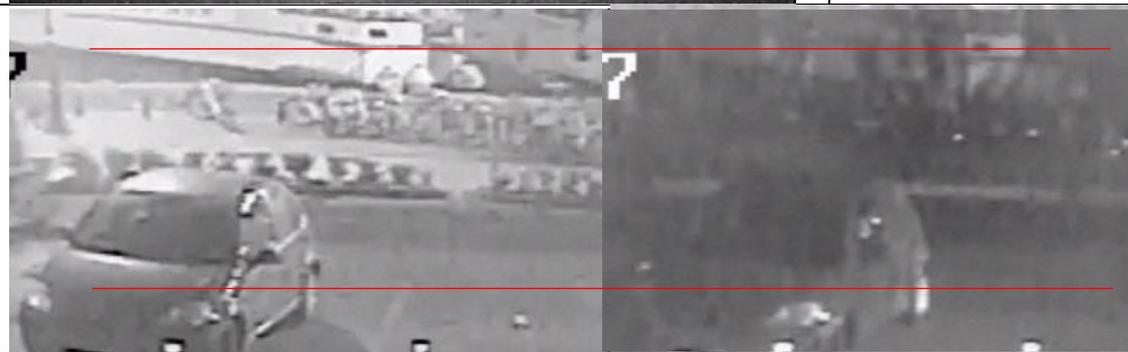
FIRST WAVE

The road is full of water but the water in this first wave do not overpass the sidewalks elevation. We attribute the maximum height as 5 cm above the sidewalks, to be sure that the wave height is not larger than this.

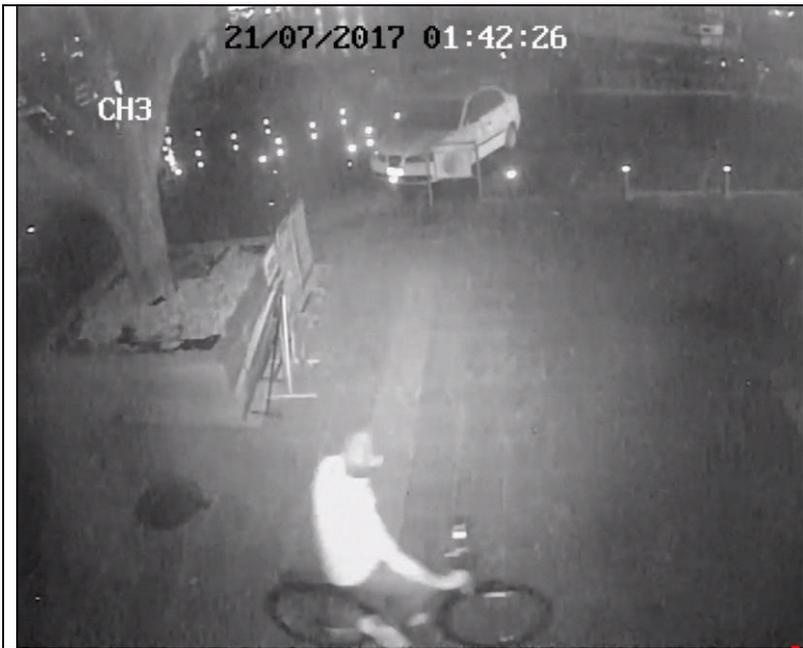
<p>The road is still wet but almost empty</p>

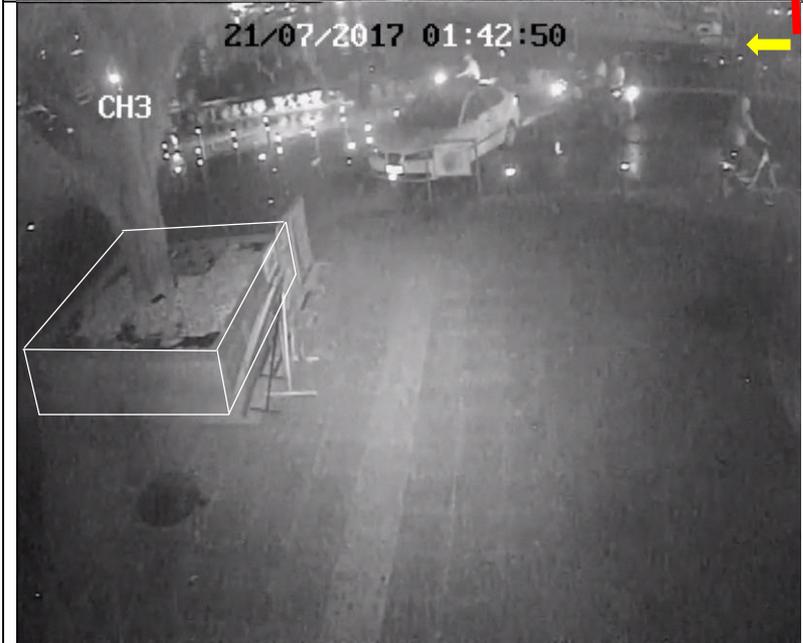
<p>This is the time of minimum height of the water in the port and the boat is down. No fender is visible.</p>

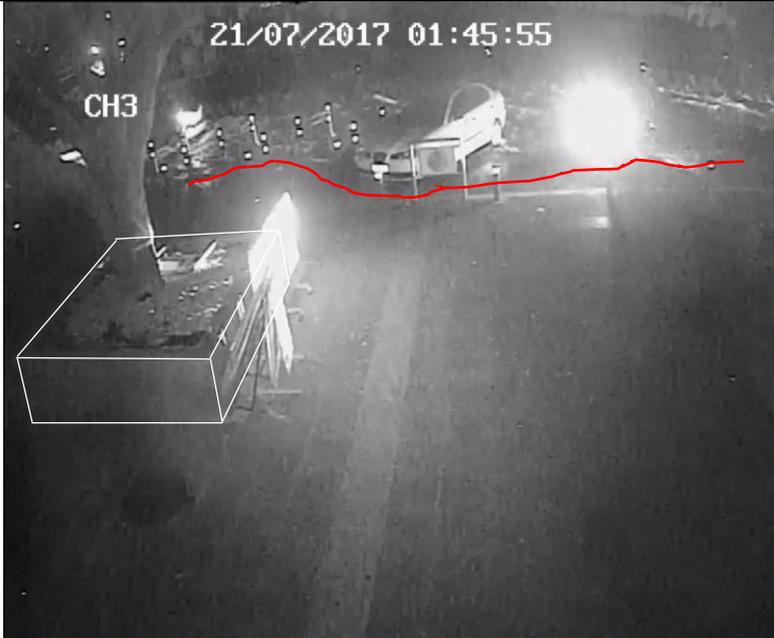
<p>SECOND WAVE: Water is out of banks and has reached the limit of the sidewalk</p>

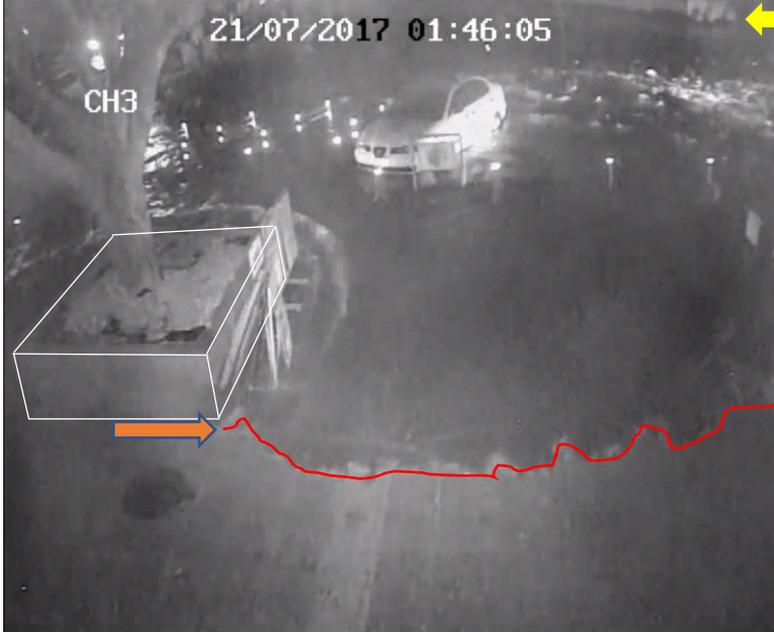
<p>At this time, the water reaches the bottom of the plant box</p>

<p>In few seconds, the water reaches half of the plant box</p> <p>The white part in the bottom of the image is reflected wave from the wall of the municipality that breaks and creates some foam</p>
	<p>This is the time of maximum. So in about 28 s the water rises and the start receding. At this time, the white car in the image starts floating and changing position</p> <p>Look at the vortex created</p>

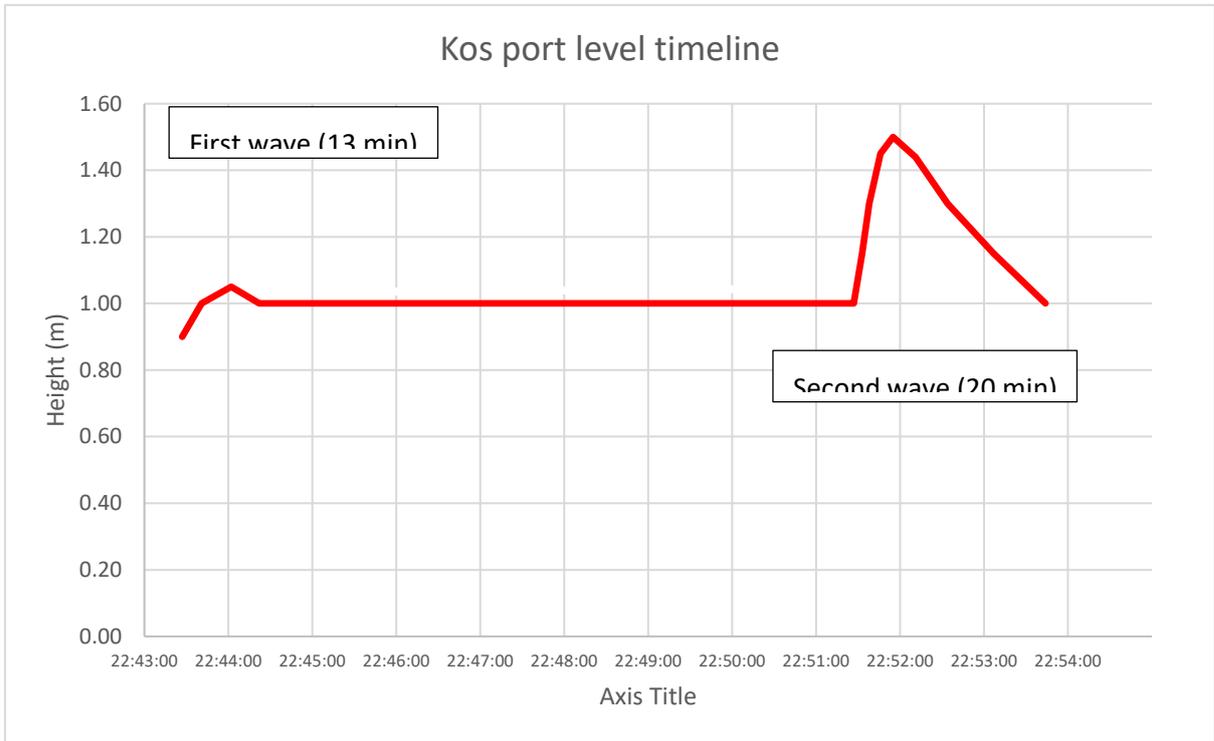
Figure 7.19: The analysis of the images and once corrected for the time delay, the plot represents the absolute height of the water, considering the location of the plant box (1 m from sea level) and the height of the plant box (46 cm). Then, the maximum 1.5 m, at the location of the plant box, occurs at 22:51 UTC but two distinct waves are present, 13 and 20 min after the earthquake.

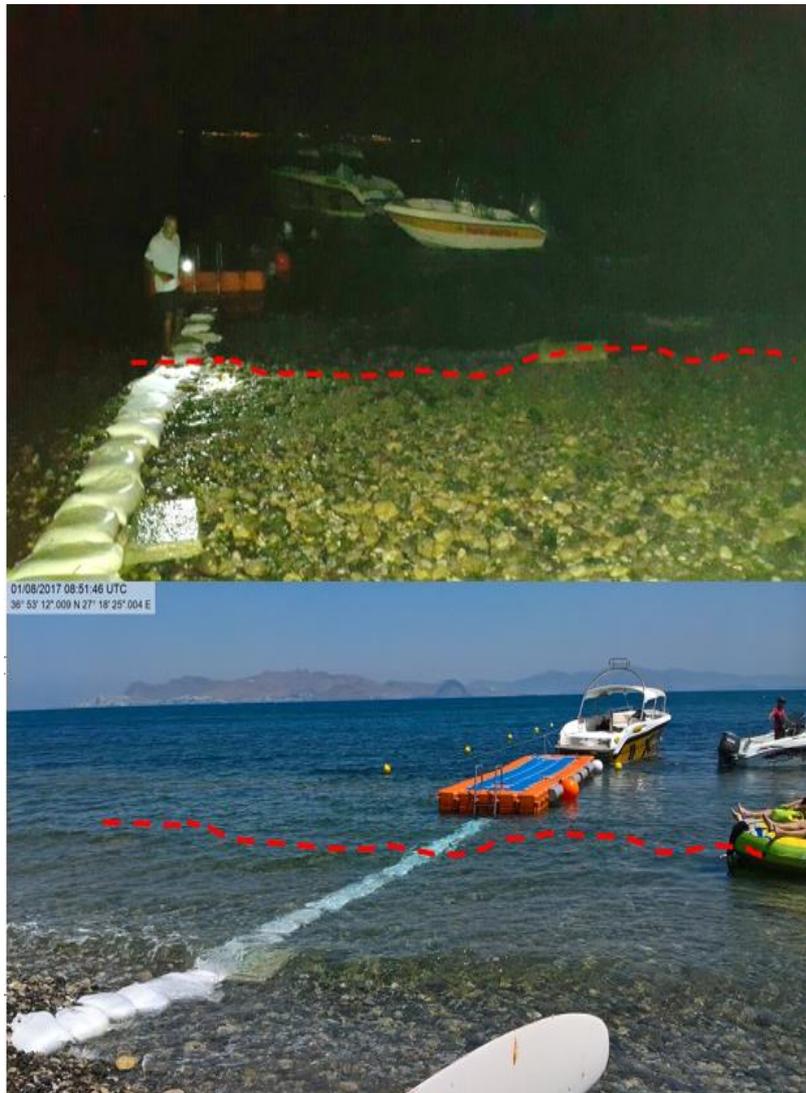
eyewitness, identifying himself as *Mike*, shows the water receding during one of the multiple waves arrivals (he mentioned that this was not the first one but he could not indicate the right time of the image). The shoreline is advanced to from its normal position (following figure). Counting the white sand bags, it seems that approximately **7-8 m** is visible.

Figure 7.20: The water receding during one of the multiple waves arrivals (at 27.30707E 36.88694N, position 14)

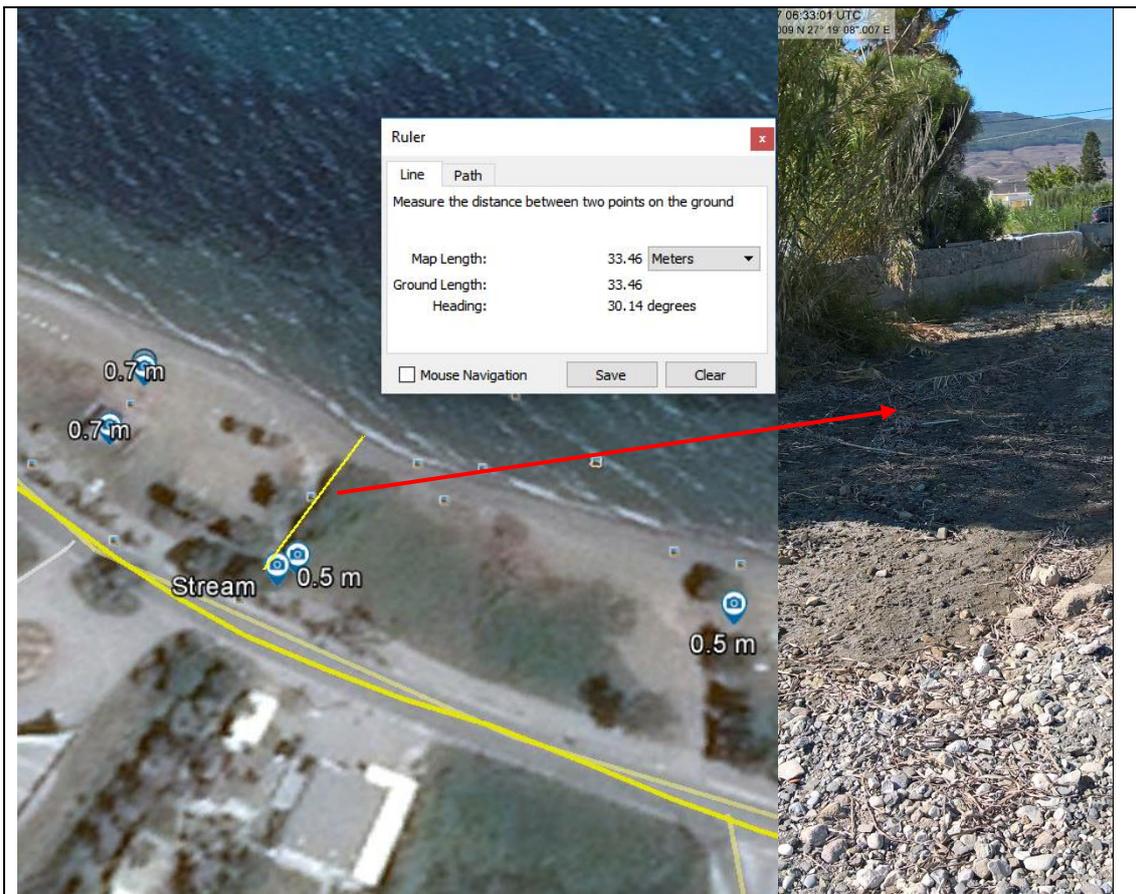
Figure 7.21: Water penetration along Leoforus Papandreu Georgiou (location 14)

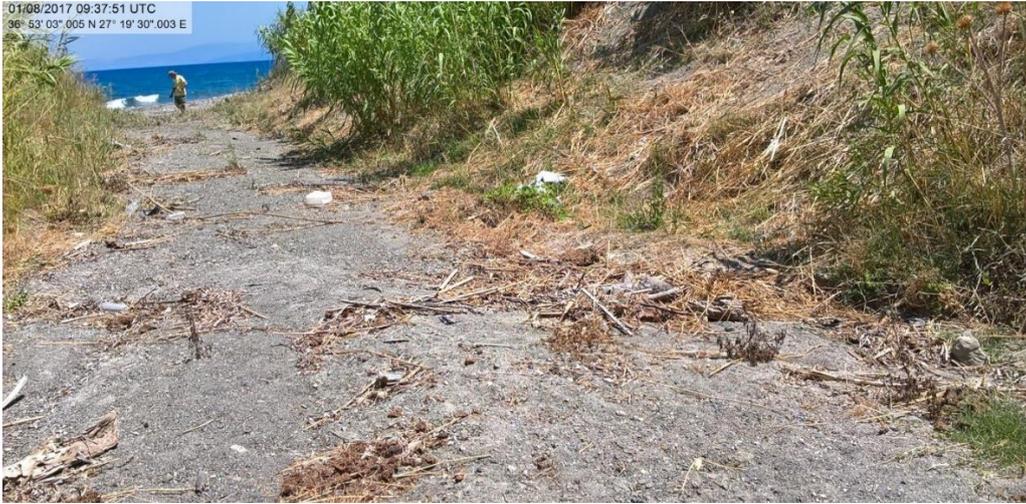
Figure 7.22: The stream at location (15) where the presence of several possibly tsunami deposits were observed.

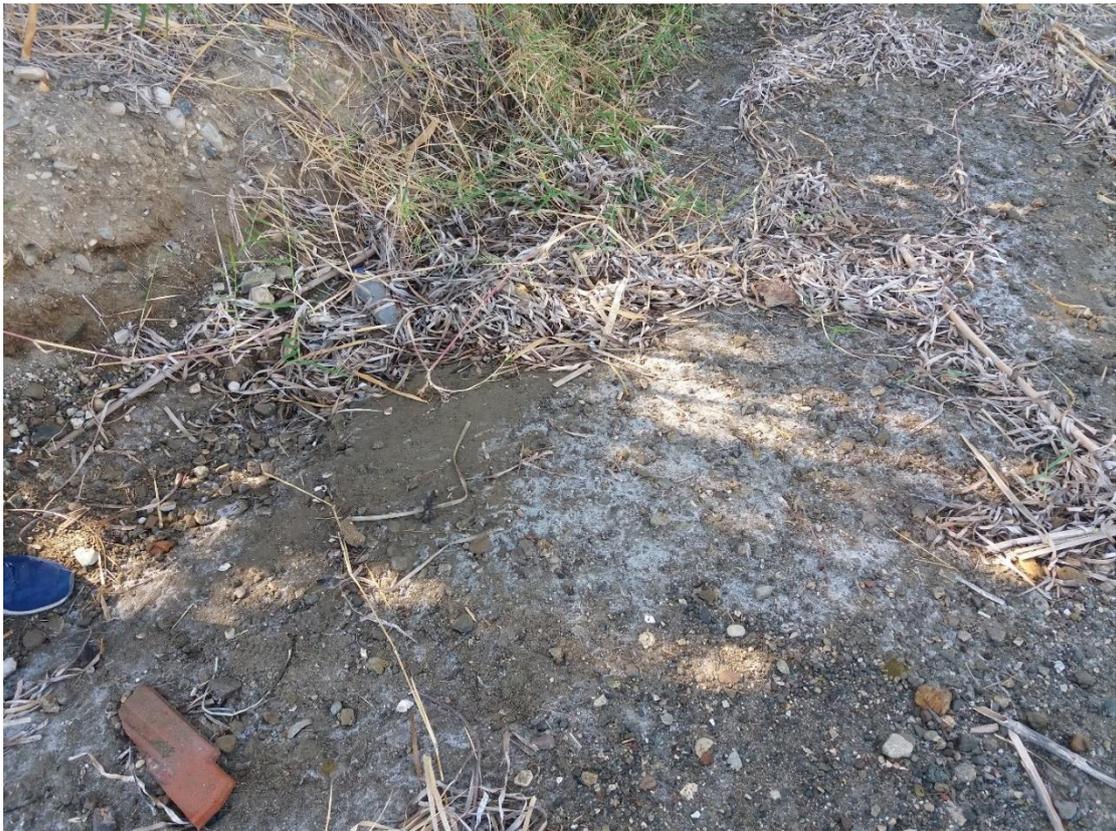
Figure 7.23: Salt remnants at the floor of the stream at location (15).

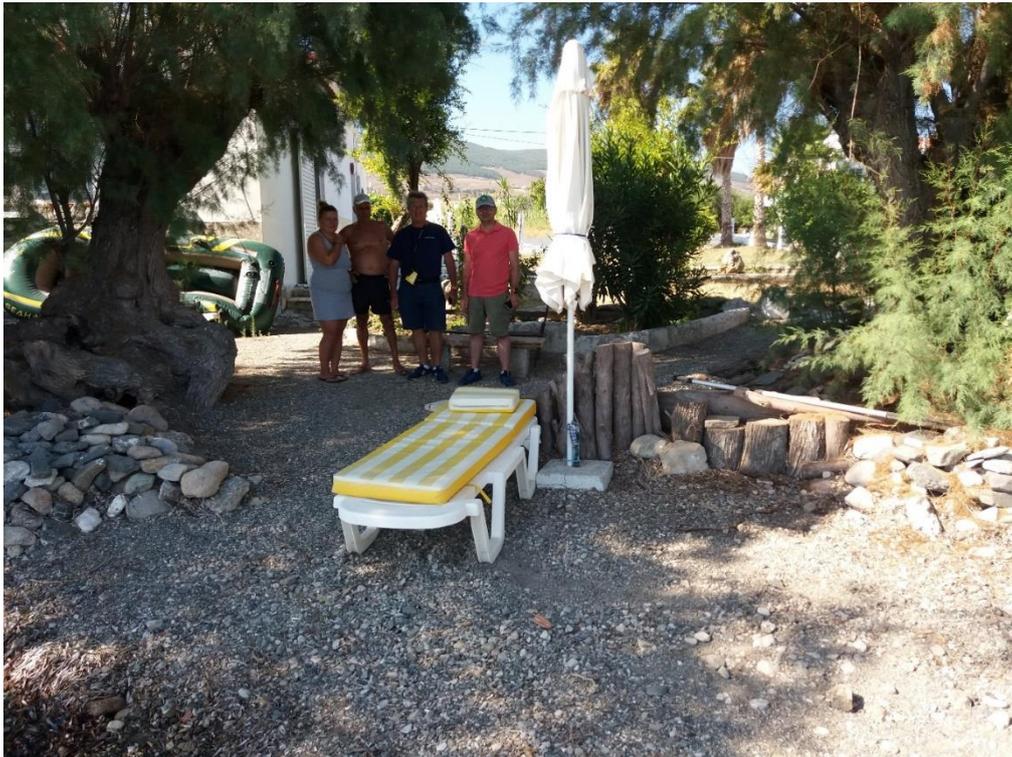
Figure 7.24: A couple (left hand side) at location (15) verified the tsunami inundation by ~15 m in their household place.

The image in Figure 7.24 is shot at 36.88489 / 27.32734 at location **(17)** and shows the line of deposits quite close to the shore, with about **0.5 m** of height above the water.
