THE 20th JULY 2017 (22:31 UTC) BODRUM/KOS EARTHQUAKE AND TSUNAMI; POST TSUNAMI FIELD SURVEY REPORT

August 17, 2017 (new version)

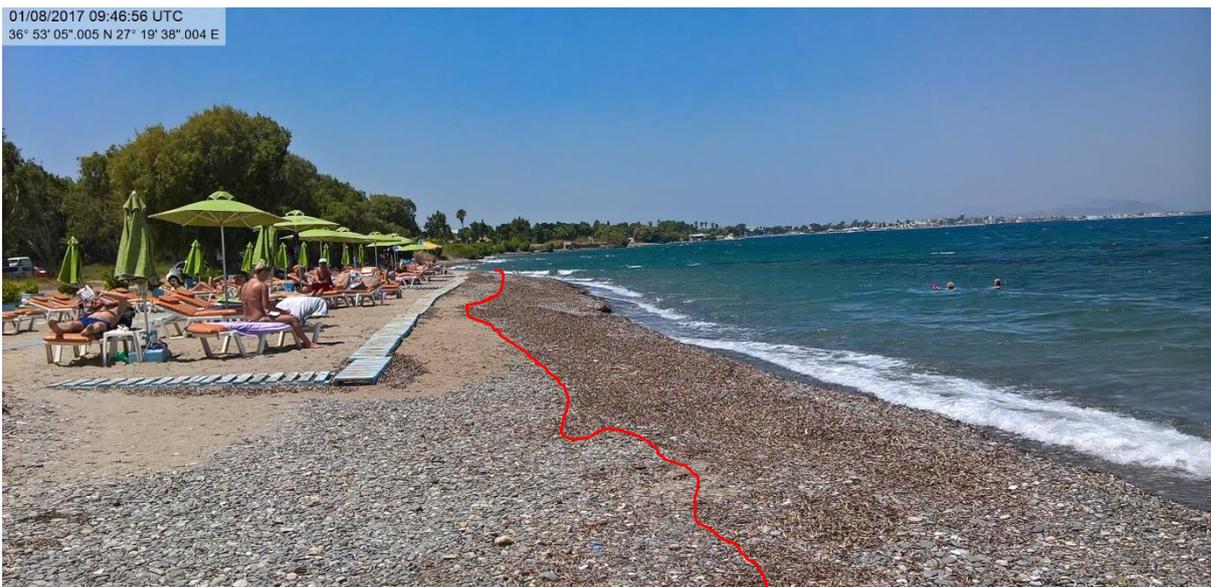
Figure 7.25: The line of deposits quite close to the shore, with about 0.5 m of height above the water.

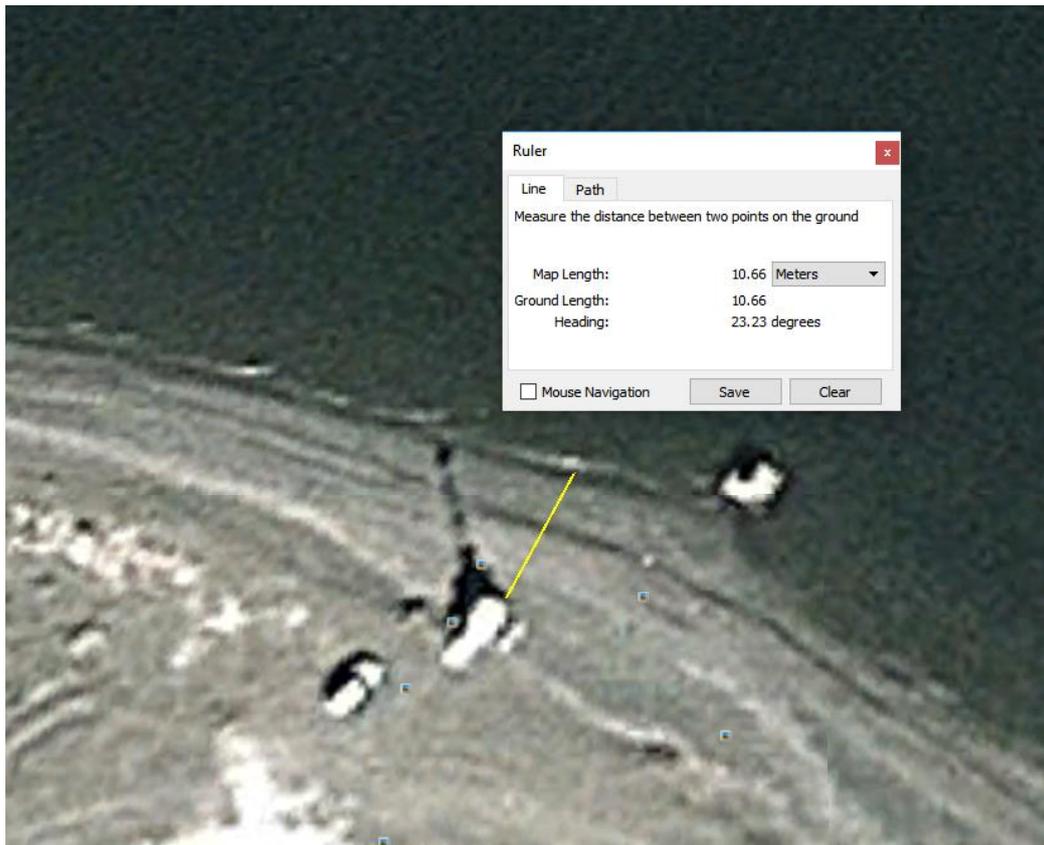
Figure 7.27: Basement of the antenna at the shoreline

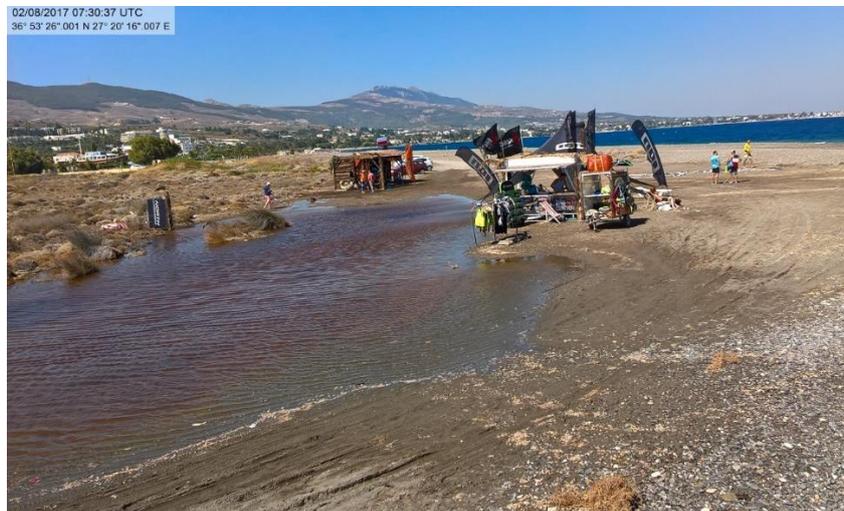
An alternative is the local subsidence that may have occurred in the Cape Louros due to the earth shaking with the large earthquake. Subsidence evidence comes from the observations at the lighthouse-antenna place, as reported above. In addition, the Mayor of Kos Mr George Kyritsis told us that two scuba divers reported to him that the sea floor around Cape Louros had deepened significantly after the earthquake. Local subsidence may have caused the very shallow water table to expose above the surface thus creating the local lake.

Subsidence evidence comes also from the marshy field situated next to the lake. In this field, we observed ground failures typical for soil liquefaction due to earthquake shaking. Namely, in the soft ground we observed fissures and local depressions, while an extensive area of the marshy field was covered by an extensive mantle of soft sand that came out from ground fissures and depressions. The sand mantle covers an area of ~30m in length and ~ 12-15m in width. A global dataset was used by de Magistris et al. (2014) to identify, on the basis of simple statistical analysis, a PGA threshold on the free ground surface below which liquefaction is unlikely to occur, regardless of the geological site conditions. The calculated value is on the order of 0.07–0.1 g⁷.

Figure 7.28: The lake as seen from the lighthouse-antenna stand. The liquefied area is at the left side. The distance to the right side is ~50-60 m. A small kiosk of the wind surf stand remained at the left edge of the lake.

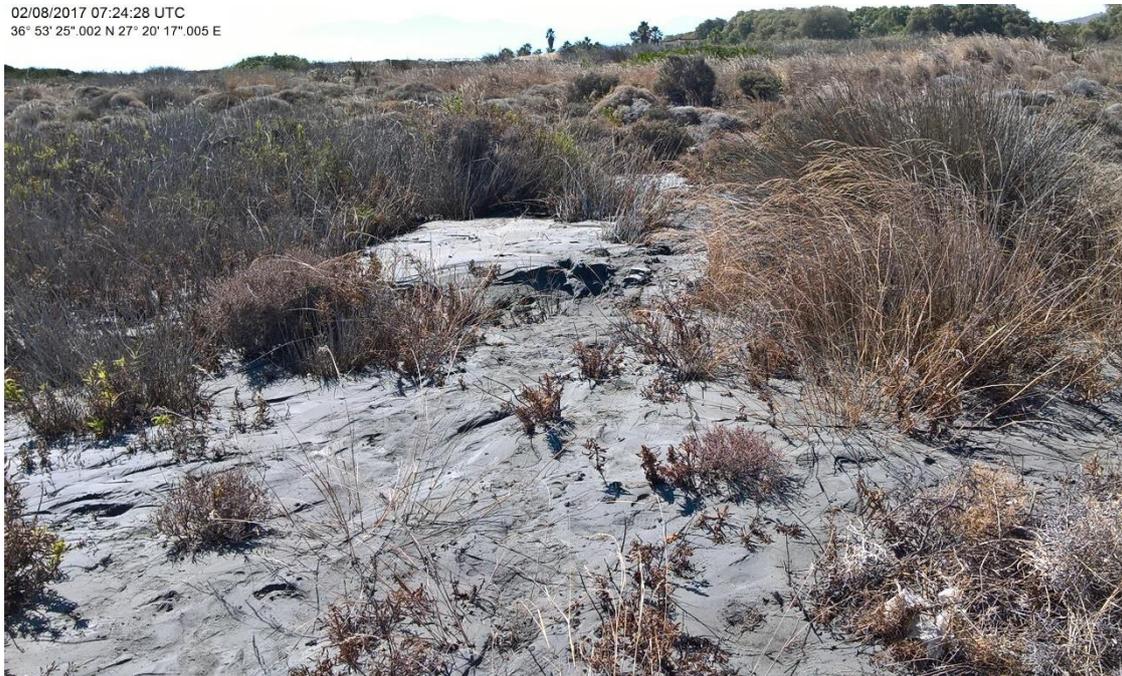
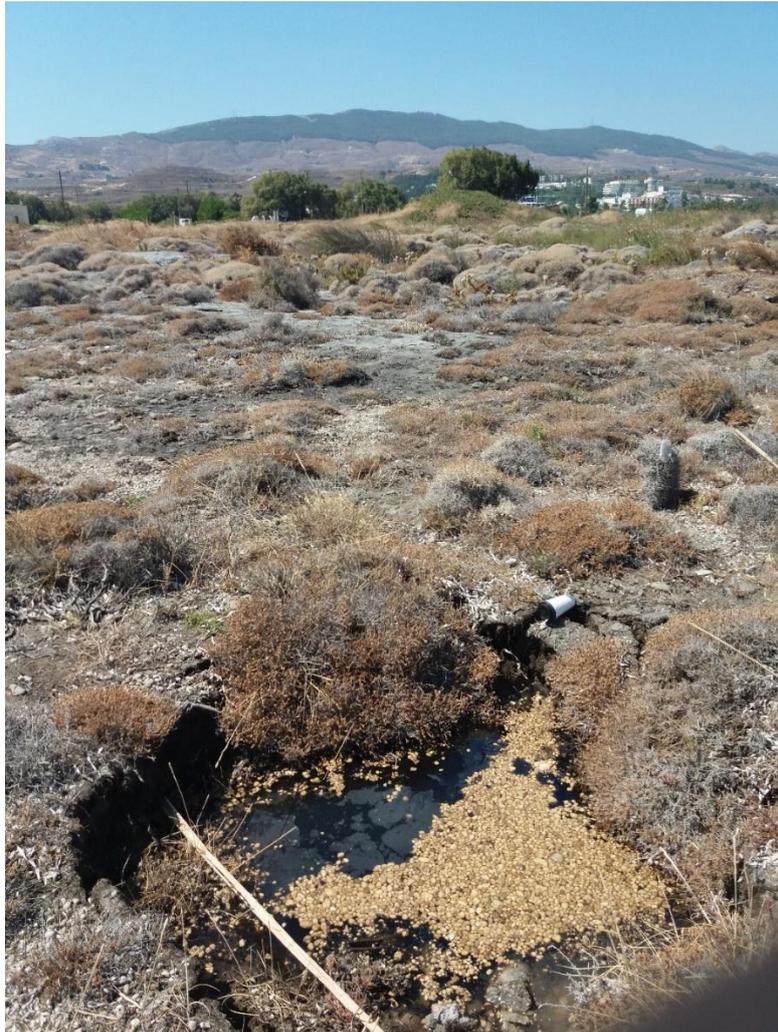
Local ground depression in the liquefied area. Sand mantle is shown at the background.

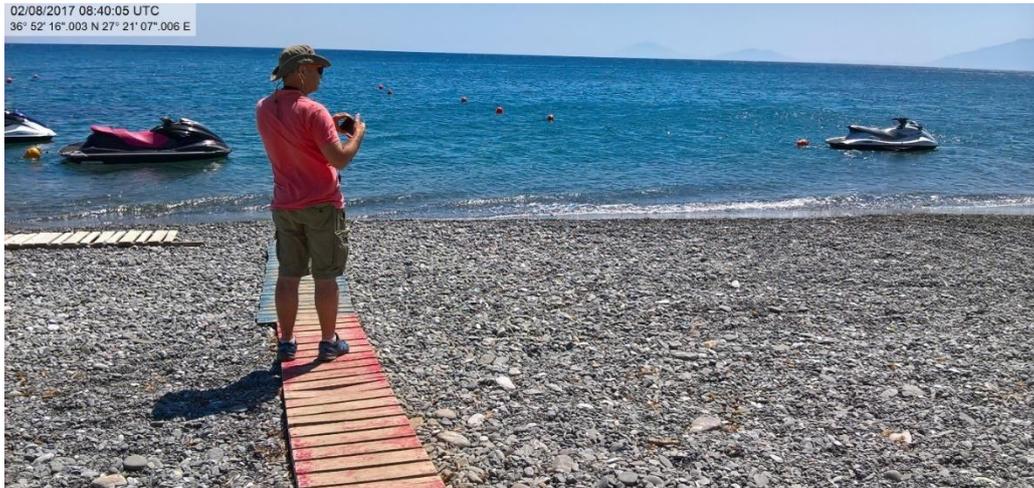
Figure 7.30: At this location 36.87120/27.35213, point (19), the estimated height is about 0.7 m.

As the height at Louros Cape varied between **0.1 and 0.5 m** the estimated height, by the deposits, restarted to increase up to **0.7 m**.

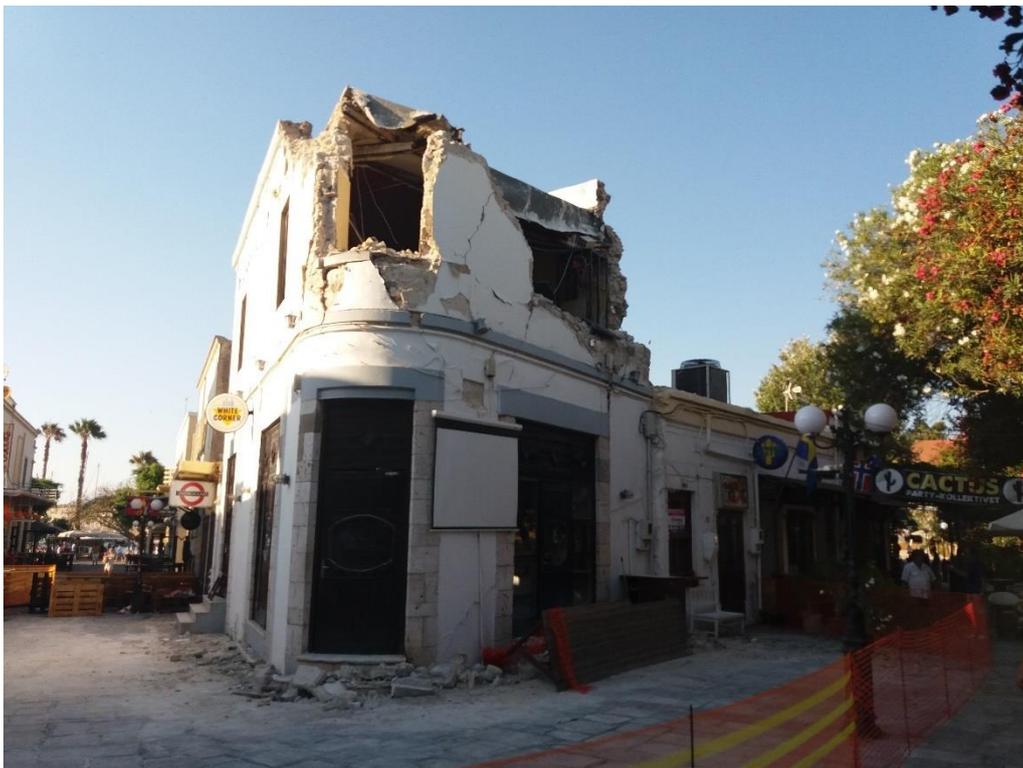
Figure 7.32: Damaged building at Kos in the old part of Kos City

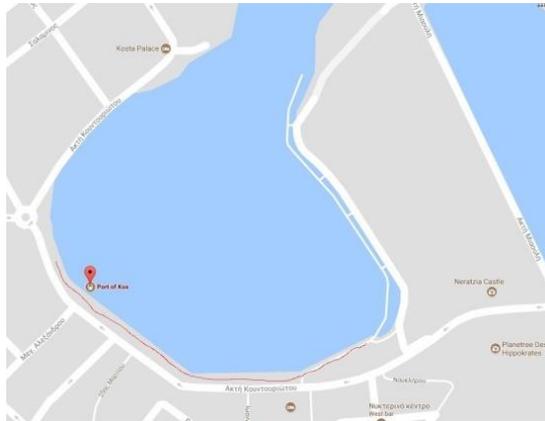
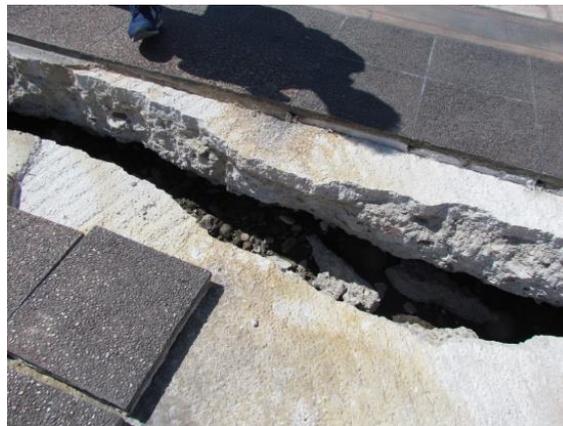
Figure 7.33: A) Damage line at the dock of port B) Damage at the dock of port C) Damage at the dock of port D) Distancing of the materials of the dock

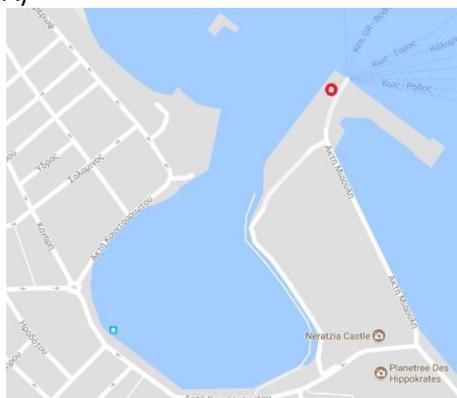
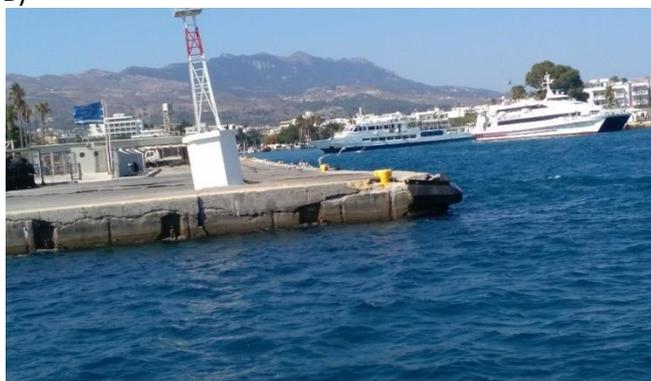
Figure 7.34: Failure on the ground of the lighthouse were occurred by the strong shaking of the earthquake and structural problems of the dock. A) Location of the light house B) Port structure deformation due to the earthquake

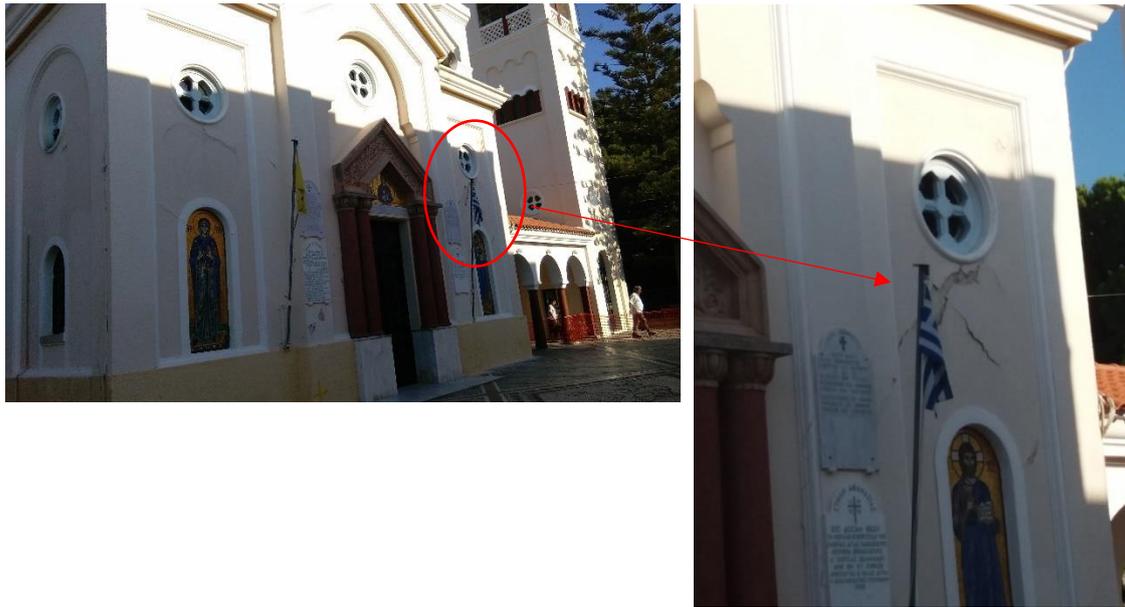
Figure 7.35: The church of Agia (St.) Paraskevi (old part of the Kos city) damaged and rendered temporarily unusable.

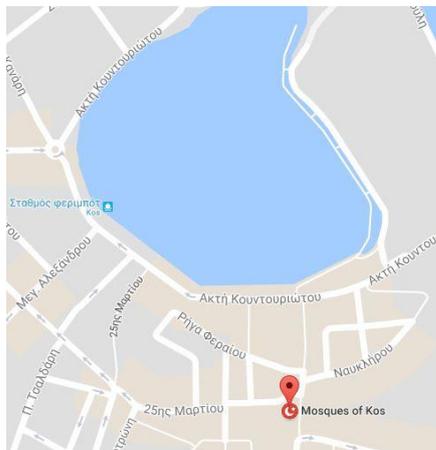
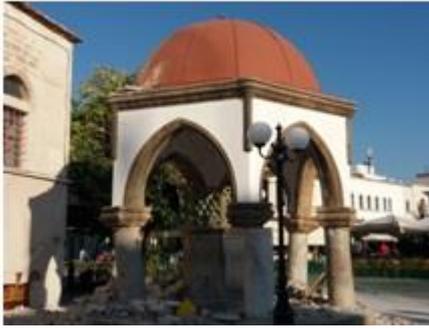
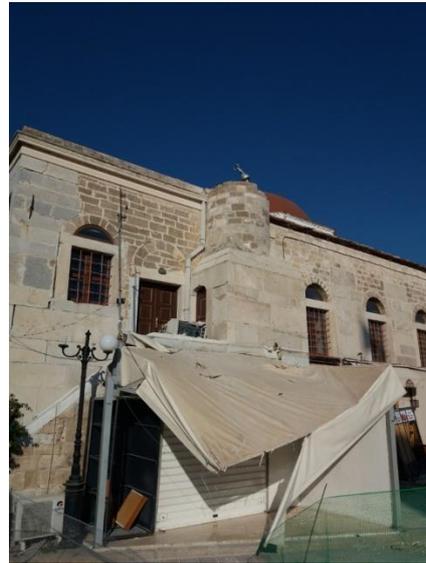
Figure 7.36: The minaret of the Mosque of Defterdar, built in Eleftherias Square at the end of 18th century (old part of the Kos city) collapsed due to the earthquake, only its base remained.

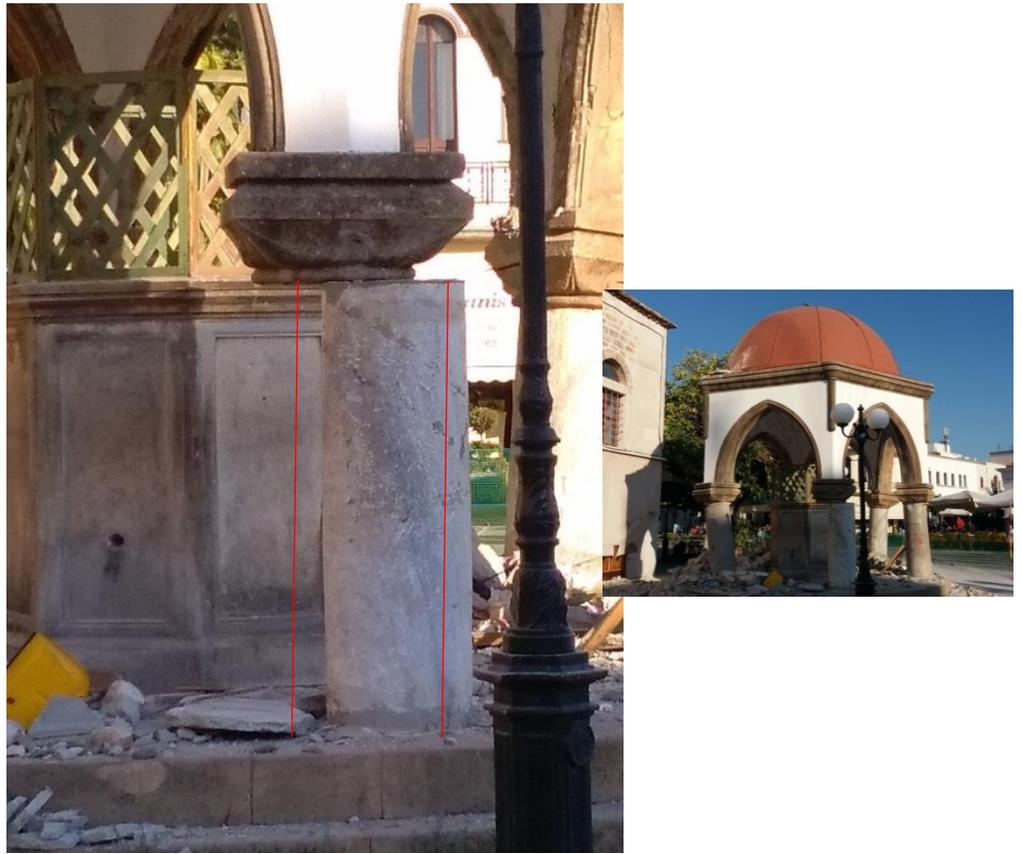
Figure 7.37: One fountain of Mauritanian style, situated next to the Defterdar Mosque (old part of the Kos city) damaged due to the strong earth shaking but also because the Mosque minaret fell on it. Please note the change of the relative position between the column and the roof structure (red lines).

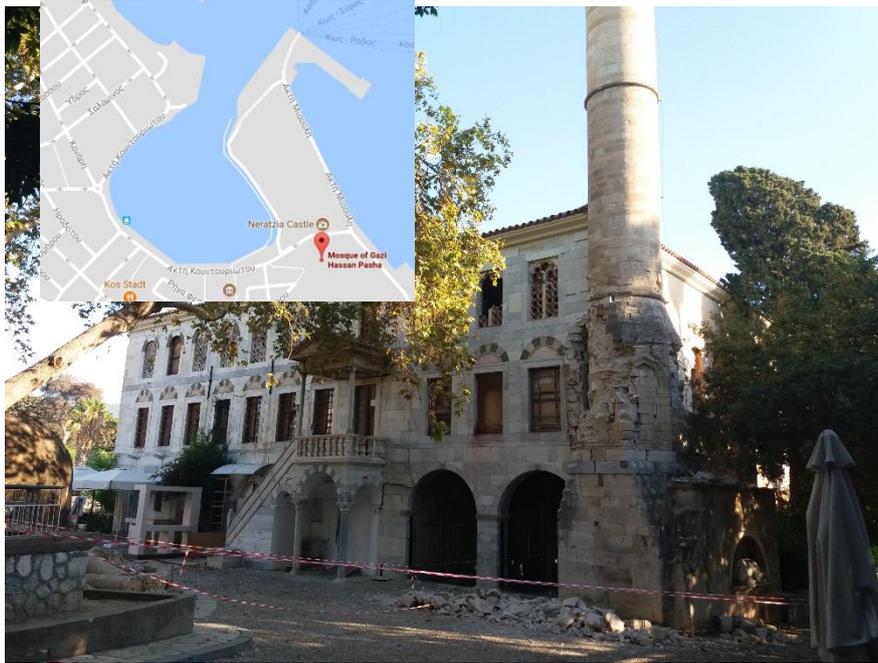
Figure 7.38: The minaret of the Gazi Hasan Pasha Mosque (old part of the Kos city) was damaged at its base. The Mosque building also damaged.

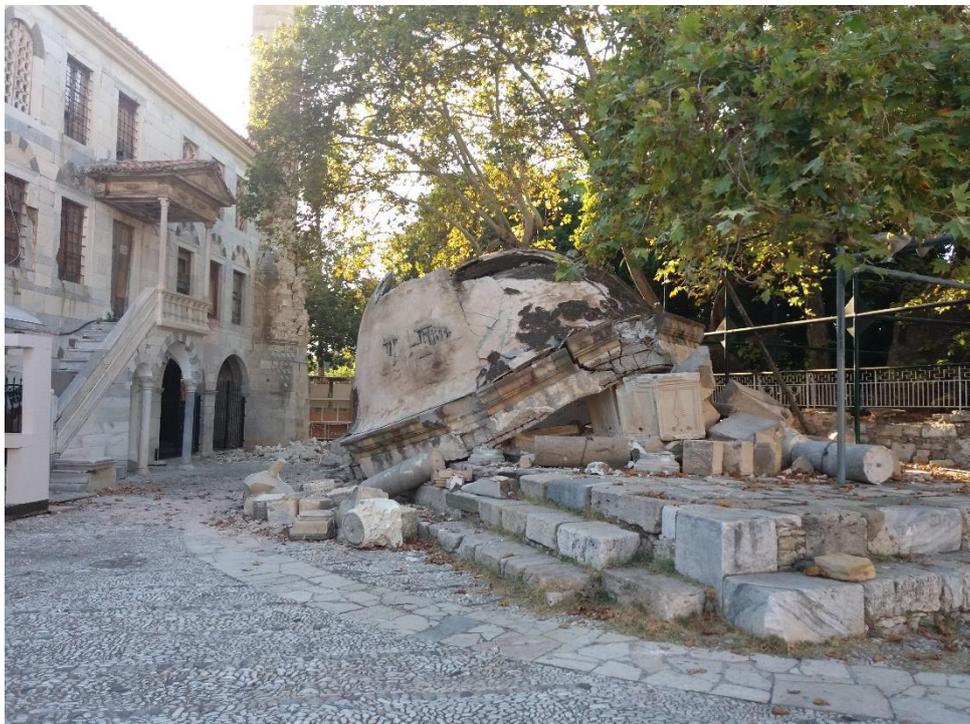
Figure 7.39: One fountain of Mauritanian style, situated next to the Gazi Hasan Pasha Mosque (old part of the Kos city) was completely collapsed.

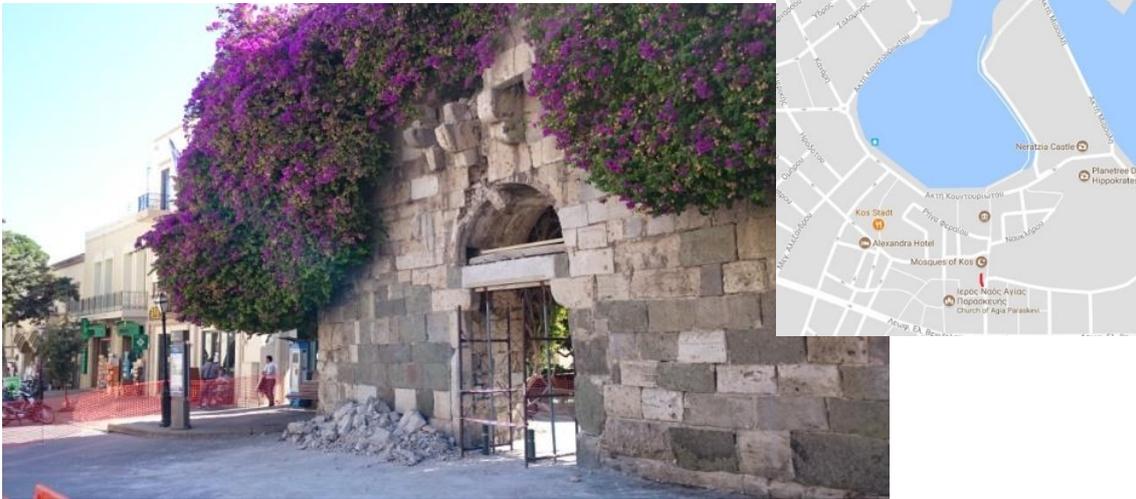
Figure 7.40: Damages occurred to a number of historical building from Roman time in various parts of the city

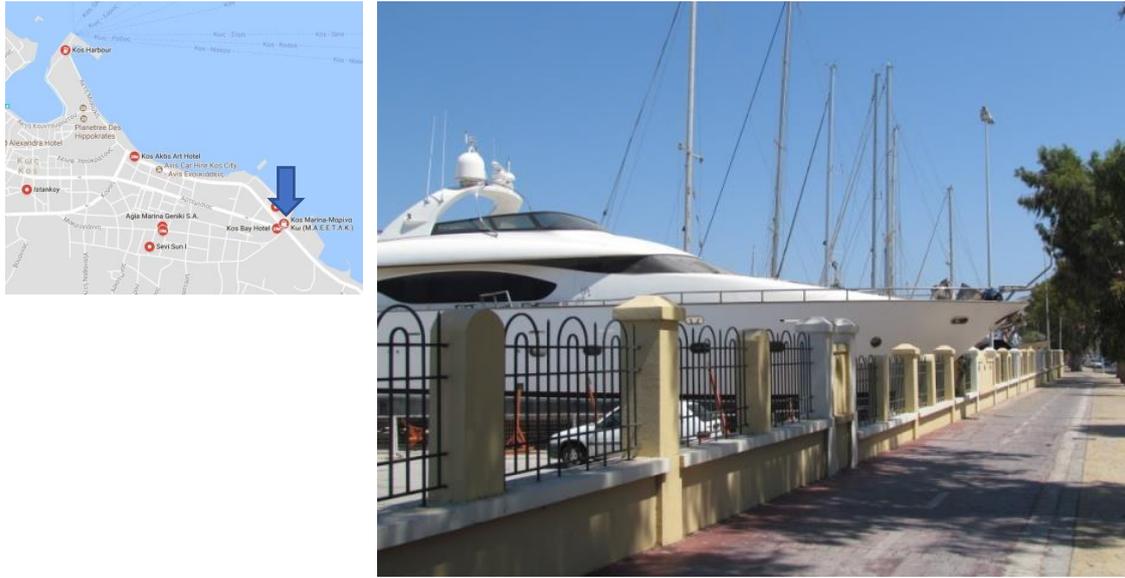
Figure 7.39: A) Location of the marina B) Sliding the ship from attachments to the walking road

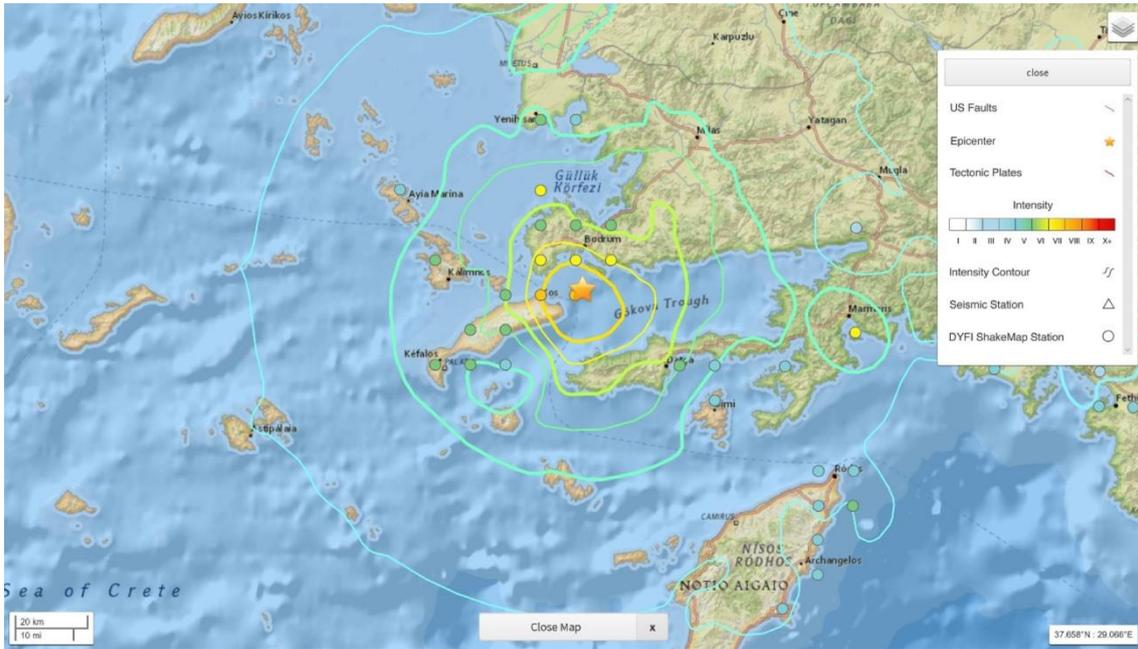
Figure 8.1 Seismic intensity in the earthquake on July 20, 2017 (USGS: lower enlarged view)

An earthquake of magnitude 6.6 occurred off the coast of Turkey, Bodrum at 22:31 on July 20, 2017 (UTC, local time July 21, 25:31). Figure 8.1 shows the seismic intensity at that time. In the Bodrum region targeted this investigation, the intensity was about 6 to 7.

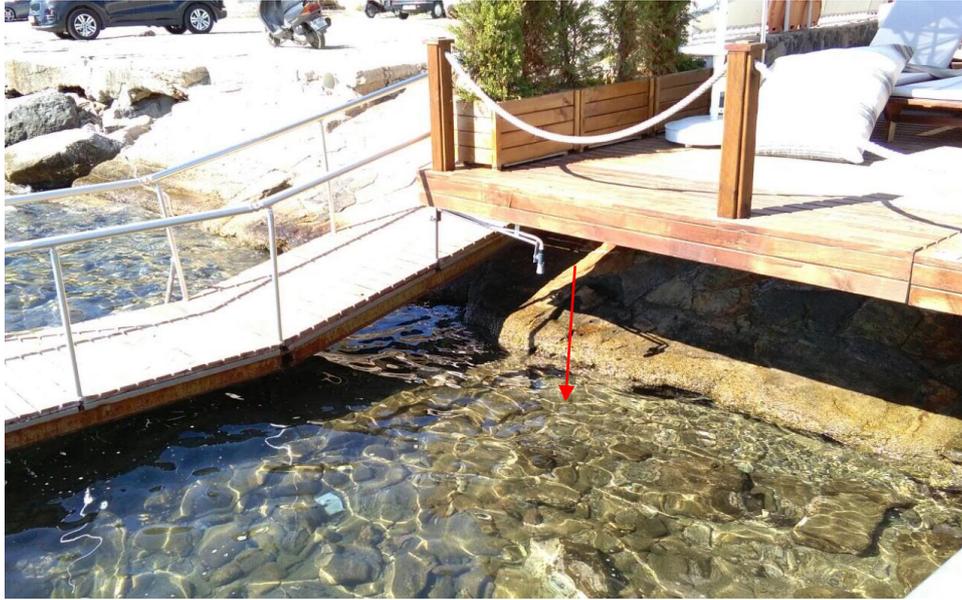
Figure B.0.2: The IDSL installed at the Voyage Hotel

The Bodrum tide gauge is located in a restricted area located about 500 m from the exit of the Bodrum port. A portable version of an IDSL (Inexpensive Device for Sea Level measurements) has been installed by Annunziato and Sozdinler on 29th July at a structure of the Voyage Hotel, 37.027506/27.416967. The objective was to verify for at least 1 full day, that the readings of the Bodrum tide gauge were consistent with the measurements of the IDSL.

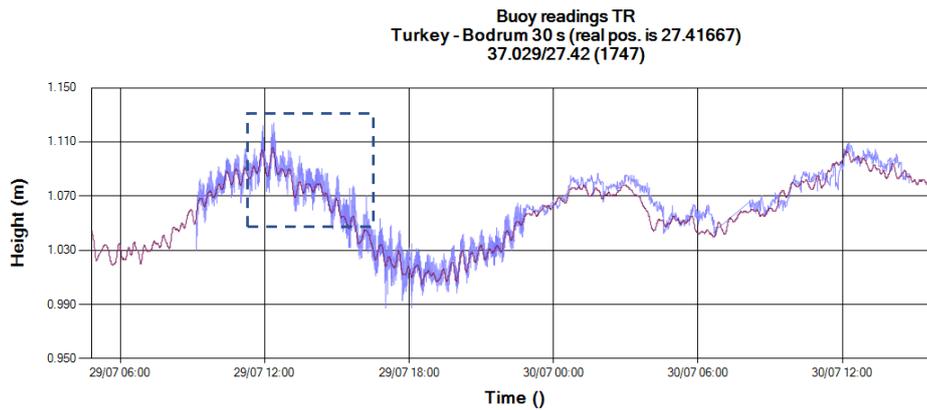
Figure B.0.3: Bodrum Tide Gauge and IDSL Buoy Readings

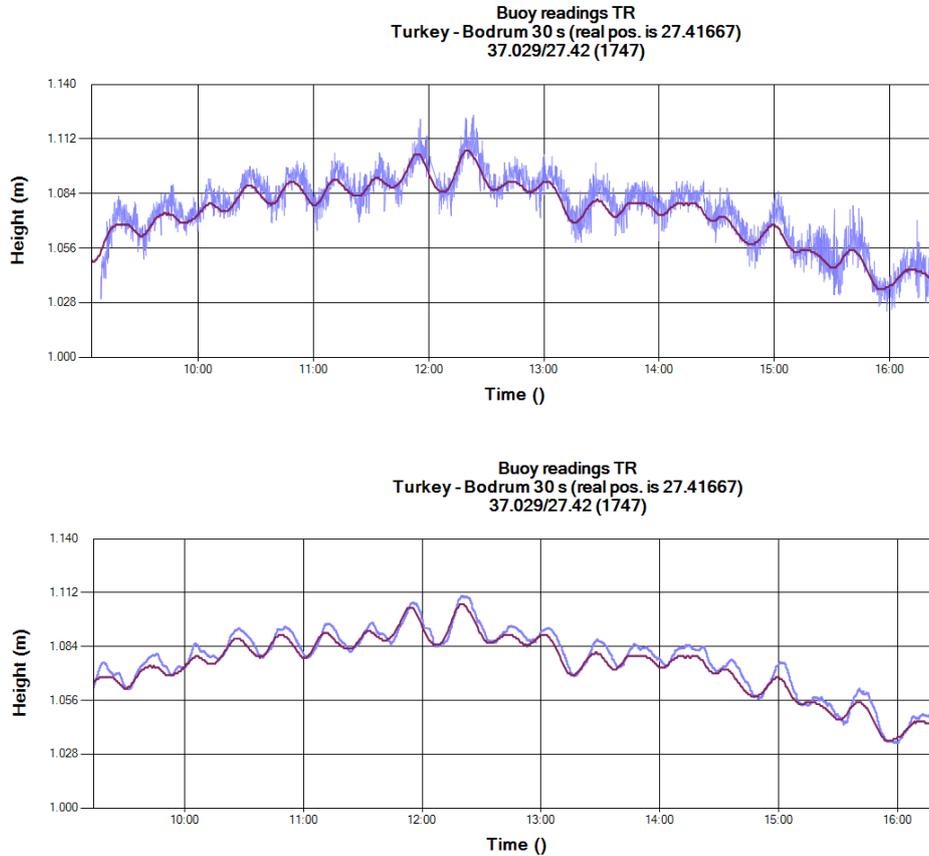
Figure B.0.4: Comparison of Bodrum Tide Gauge and IDSL Buoy Readings
