Date: 20th May, 2011

## GEOLOGICAL PRELIMINARY FIELD REPORT OF THE LORCA EARTHQUAKE (5.1 $M_w$ , 11<sup>TH</sup> MAY 2011)

*Translation from the original report in Spanish*

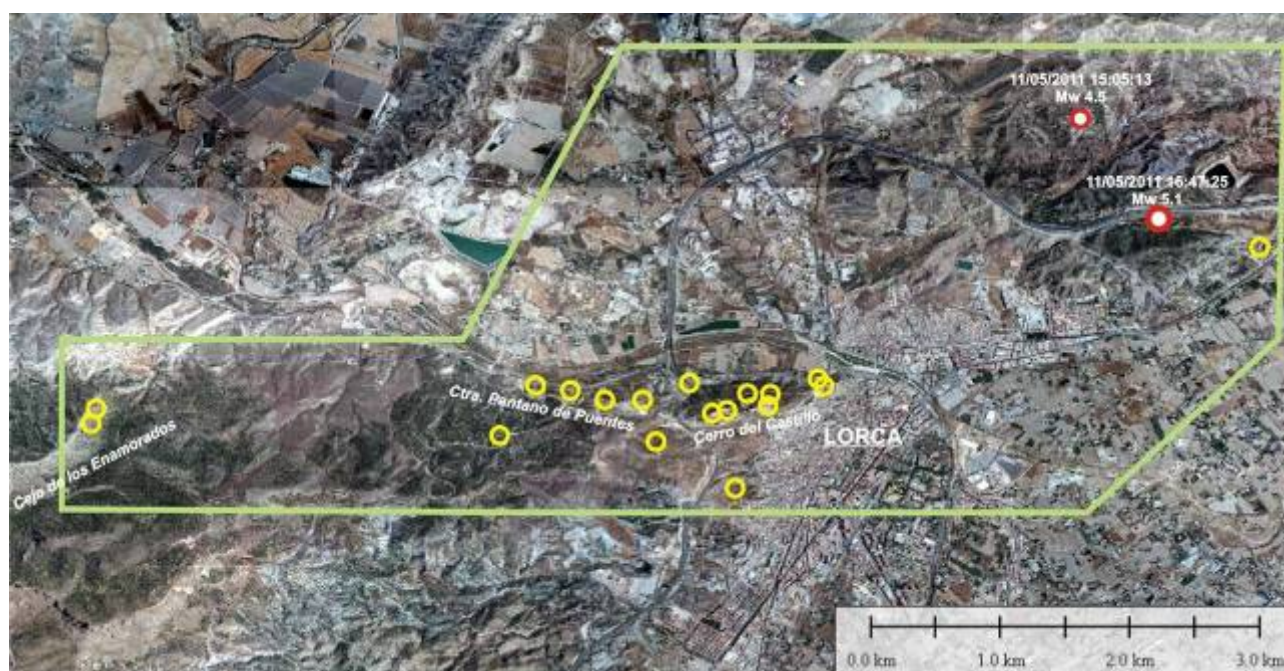
Few of the instabilities produced by the earthquake can be referred as significative in the sense that they have produced some damage in buildings and temporal road-cuts.

In particular, at the easternmost point of Lorca's Castle cliff, a fallen rock-block has destroyed part of the wall enclosing the patio of a house. Alike, on the road up-the-hill to the castle few rock-falls have badly damaged the pavement. A similar situation has taken place on the road to the Pantano de Puentes, which was temporarily closed to traffic. It is remarkable that on Friday 13<sup>th</sup> (aprox 24 h after the earthquake) both situations were already solved and driving was possible with relative normality.

Figure 4.1: Situation of the main slope instabilities identified in the field survey.

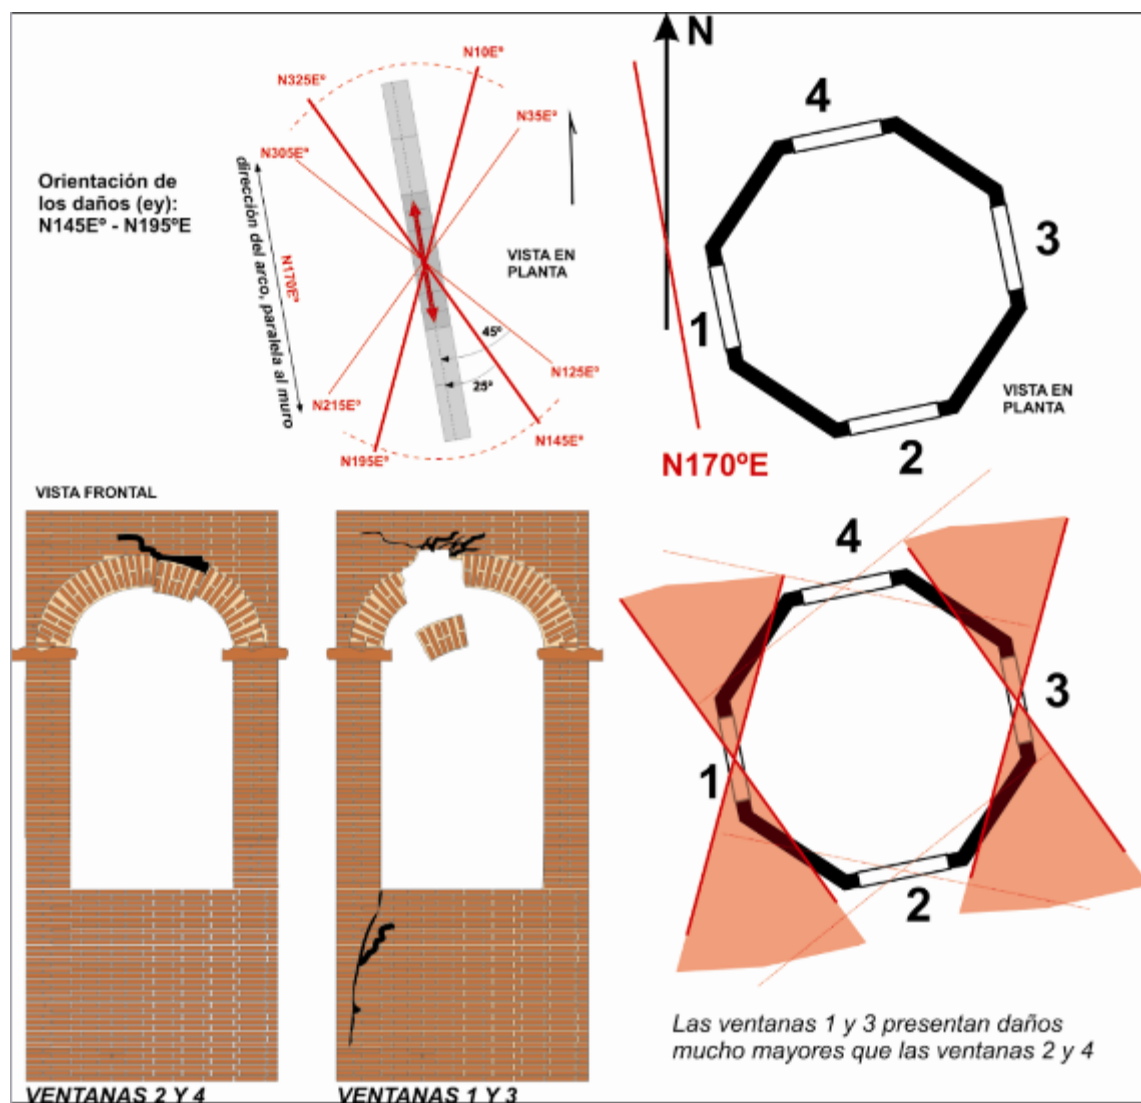
Figure 5.8: Example of analysis of deformation structures and the results of the orientation assessment of the strain (San Juan's Church).
