May 1, 2003 Bingöl (Turkey) Earthquake

Kıvanç KEKOVALI, Doğan KALAFAT, Yavuz GÜNEŞ, Mehmet YILMAZER

Kandilli Observatory and Earthquake Research Institute - Seismology Division,
Boğaziçi University, Istanbul, Turkey

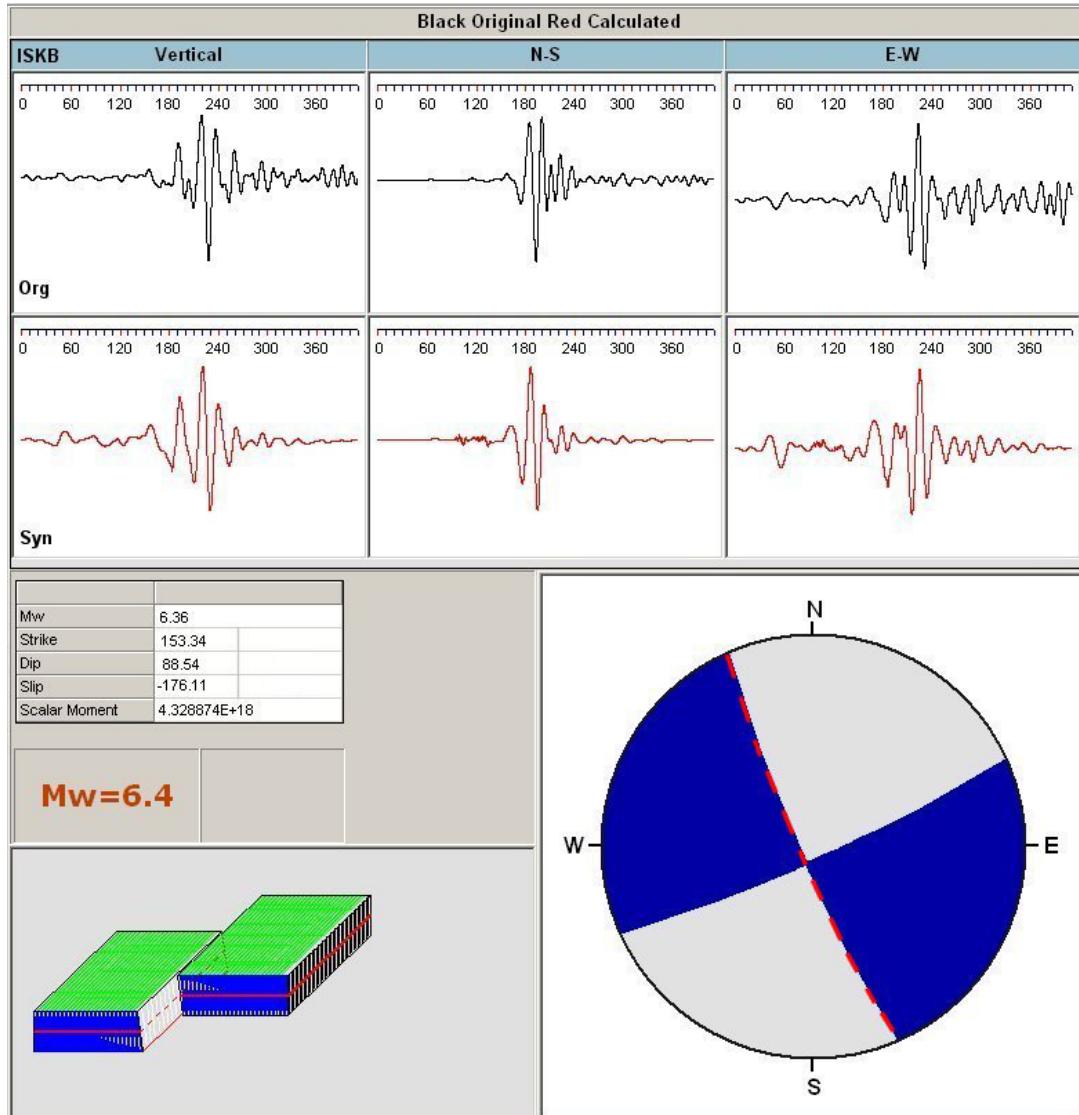
In the Central station, seismological data are interpreted (P and S arrivals identification, first onsets, signal duration) and processed by computer. Figure 3 shows the original waveforms recorded at ISKB Broadband station in Kandilli Observatory and calculated synthetic waveforms in three components. The fault plane solution indicated that the causative fault was a right-lateral strike slip fault (strike 153°, dip 88°). This fault plane coincides with the aftershock distribution and is believed to represent the actual fault plane. The seismic moment is $M_0 = 4.3 \times 10^{18}$ Nm indicates a moment magnitude (Mw) of 6.4.

Figure 3. Focal mechanism solution of the mainshock.

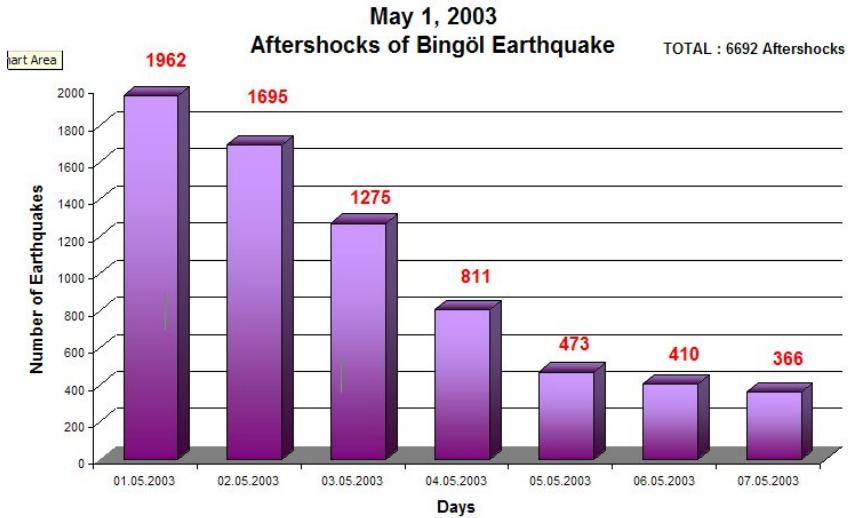
Following the occurrence of the mainshock, a total of more 6700 aftershocks were recorded between 1-8 May, 2003 by Seismology Division (Figure 4). The number of aftershocks decreased with time. Aftershocks of 2003 Bingöl earthquake are generally located in Bingöl-Sancak-Adaklı region. The distribution of these earthquakes with days is illustrated in the following figure.

Figure 4. Distribution of aftershocks occurred between 01-08 May, 2003.

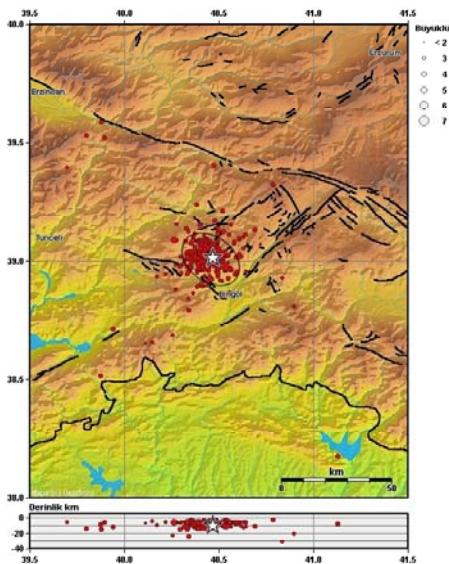
As seen from figure 5 the aftershocks with $M \leq 4.3$ took place over a large area around the epicenter of the main shock. Therefore, it is difficult to estimate an evident faulting strike from this distribution. However, based on the evaluation of the aftershocks with $M \geq 4.3$, they show an alignment in NW- SE direction that is consistent with the fault break (Figure 6).

Figure 5. The aftershock activity with $M \leq 4.3$.

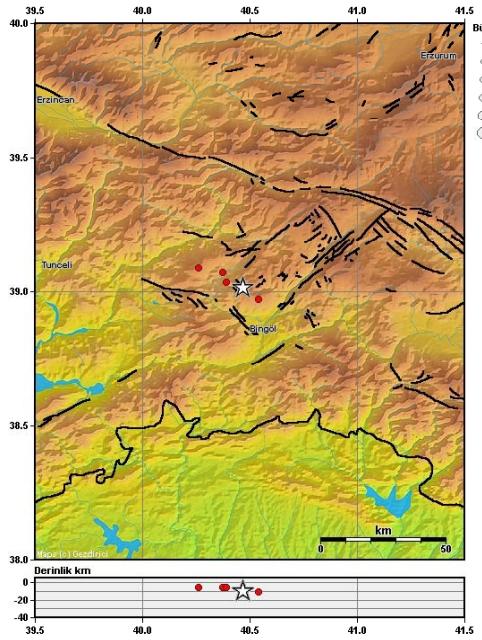
Figure 6. The aftershock activity with $M \geq 4.3$.
